# RESTORATION OF TWO PAINTINGS AND DECORATIVE FRAMES AT KURMENES ST. PETER'S ROMAN CATHOLIC CHURCH

**IRBE GRĪNBERGA**, Mg Art  
Grandmaster-restorer of easel-paintings  
grinberga.irbe@gmail.com  
Riga, Latvia

**DACE PĀŽE**, Mg Art  
Easel painting master-restorer  
paze.dace@gmail.com  
Riga, Latvia

**AIGARS PILENIEKS**  
Restorer of furniture and interior items  
info@3rstudija.lv, www.3rstudija.lv  
Private workshop, Riga, Latvia

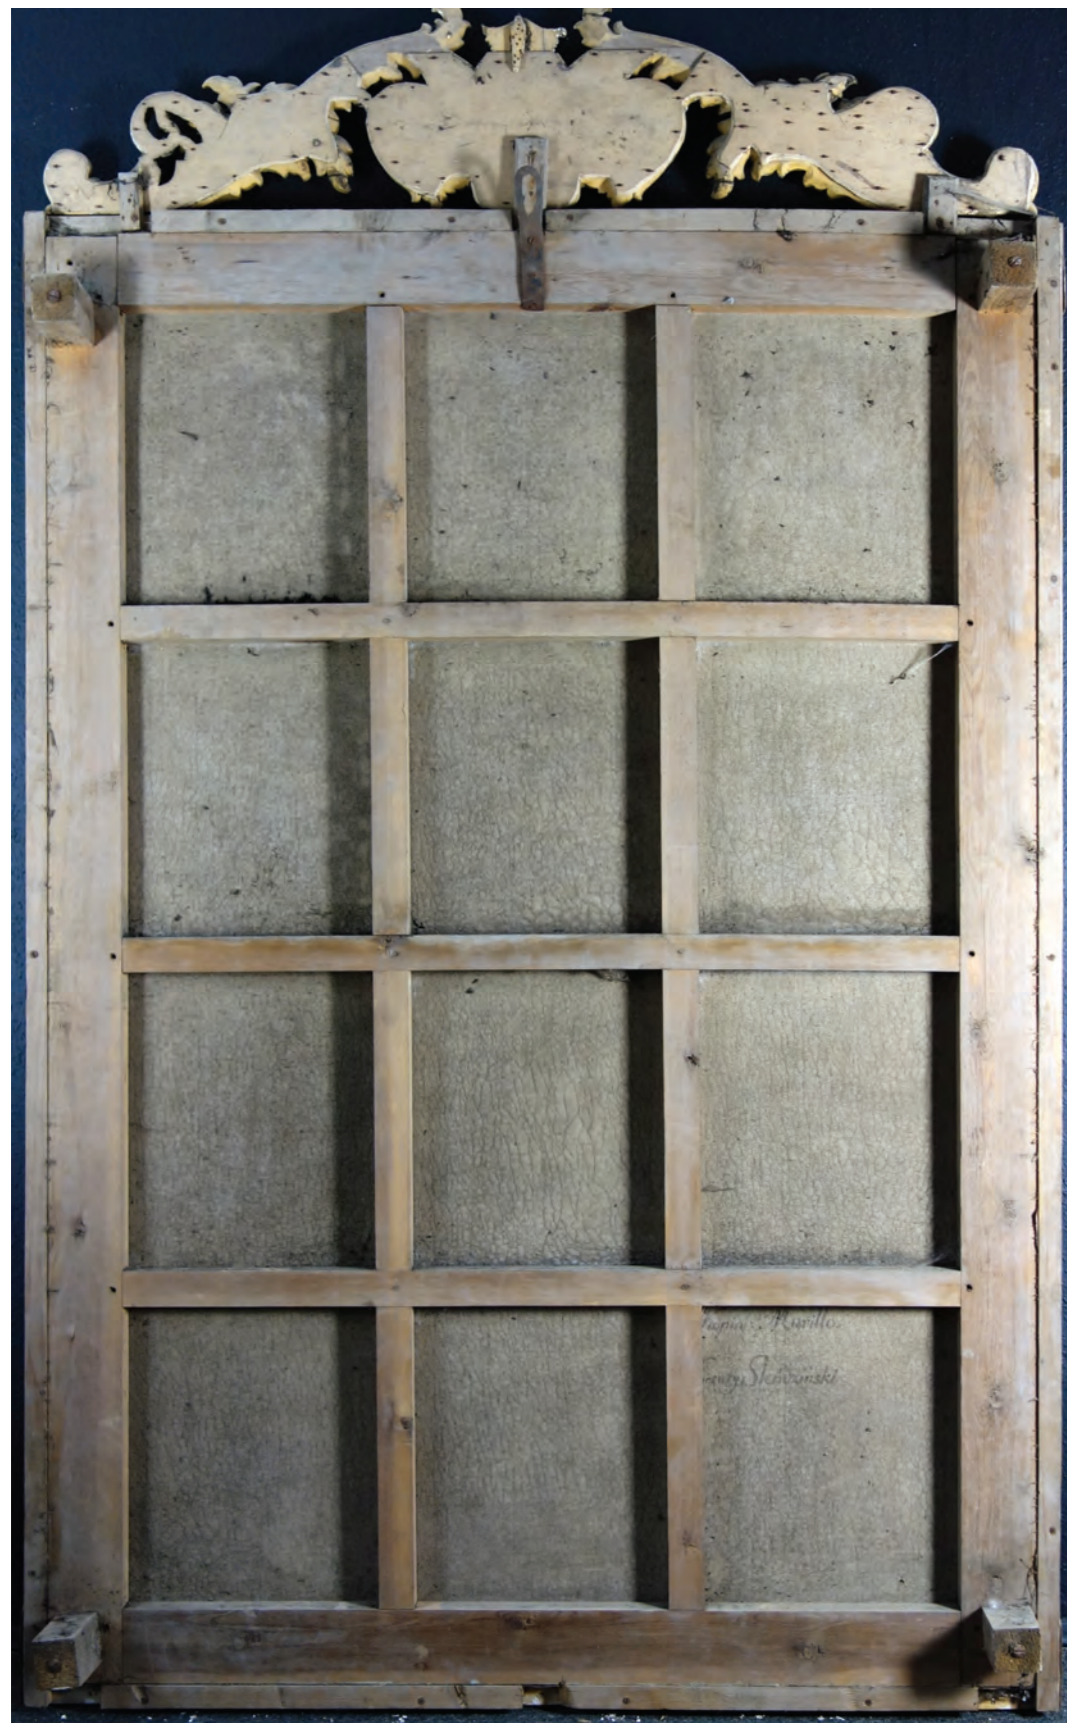
"St Anthony" back before the restoration

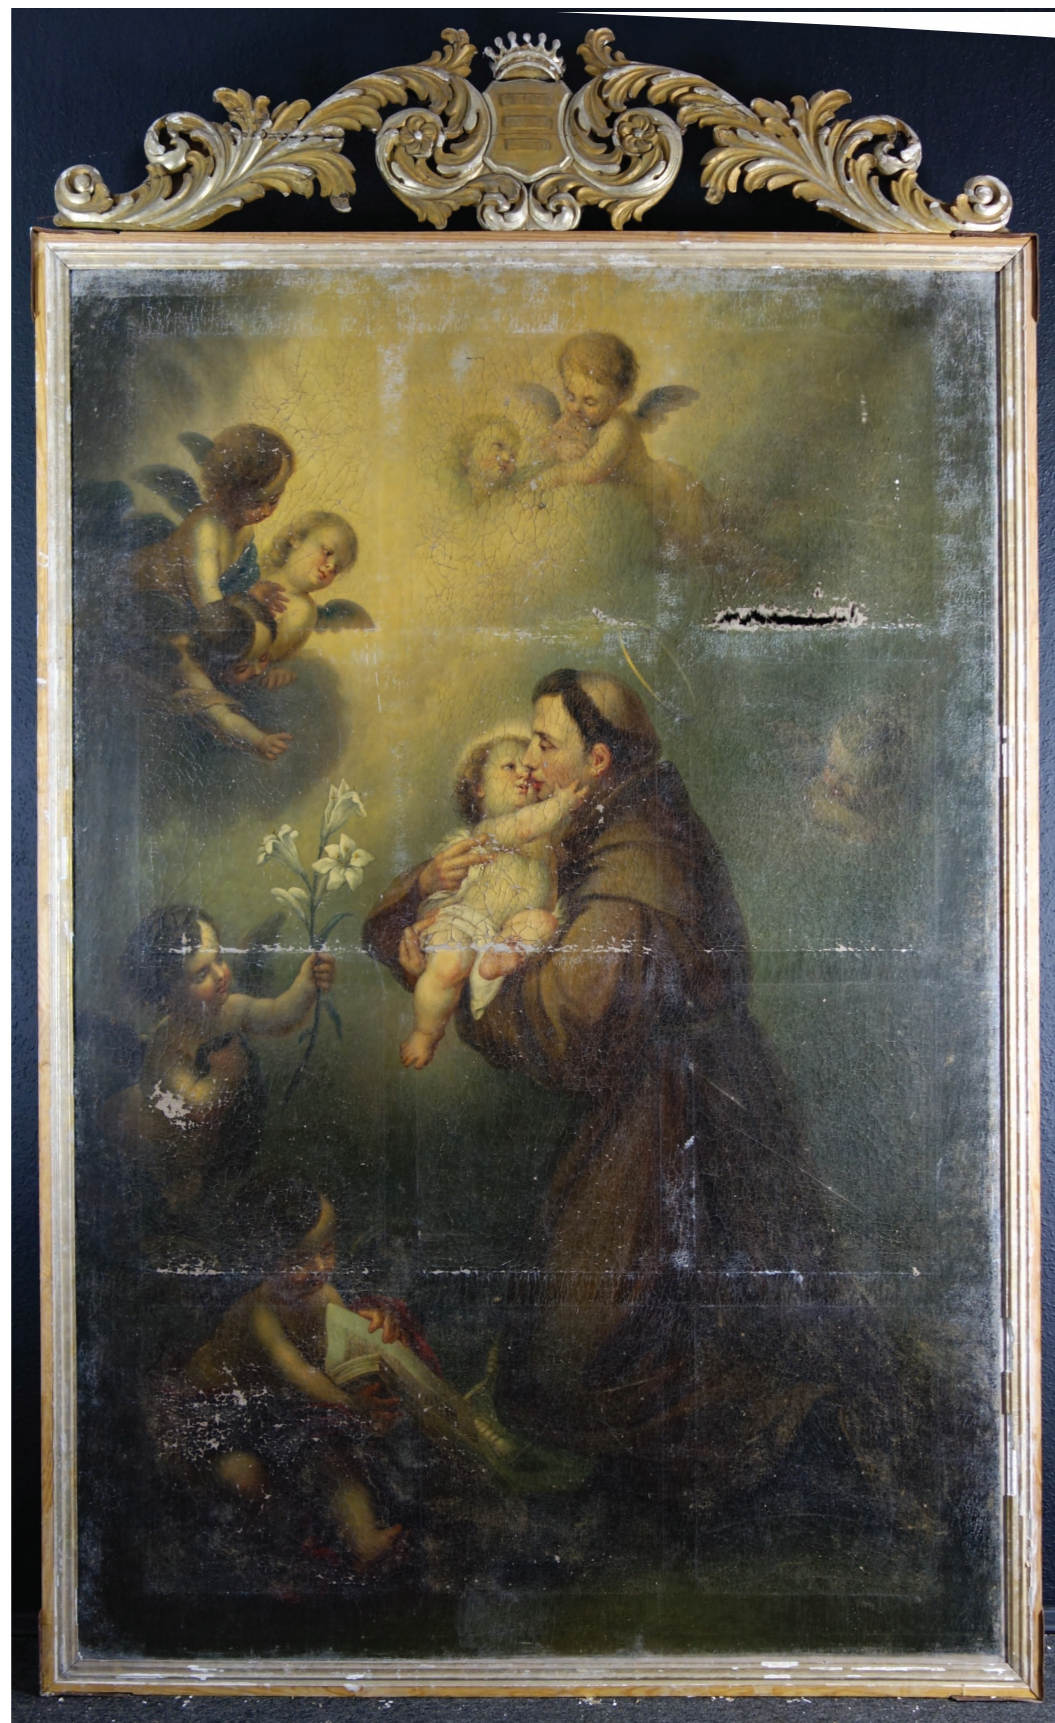
"St Anthony" before the restoration

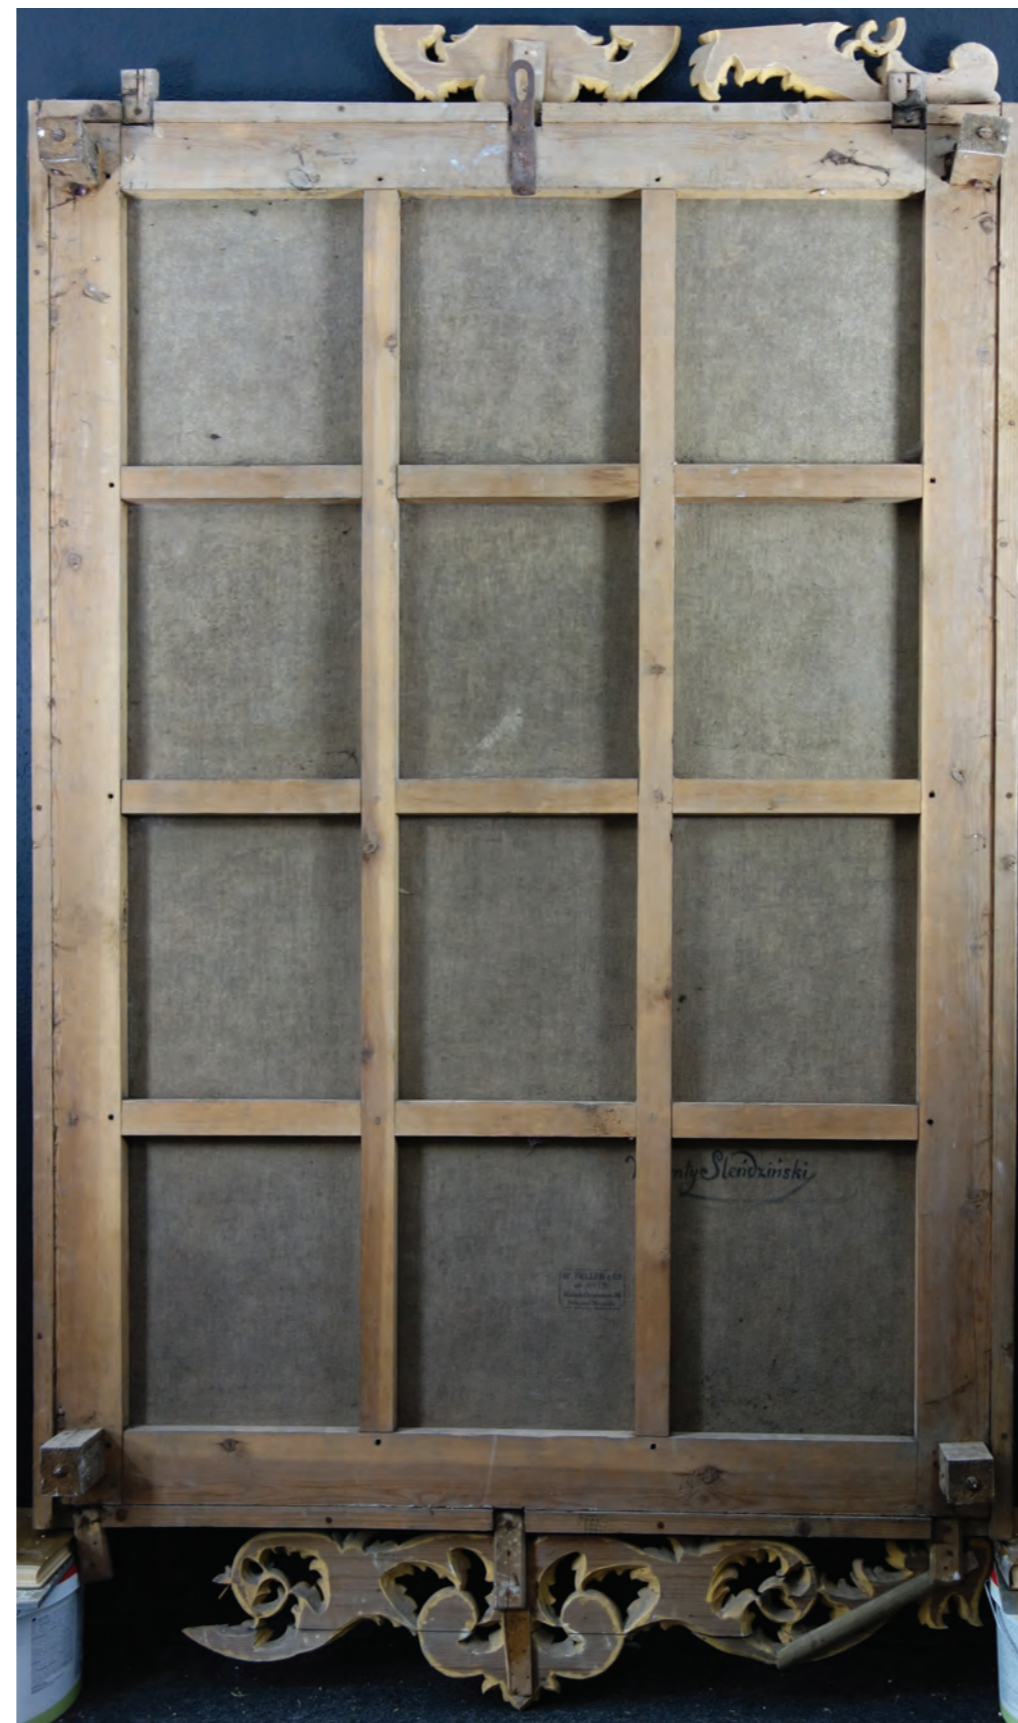
"An angel frees St. Peter from prison" back before restoration

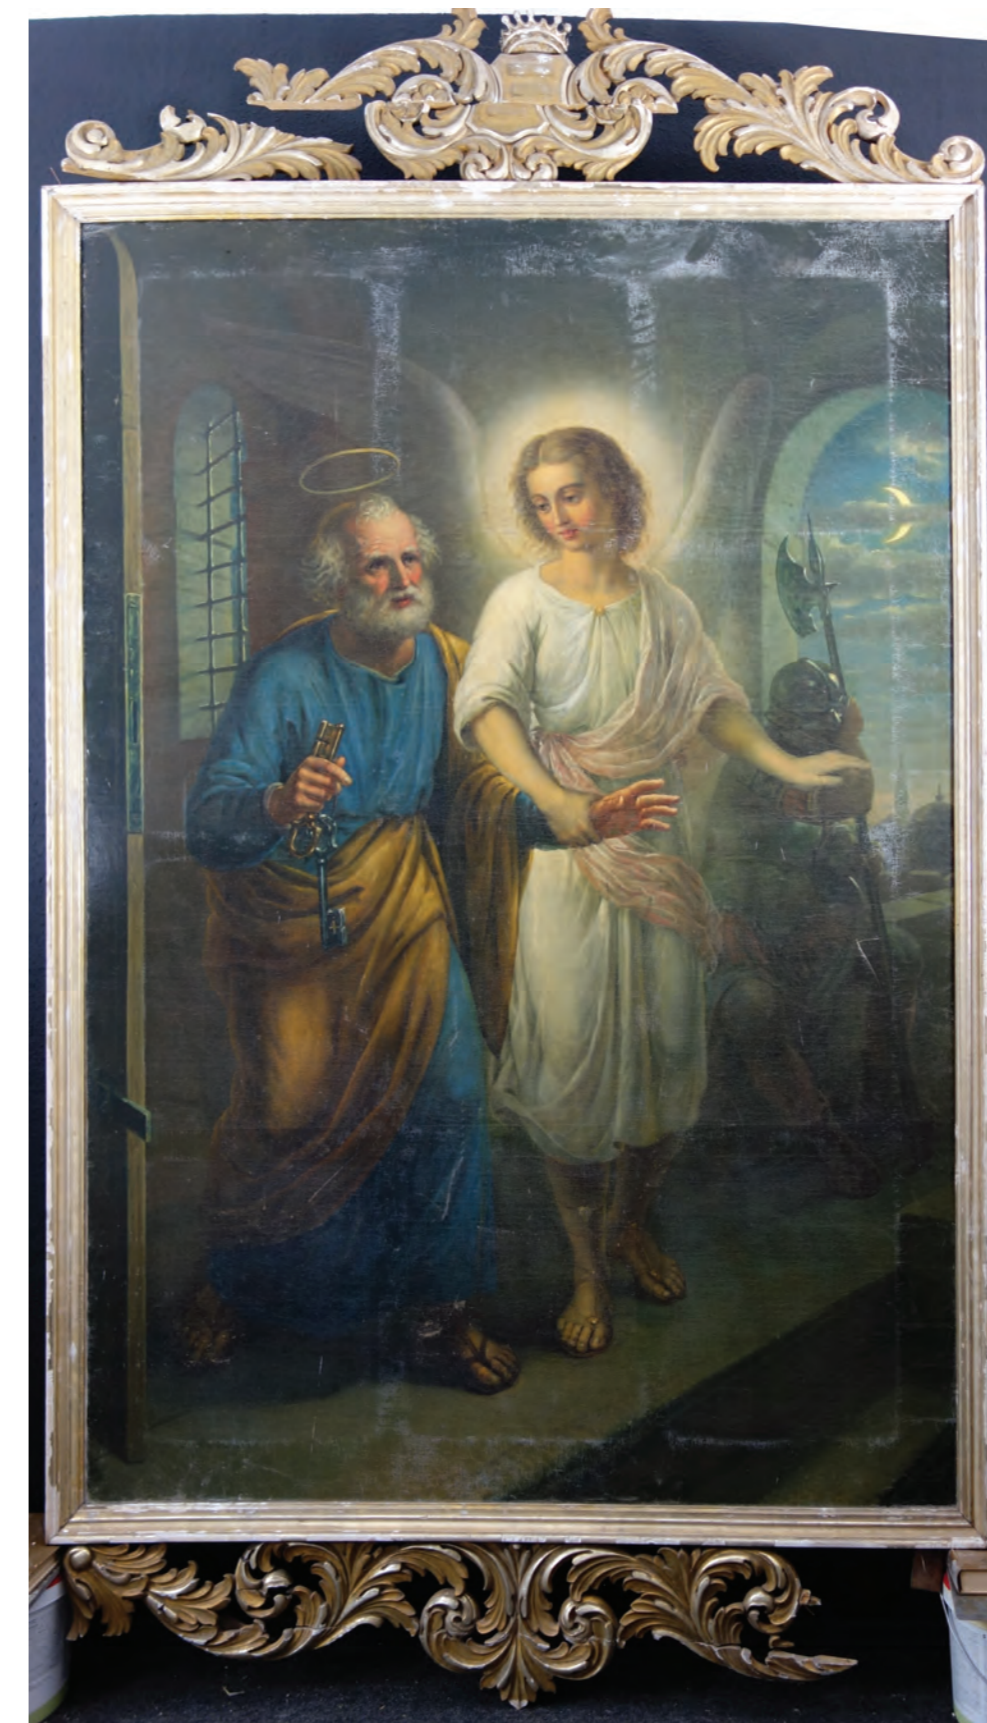
"An angel frees St. Peter from prison" before restoration

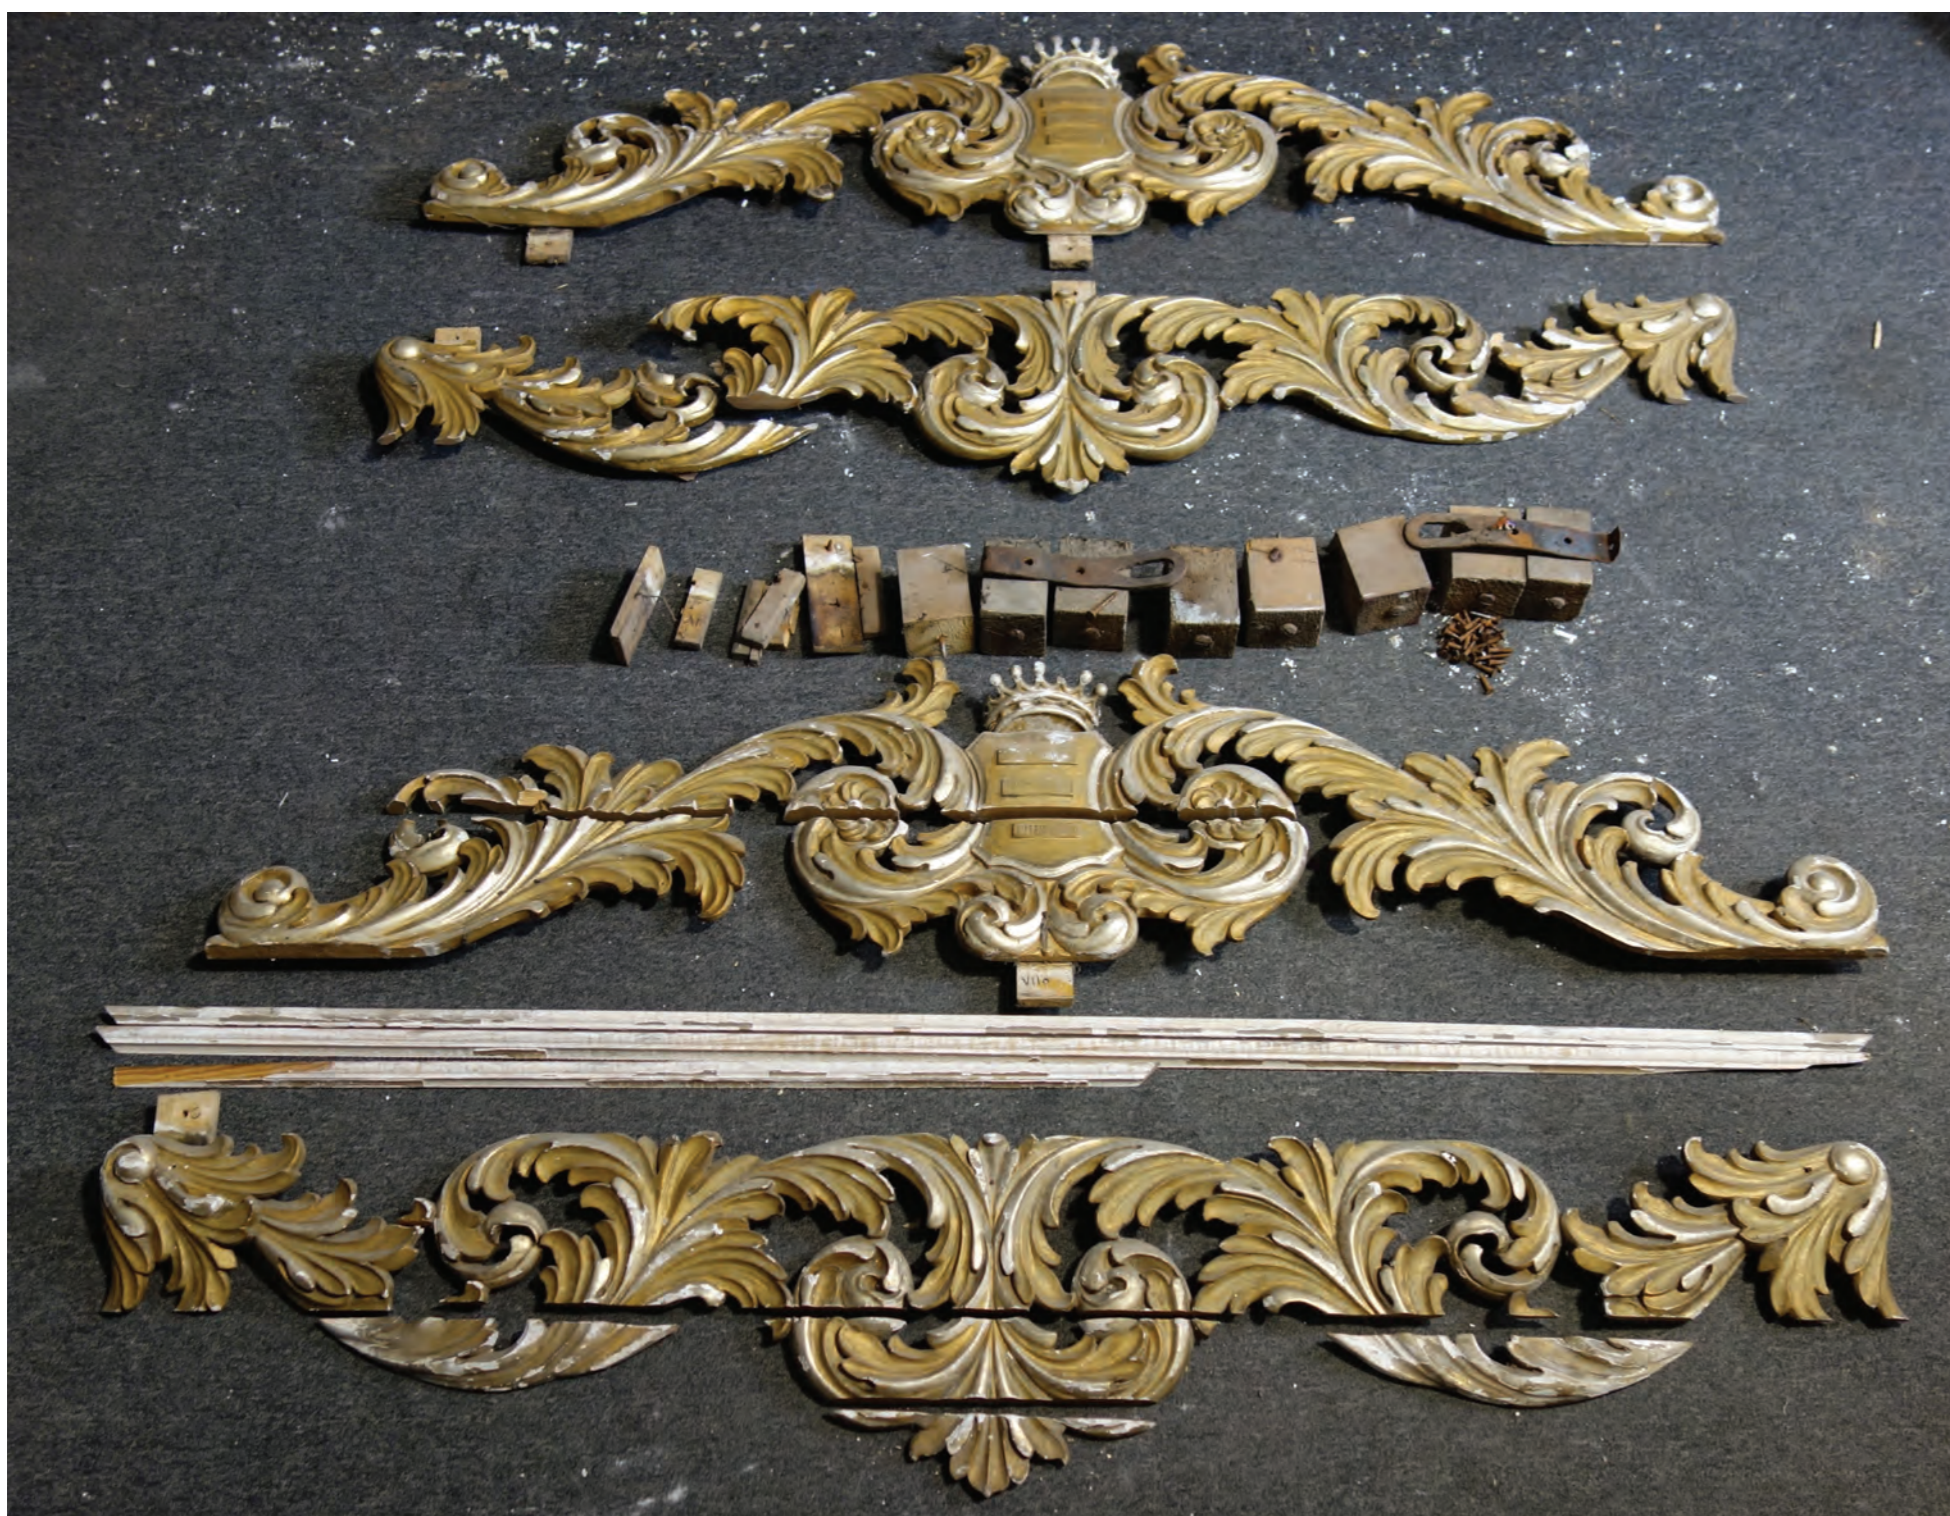
The decorative upper frames of the paintings are rectangular in shape with decorative wood carvings on their bottoms and tops. The frames are made of pine wood. To obtain slats of such a thick size and profile, they are glued from two parts. The decorative frames are poorly preserved, starting with the finishing layer, which separated in large areas, and their structural strength. Profile strips did not connect with each other and in some places, there were gaps in the places of gluing, but not completely separated. Some of them have disappeared. The decorative wood carvings of the frames have been partially preserved. A lot of wood carving parts have come off and disappeared. On the edges of the frame, there are small wooden breaks. The frame is finished with chalk primer and bronze paint.

Decorative frame details

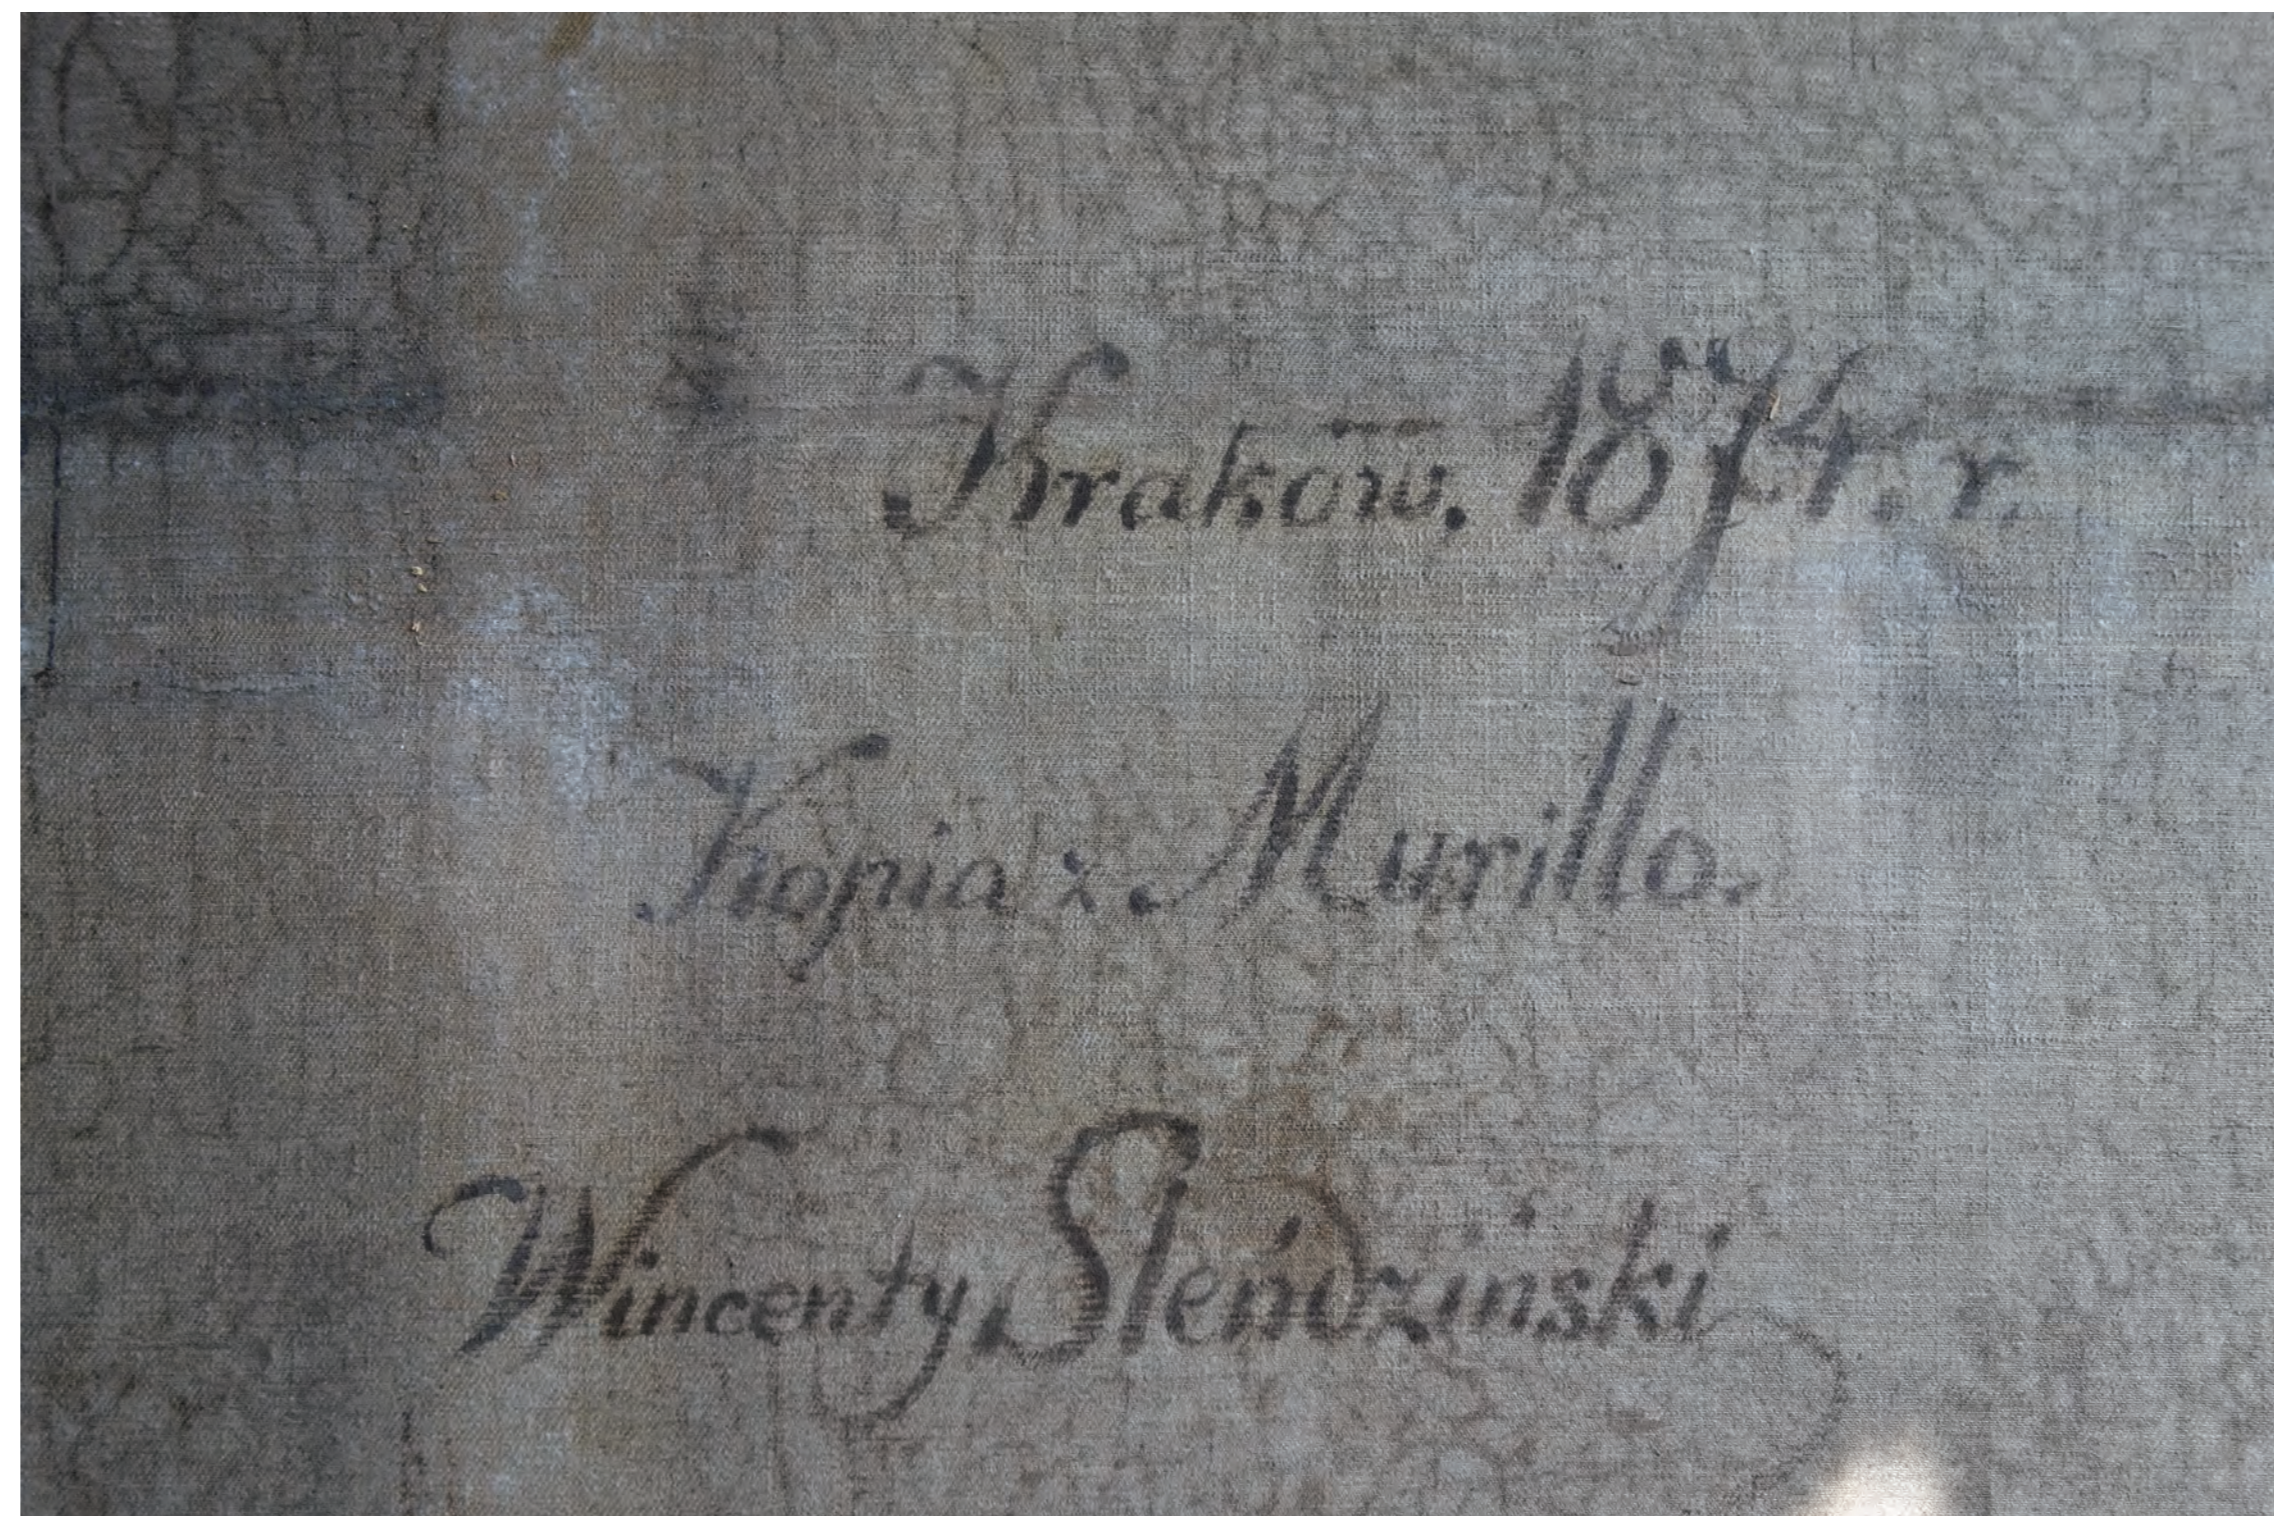
"St Anthony" fragment of the back before the restoration

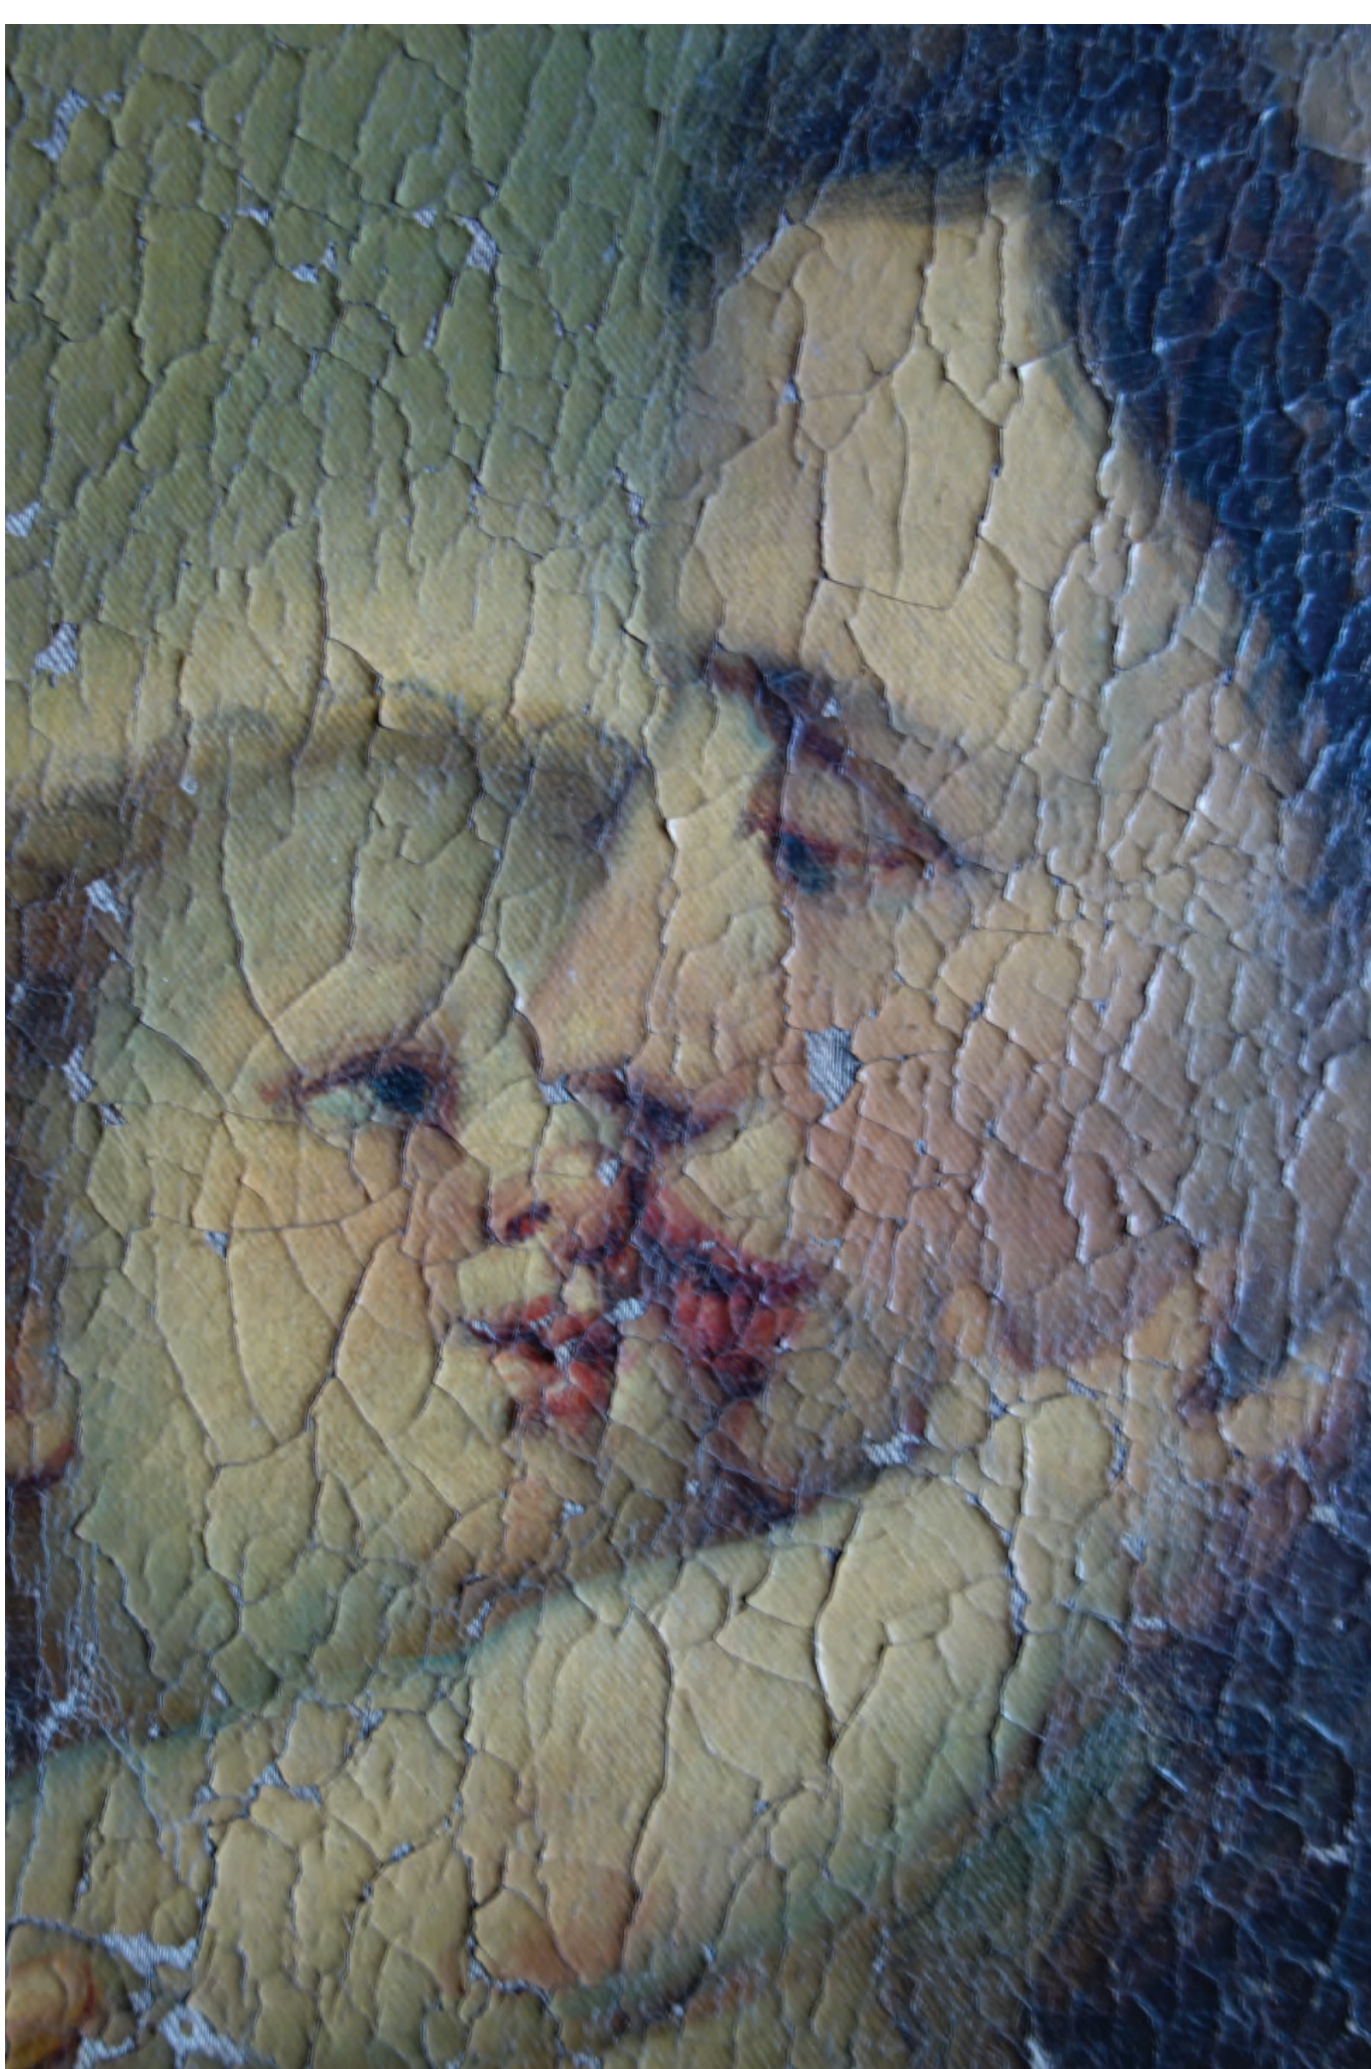
"St Anthony" fragment before restoration

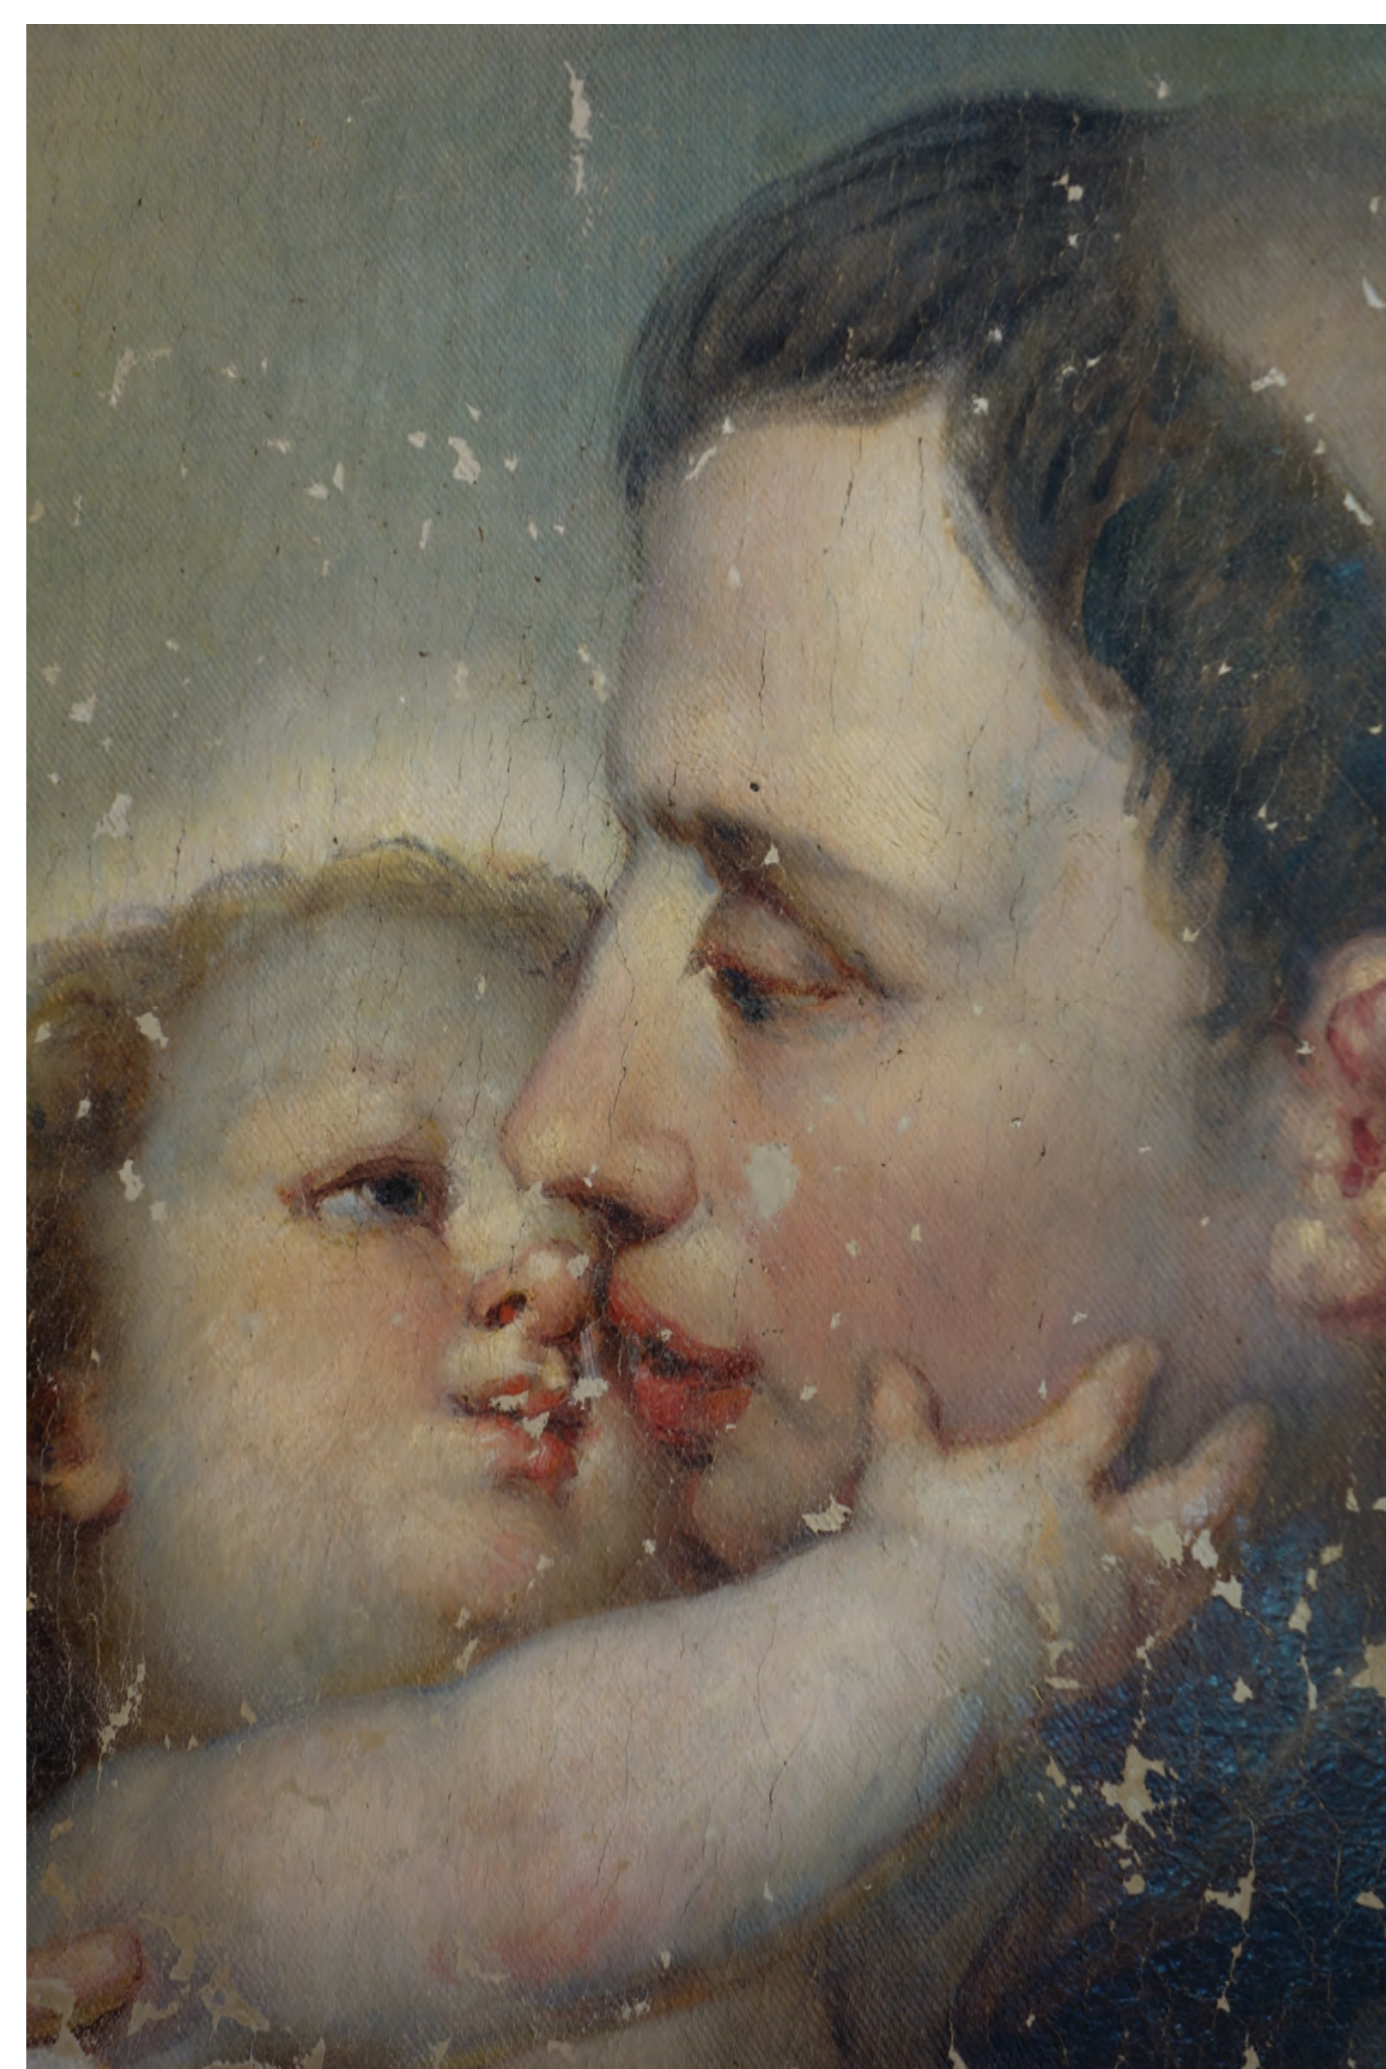
"St Anthony" fragment in restoration process

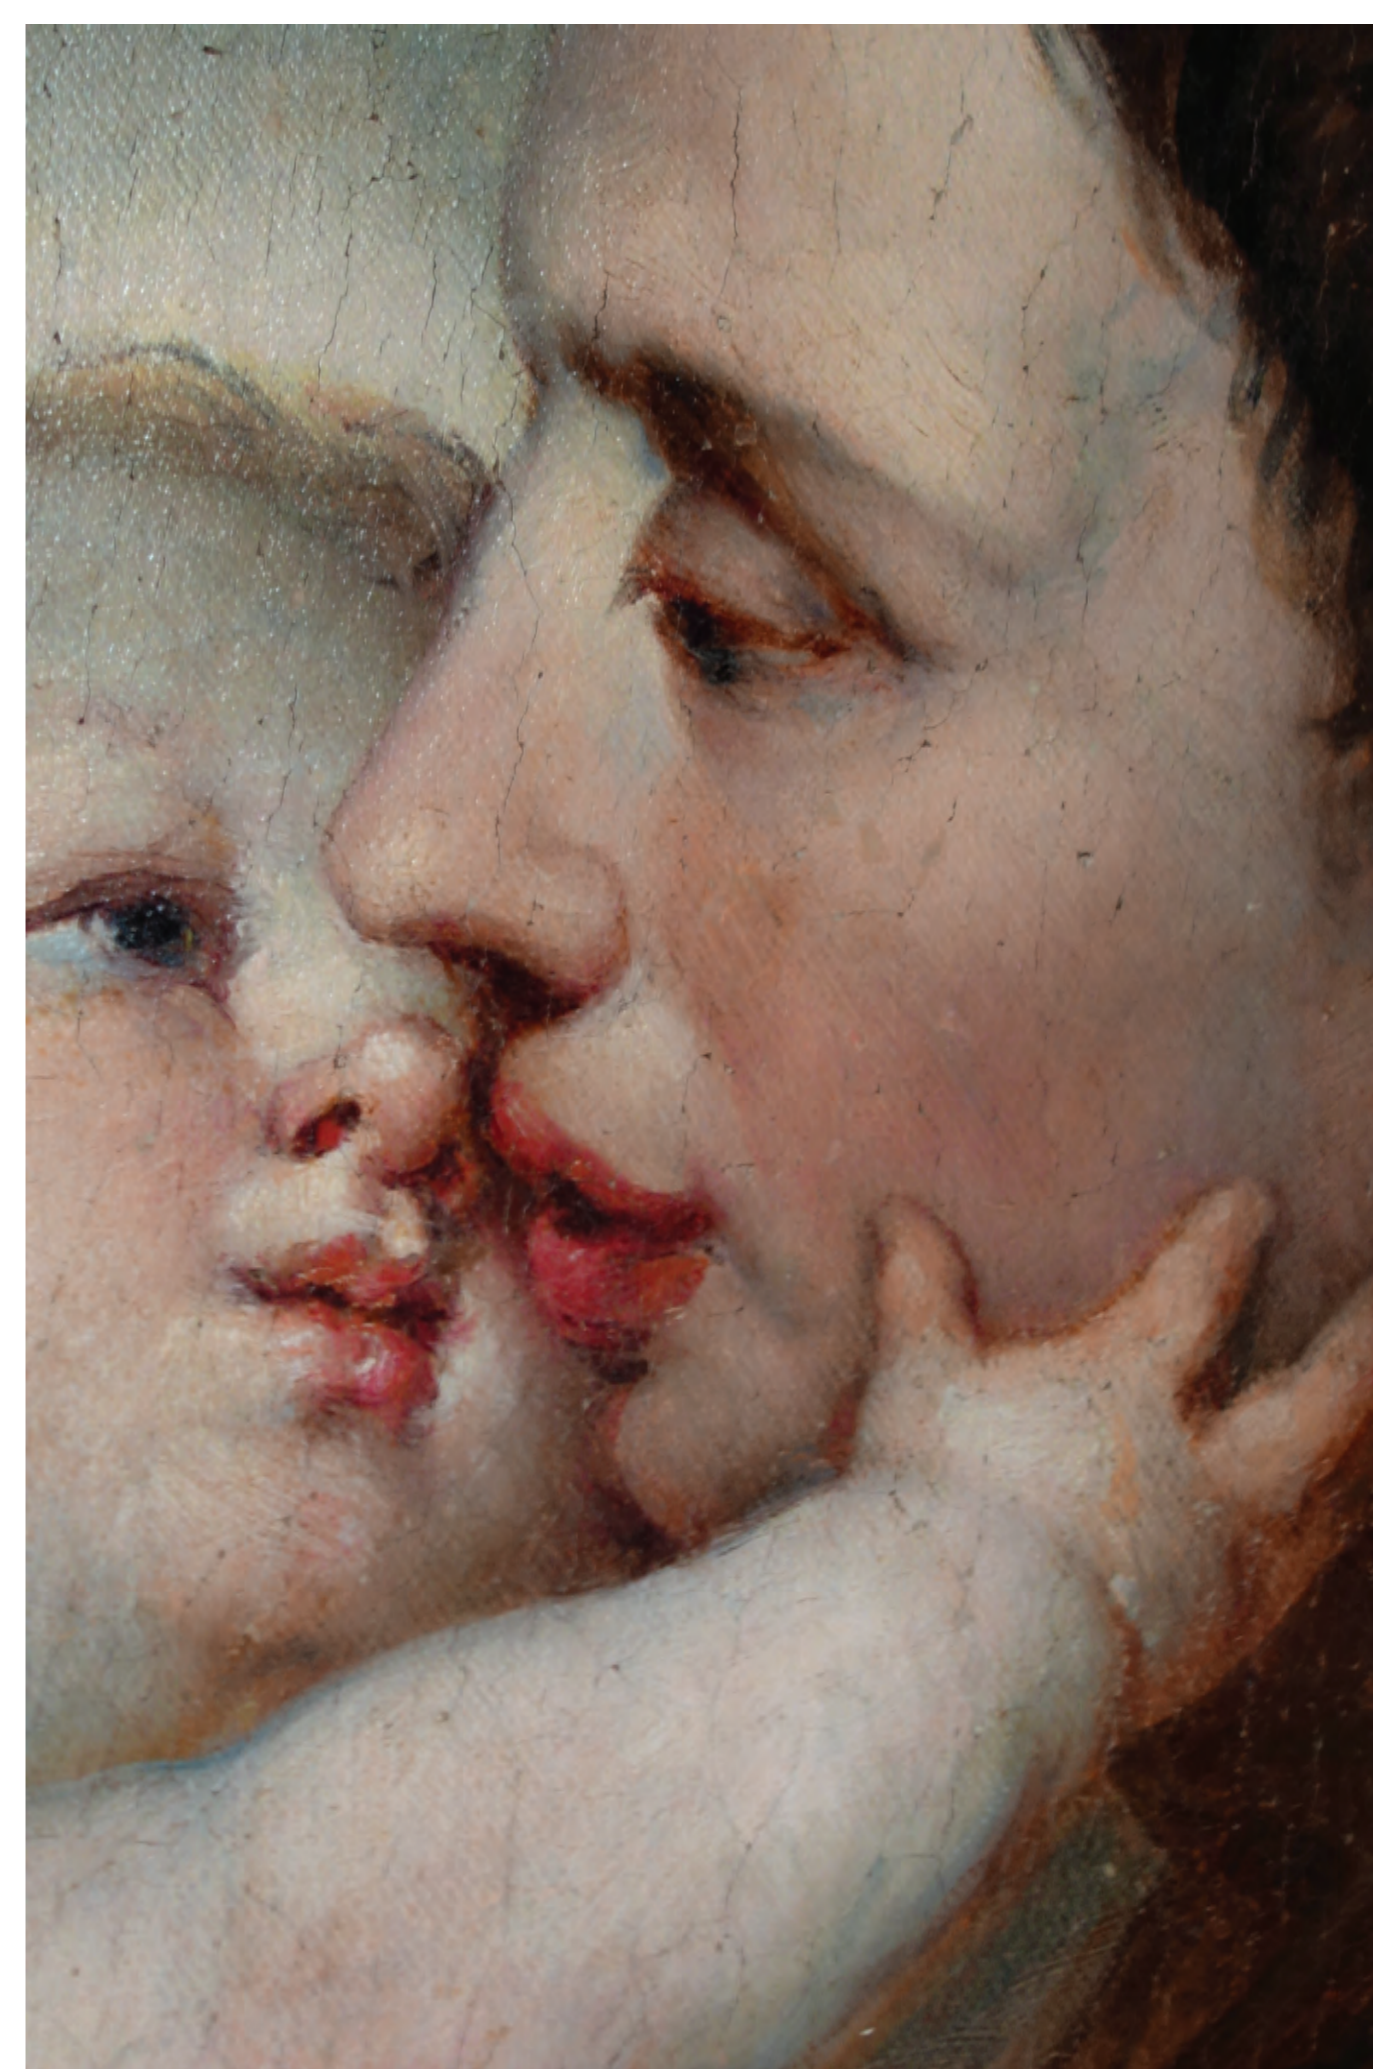
"St Anthony" fragment after restoration
