CONSERVATION OF THE FRAGMENT "THE HOLY TRINITY" OF THE PAINTING FROM THE 18TH CENTURY AT THE CATHEDRAL OF SAINT JOSEPH IN LIEPAJA

DITA MURZIŅA, Mg. Art.
 Senior master conservator of painting
 murzina.dita@gmail.com
 Latvian National Museum of Art
 Rozentāla square 1, Riga

AUTHOR: UNKNOWN ARTIST
TITLE: HOLY TRINITY (FRAGMENT)
DATED: 18TH CENTURY
MATERIAL: CANVAS
TECHNIQUE: OIL
SIZE: 62.7 X 46.5 CM;
AFTER THE CONSERVATION: 68.2 X 51.8 CM
OWNER: THE CATHEDRAL OF SAINT JOSEPH IN LIEPĀJA

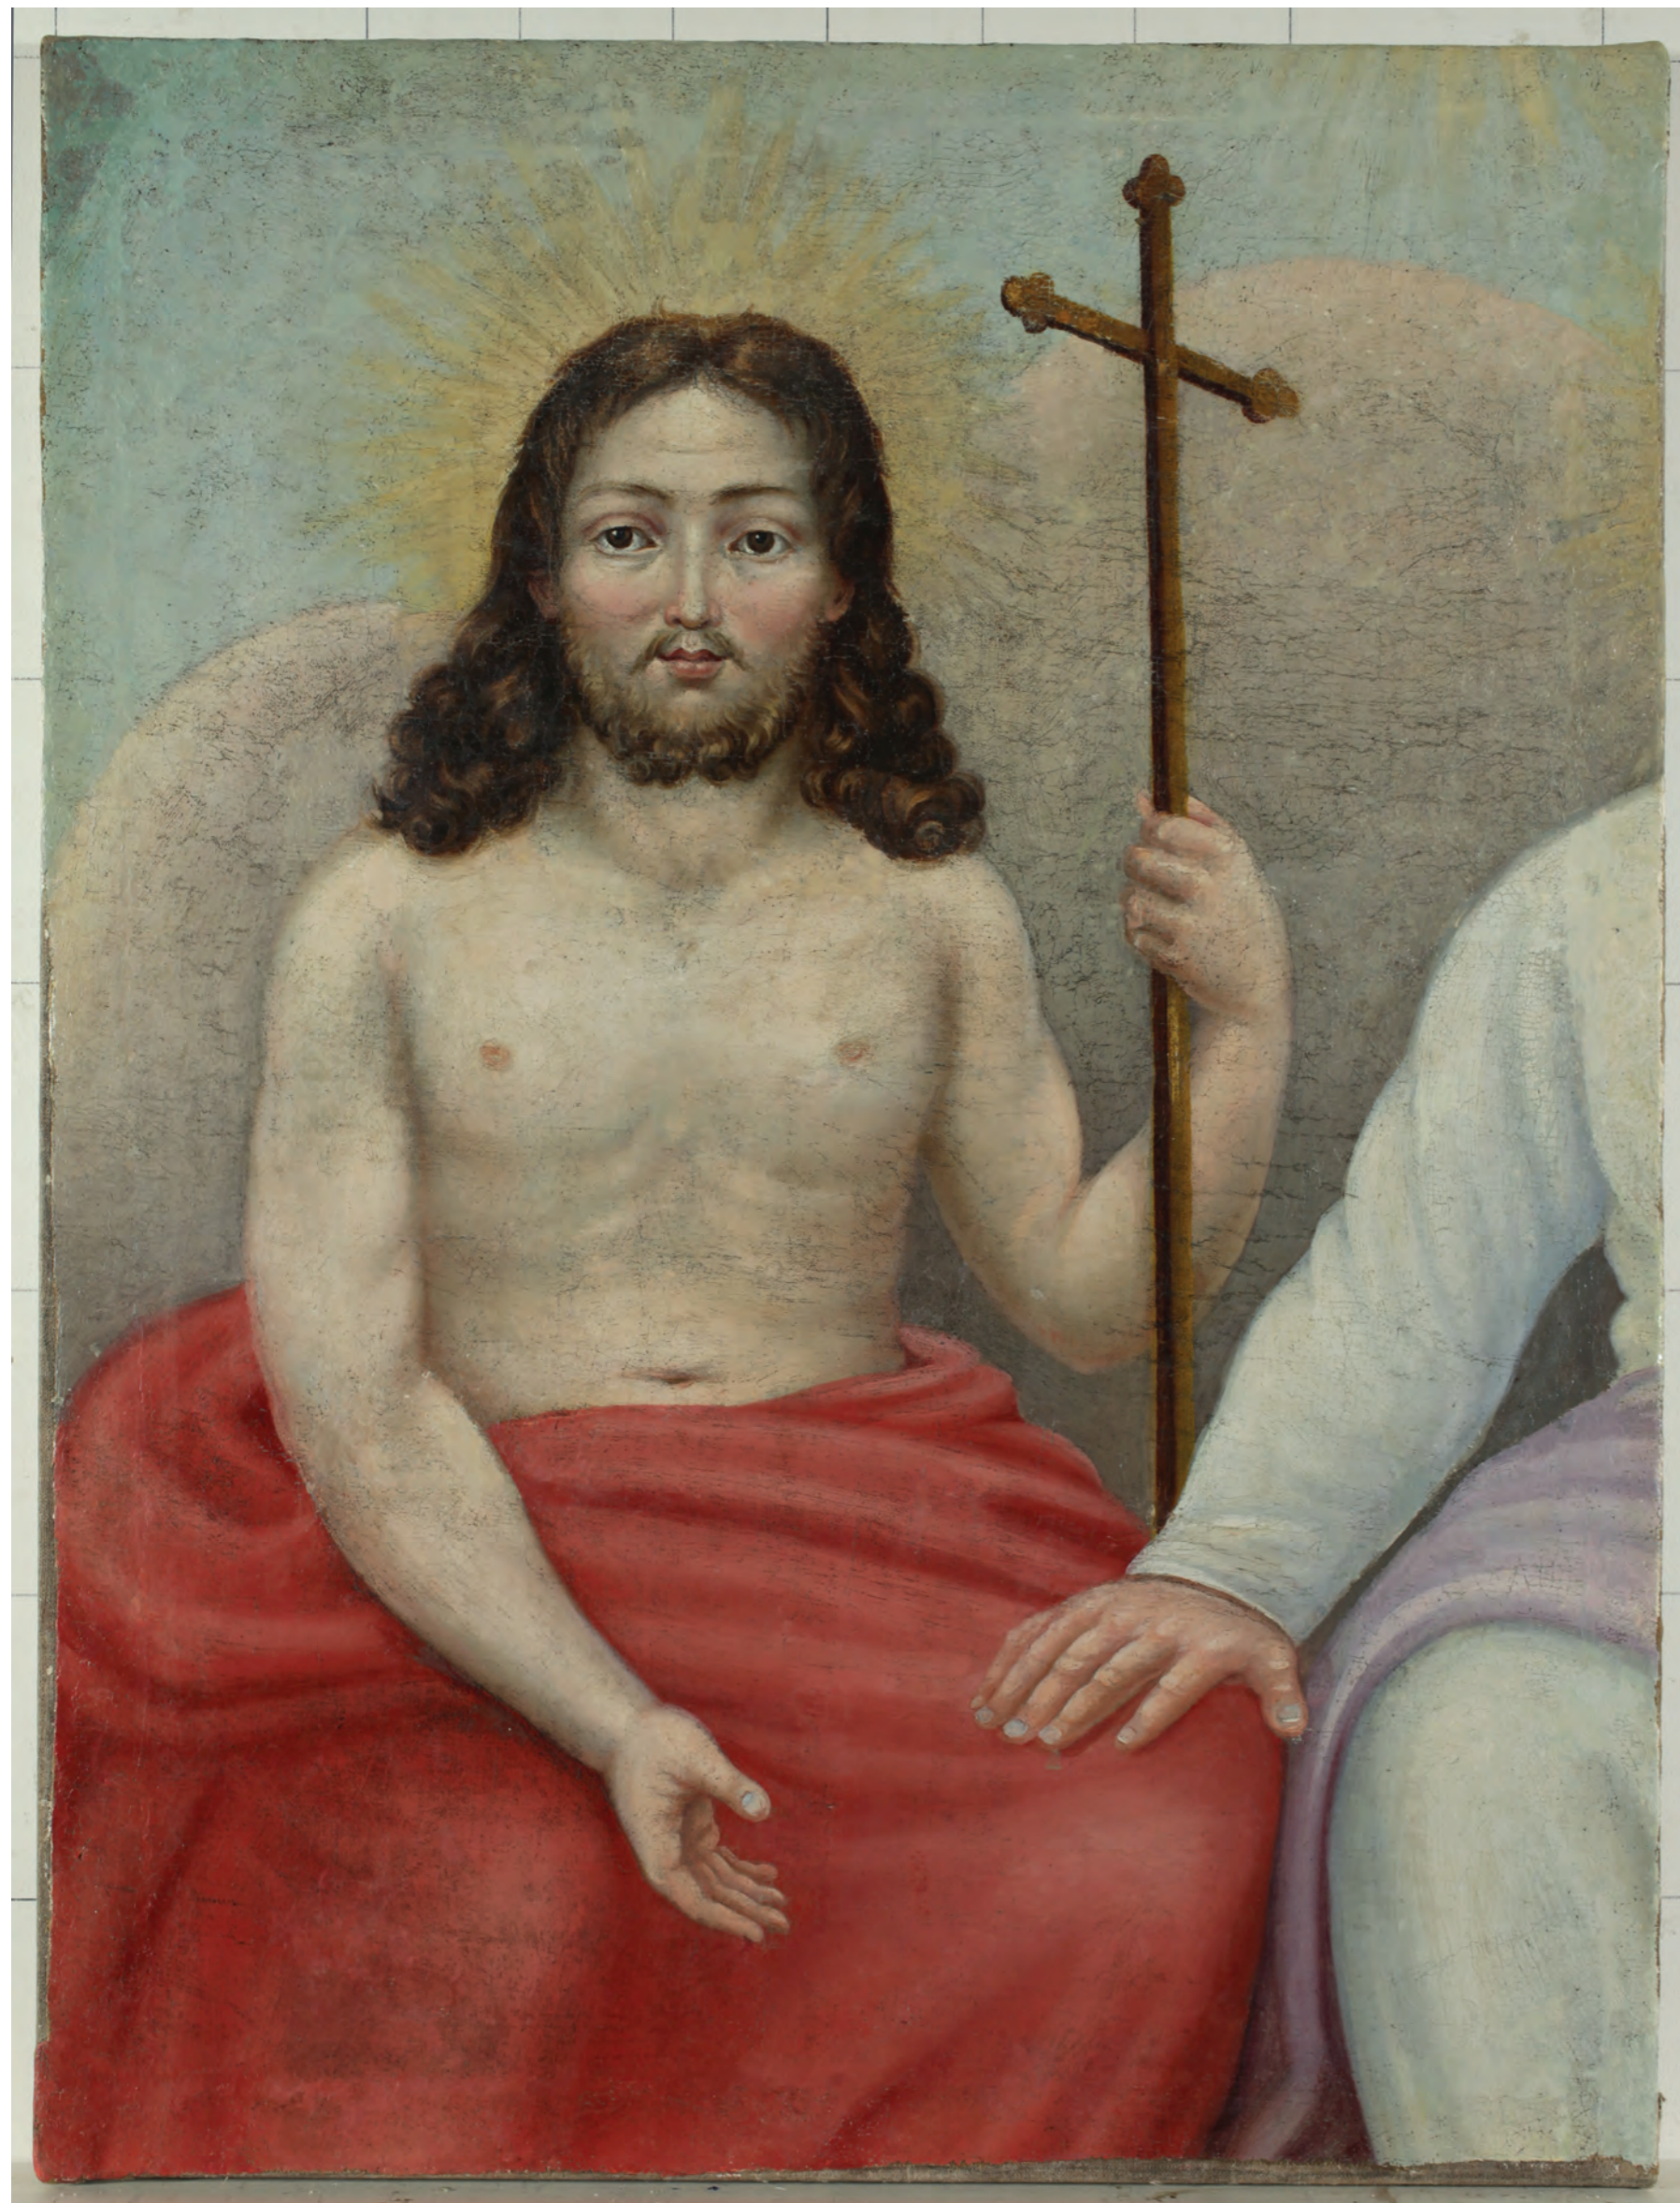
The painting after conservation.

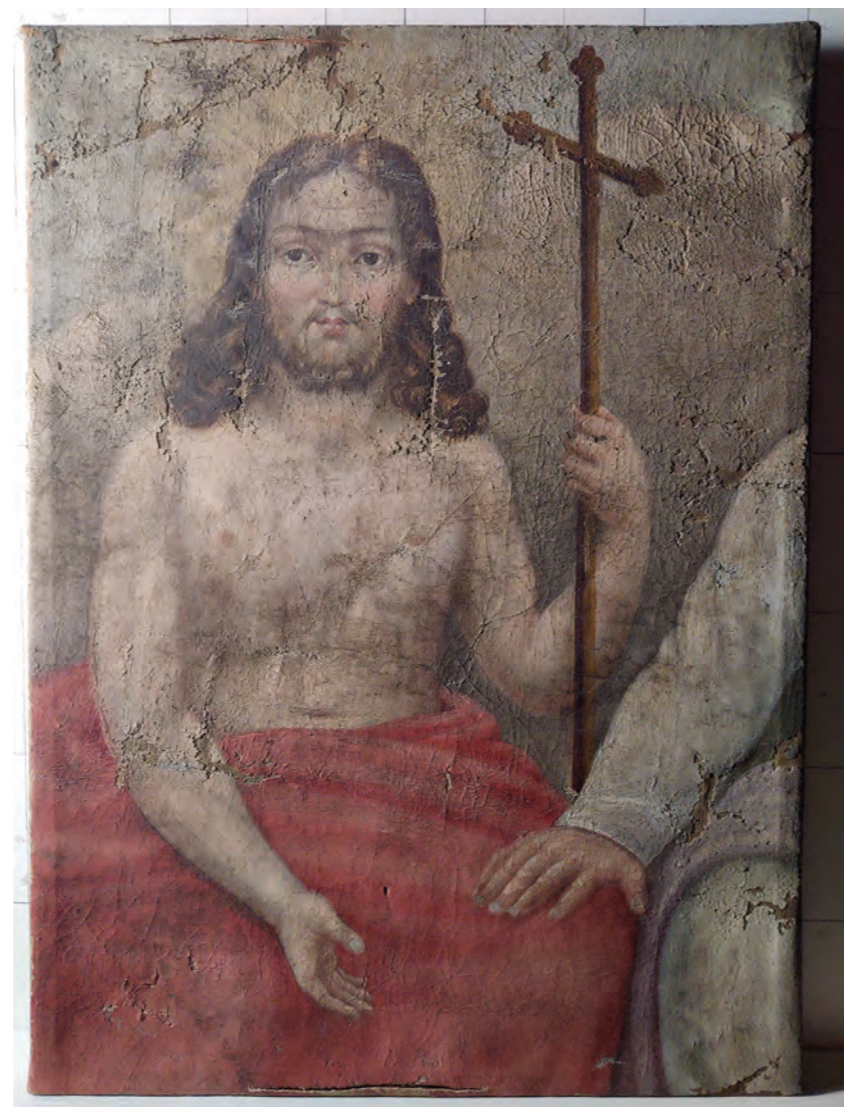
The painting before treatment.

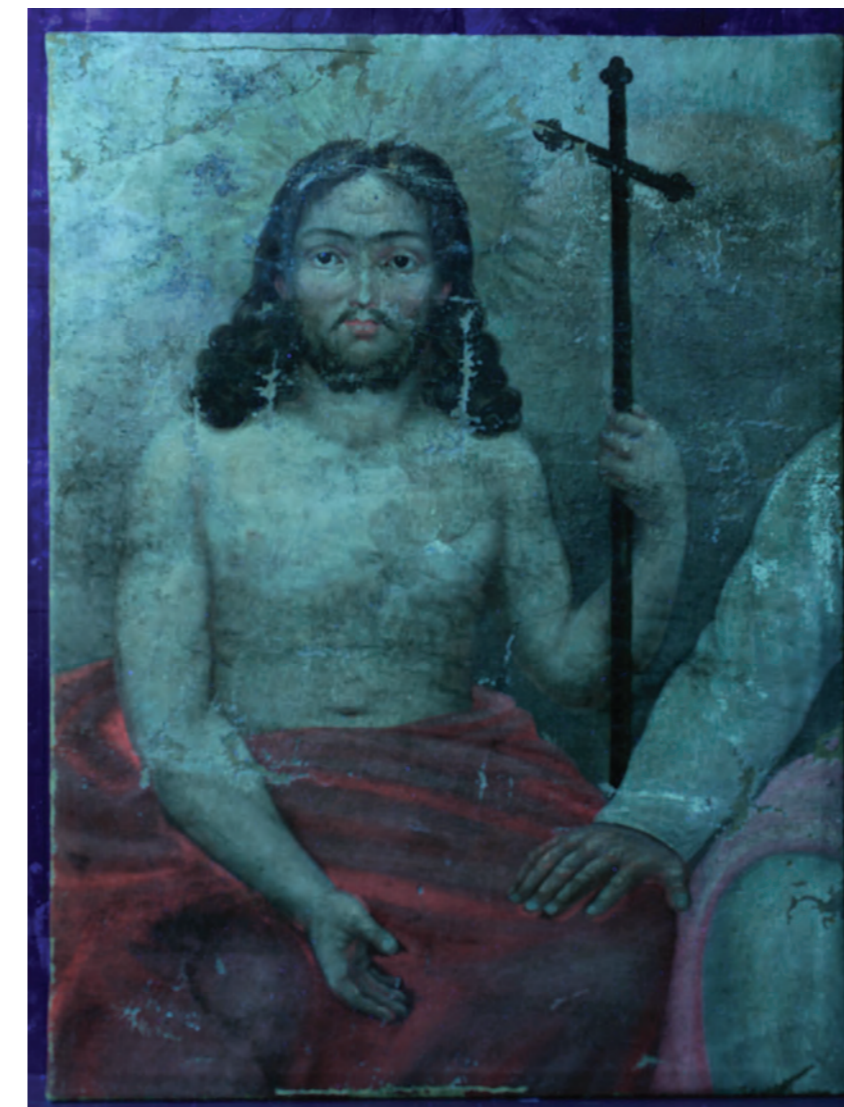
The painting before UV light treatment.

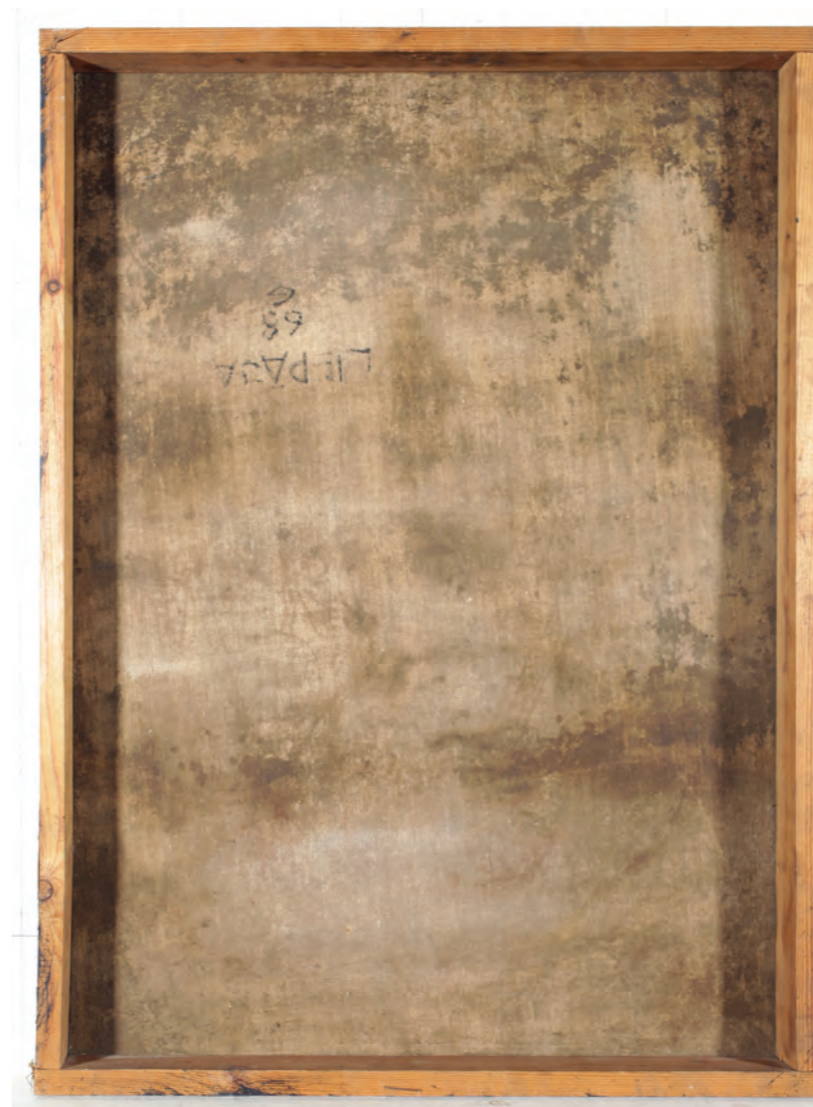
The back of the painting on the old stretcher frame before conservation.

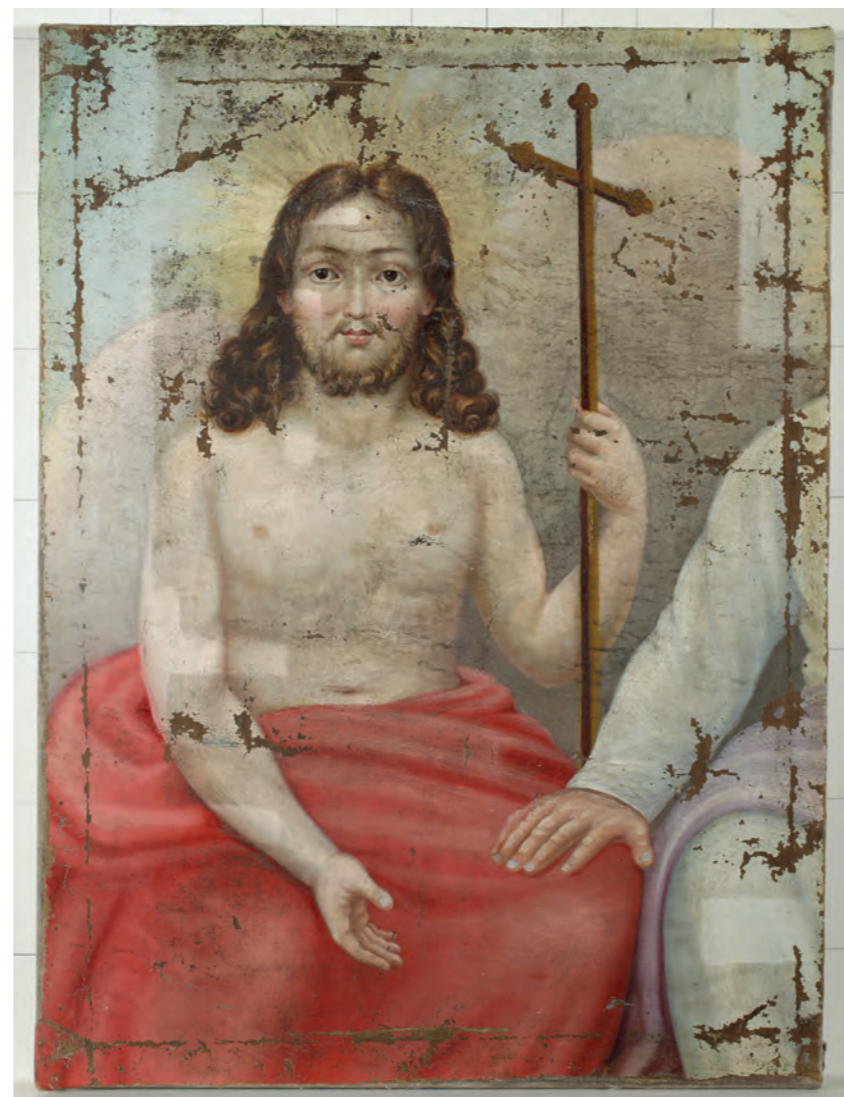
The painting during the process of conservation with partly removed varnish.

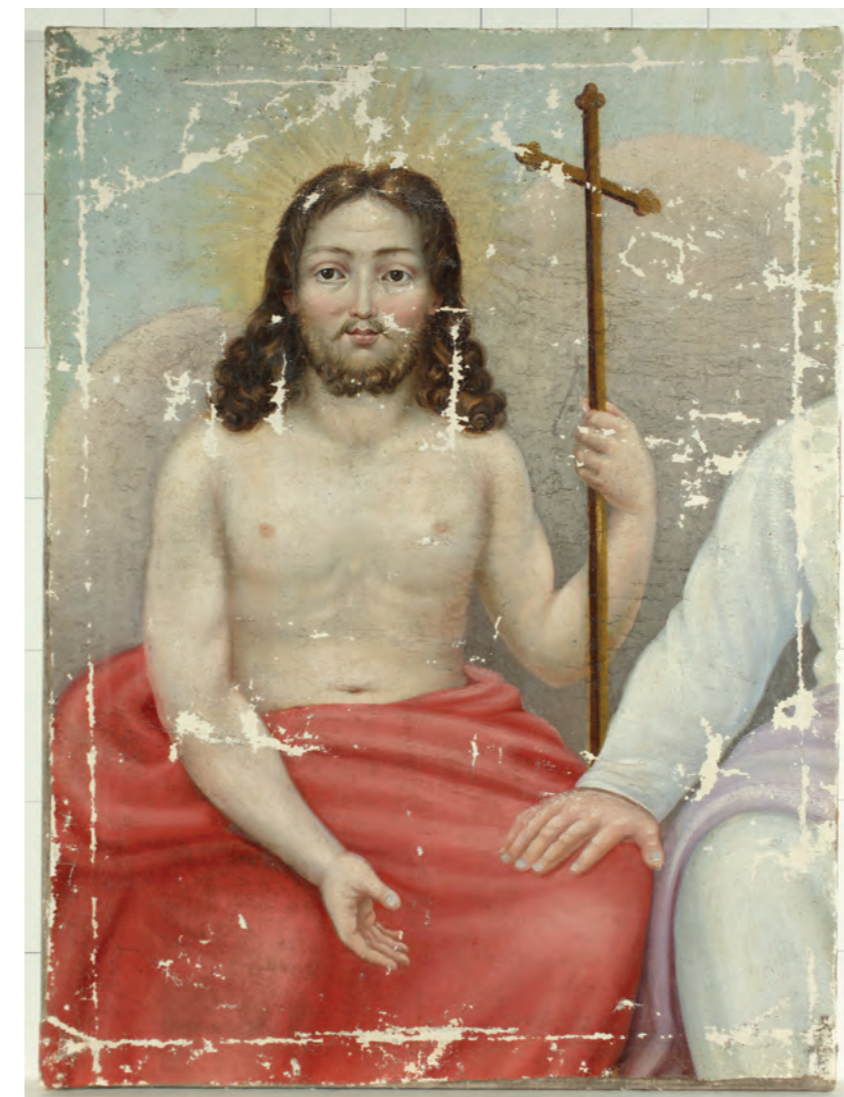
The painting during the process of conservation. Lost ground and flaking losses were filled with conservation ground and coated with varnish.

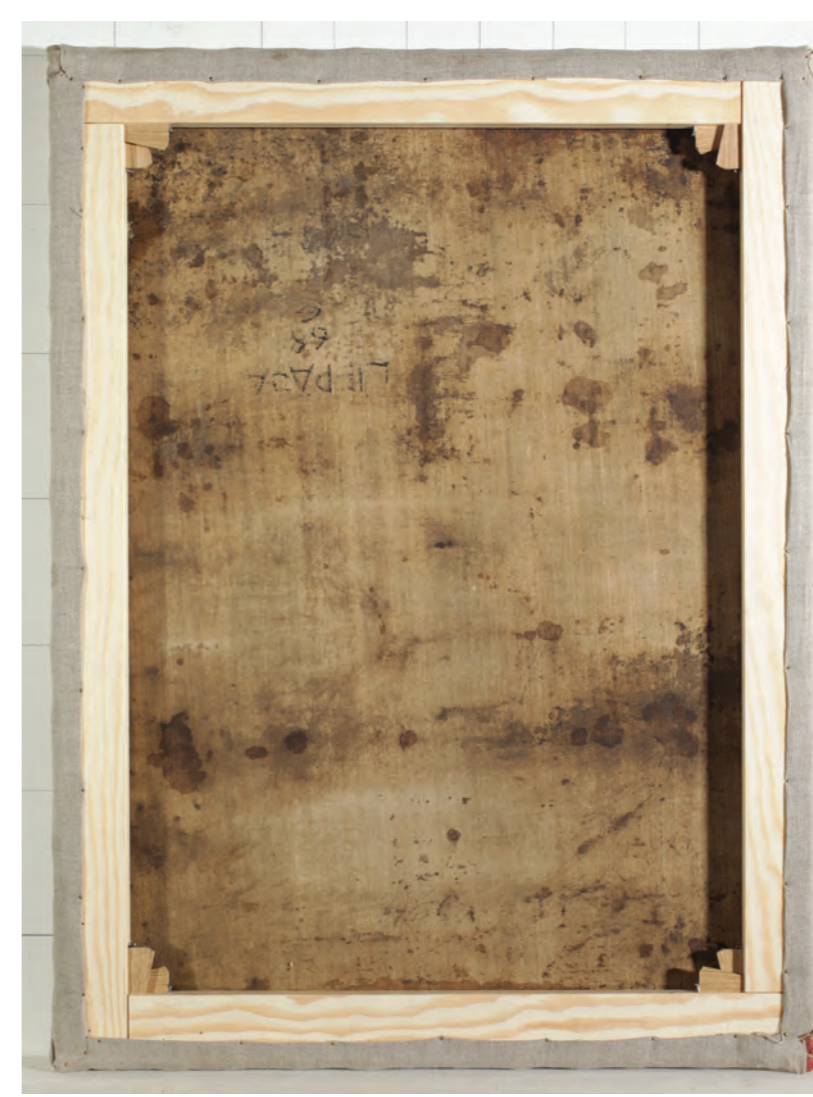
The painting after conservation - lined edges, the painting put on a new stretcher frame, removed varnish and retouching.

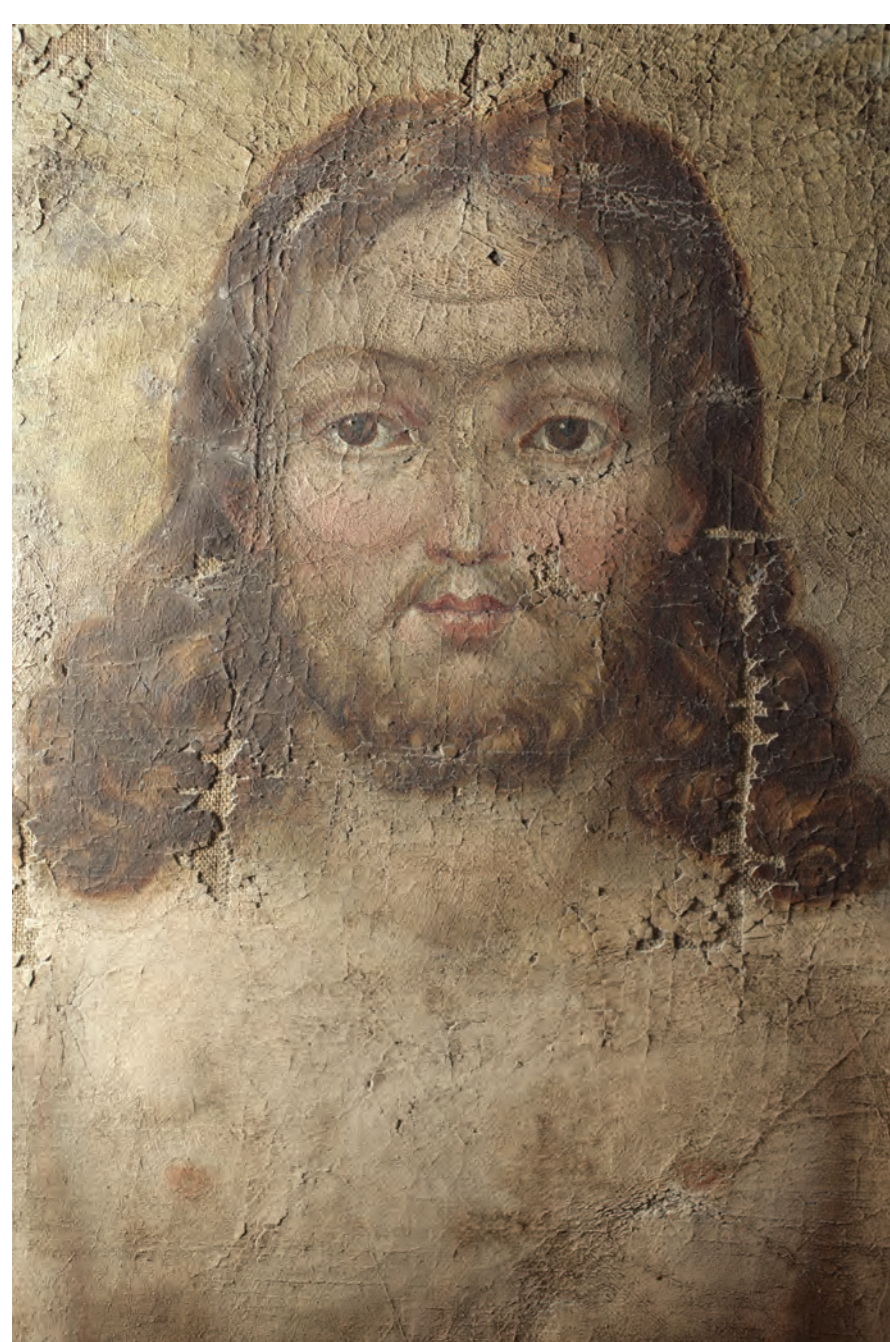
A detail before treatment. Lost ground and flaking losses.

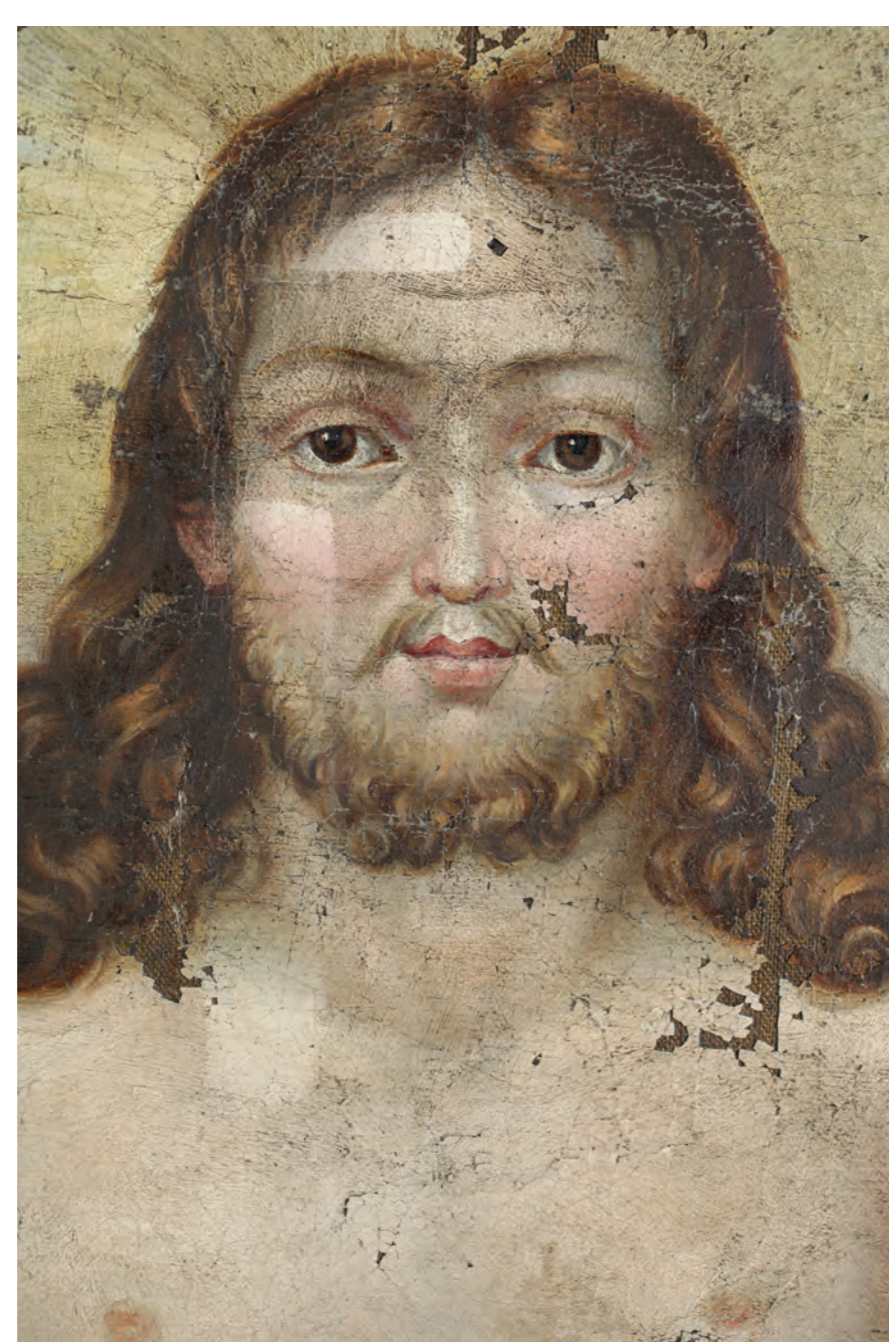
A detail during the process of conservation with partly removed varnish.

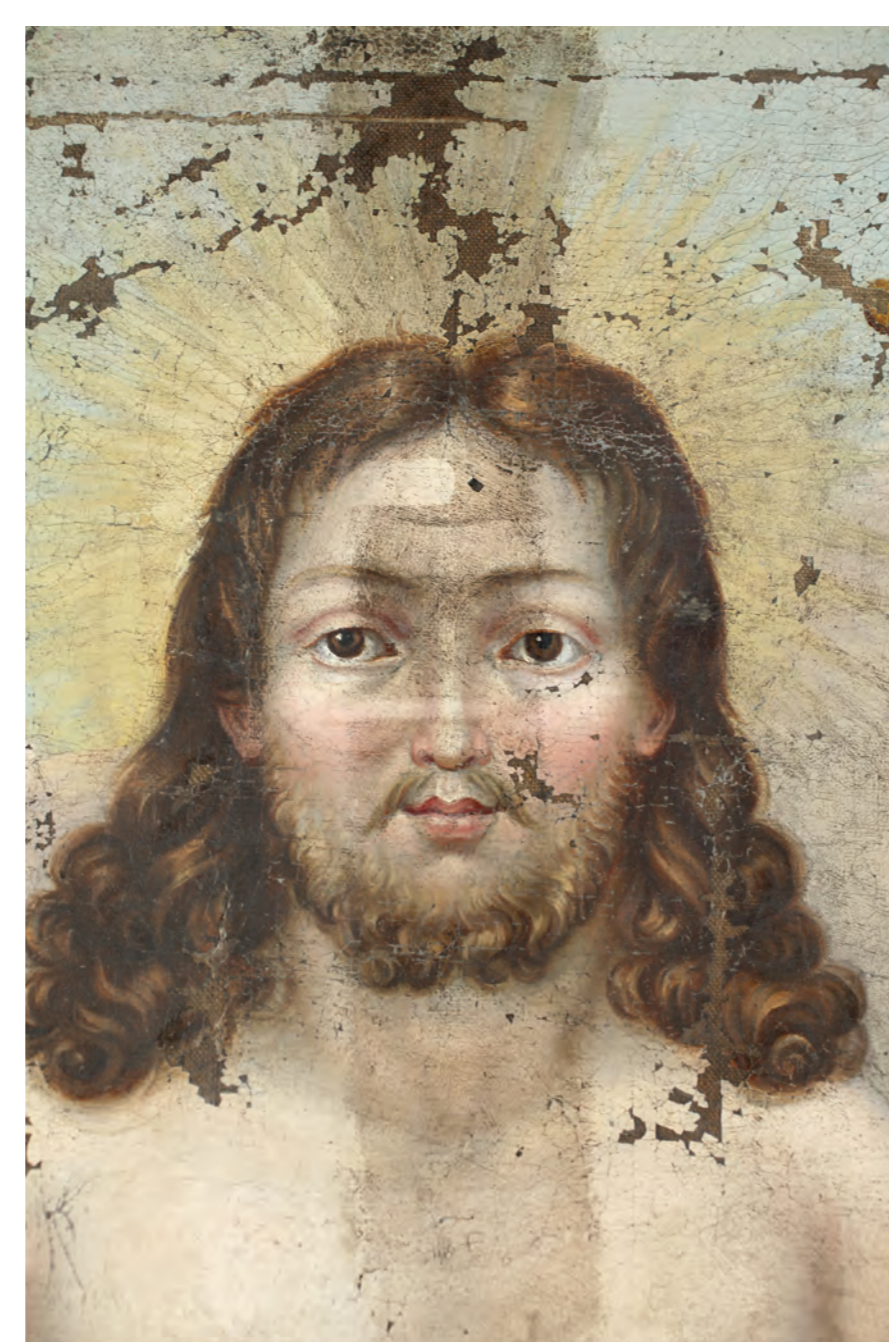
A detail during the process of conservation with partly removed varnish.

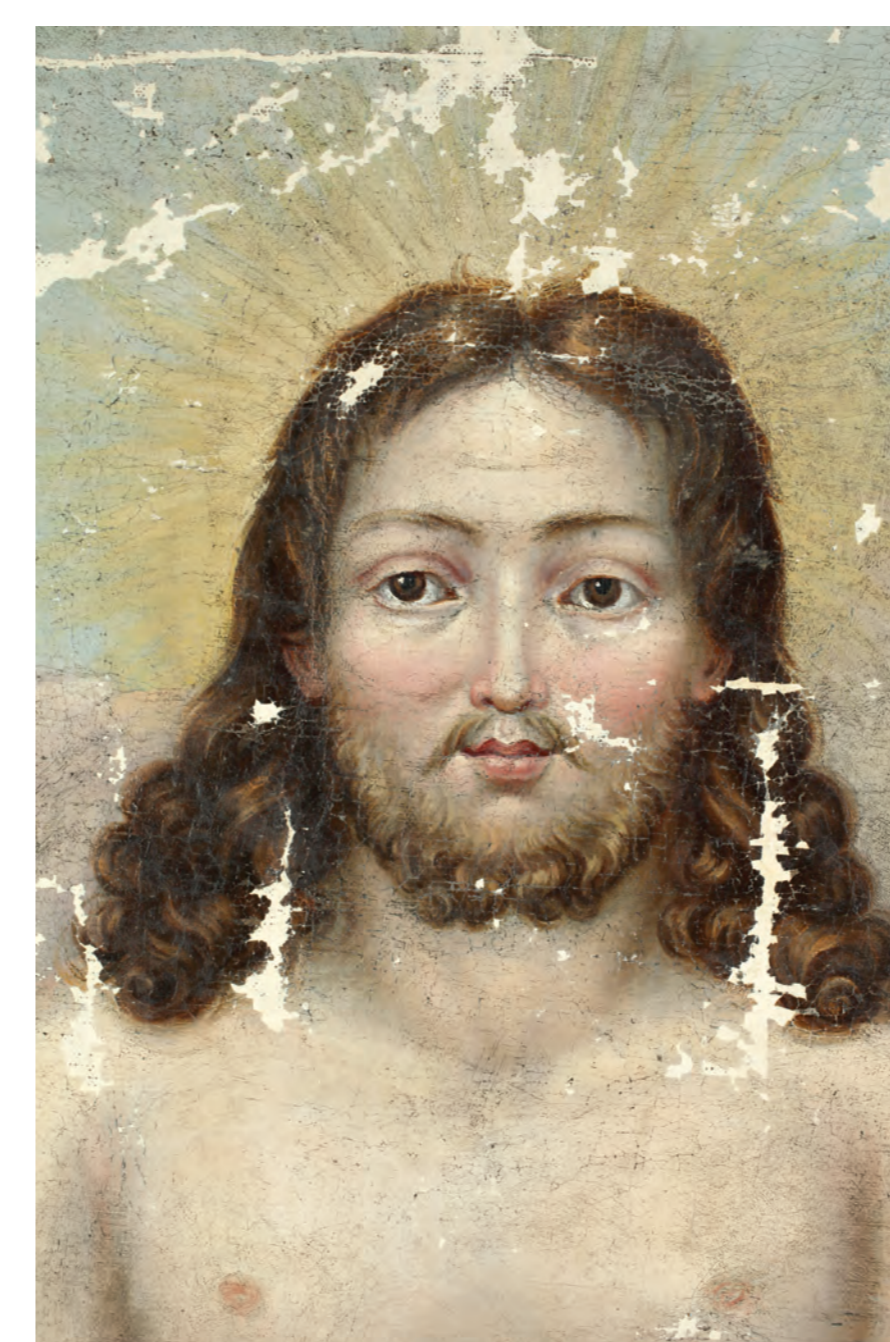
A detail during the process of conservation. Lost ground and flaking losses were filled with conservation ground and coated with varnish.

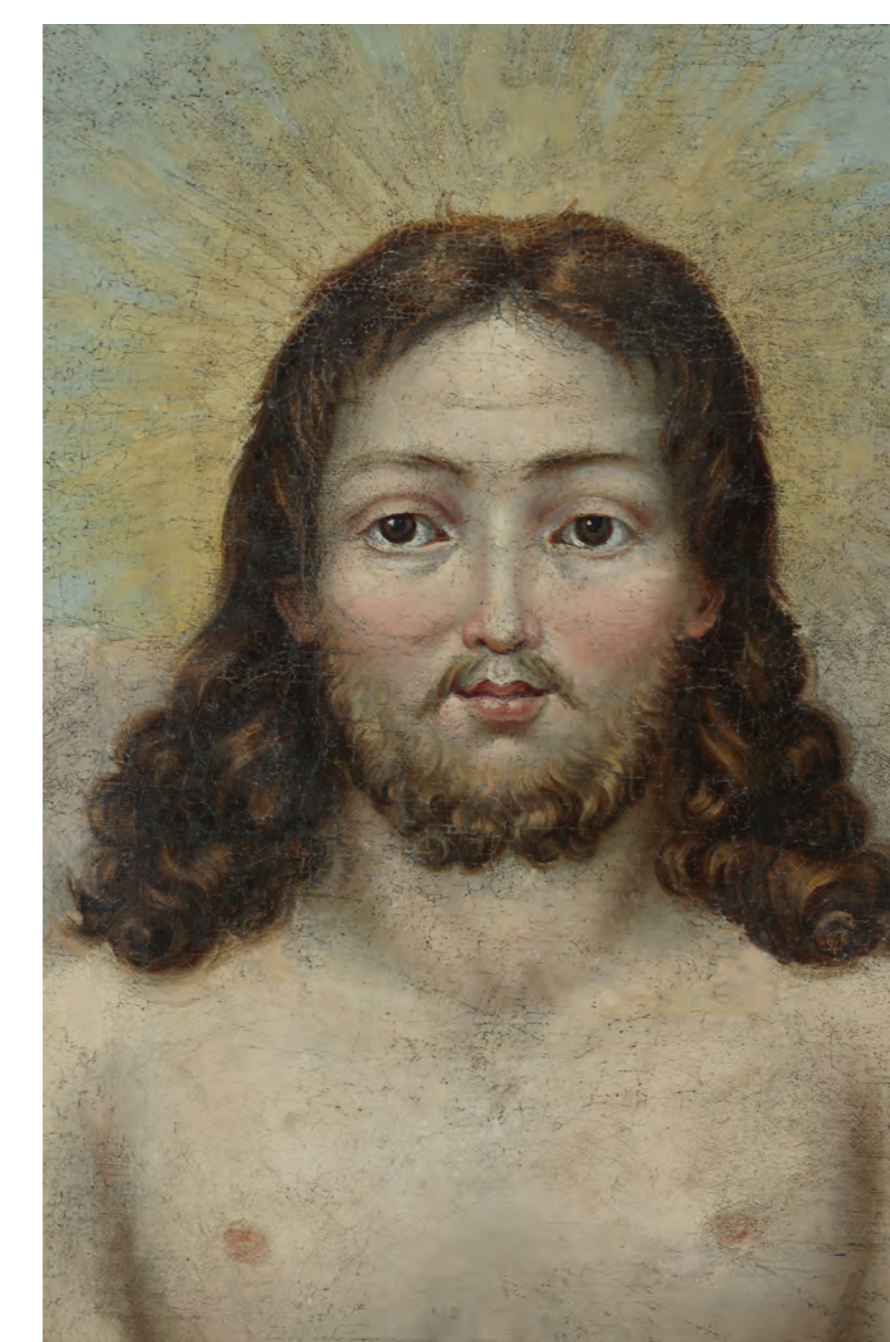
A detail after conservation.

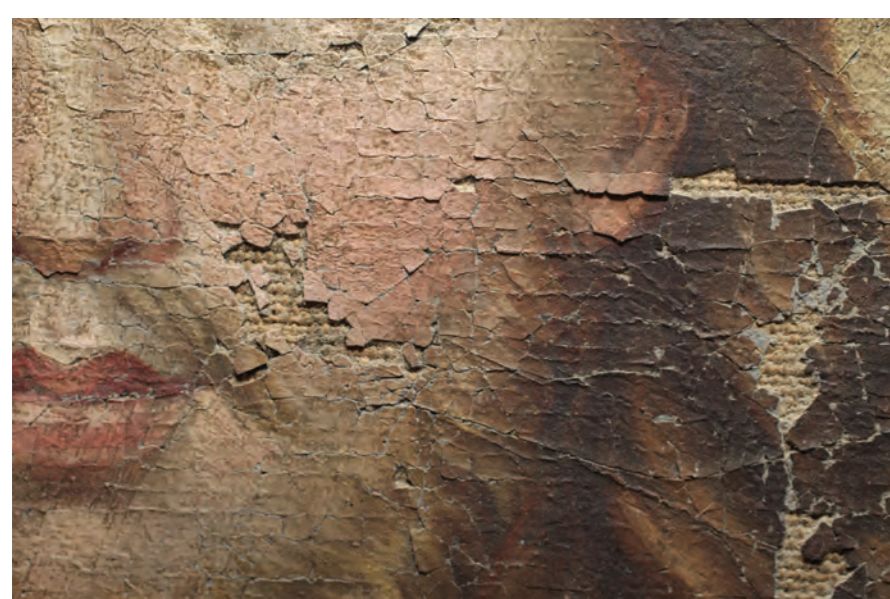
A detail before treatment. Lost ground and flaking losses.

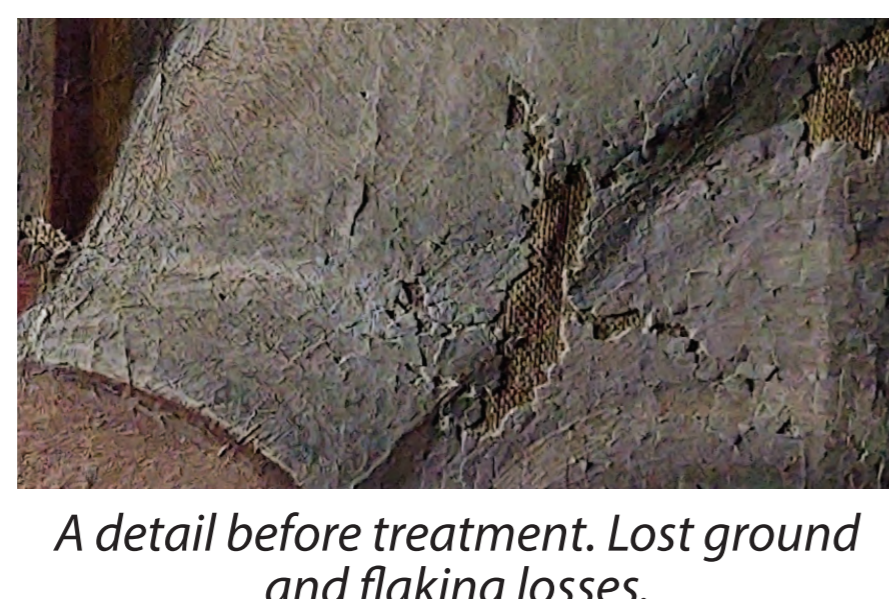
A detail before treatment. Lost ground and flaking losses.

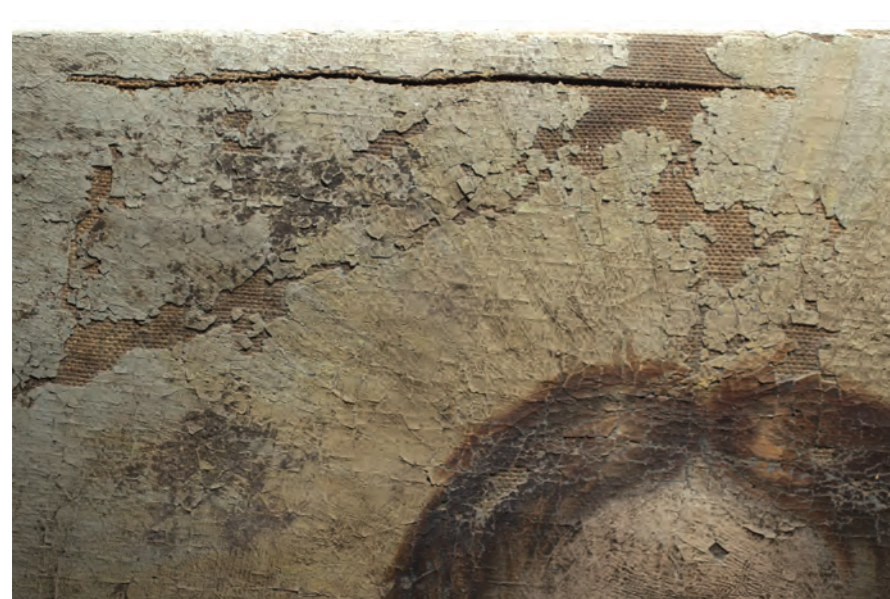
Wavy deformation of the surface. On the top and bottom, there are two 14 cm long cuts with a sharp knife, which show that someone wanted to cut the painting from the subframe in an even smaller format, as it is now. The painted canvas is used for the borders, which is folded with the painting on the subframe. The sub-frame is rigid, without wedges, made of low-quality, thin mouldings, made like a box, in poor technical condition, cannot be exhibited in the future. Hard, reticulated craquelure of the primer and paint layer, with dangerously moving and raised edges in some points. In many places along the edges of the cut, on the face of the Christ and in other places, losses of the primer and paint layer. The varnish layer is thin, uneven and slightly yellowed. Large dirt on the surface. The author's signature cannot be found.

A detail before treatment. 14 cm long mechanical cut in the canvas.

1. The painting was removed from the old stretcher frame.
2. Smoothing out of the deformation, fixing of the dangerously raised craquelures in the primer layer and paint layer, pressing (the fish glue has been used).
3. Closure of the cuts with the edge joining method and canvas fluff (PVB glue-polyvinylbutyral was used).
4. Duplication of the new edges.
5. The painting was stretched on the new stretcher frame.
6. The surface dirt was removed, spots of uneven, yellowed varnish layer were softly thinned (ethyl alcohol + turpentine).
7. The areas of loss of the primer layer were filled with conservation primer from fish glue and coloured chalk, and then grinded.
8. Application of a new varnish. (Dammar varnish+ turpentine).
9. The painting was retouched.

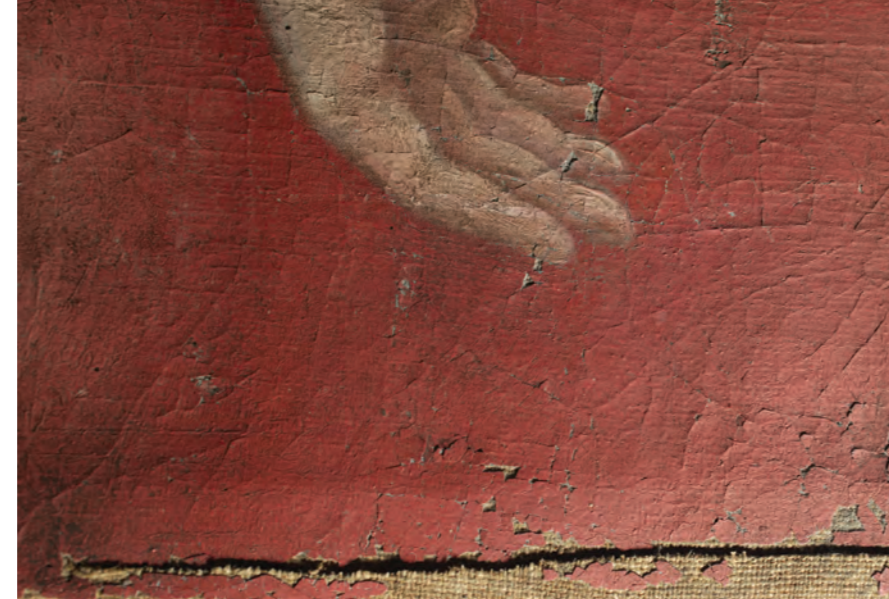
A detail before treatment. 14 cm long mechanical cut in the canvas.

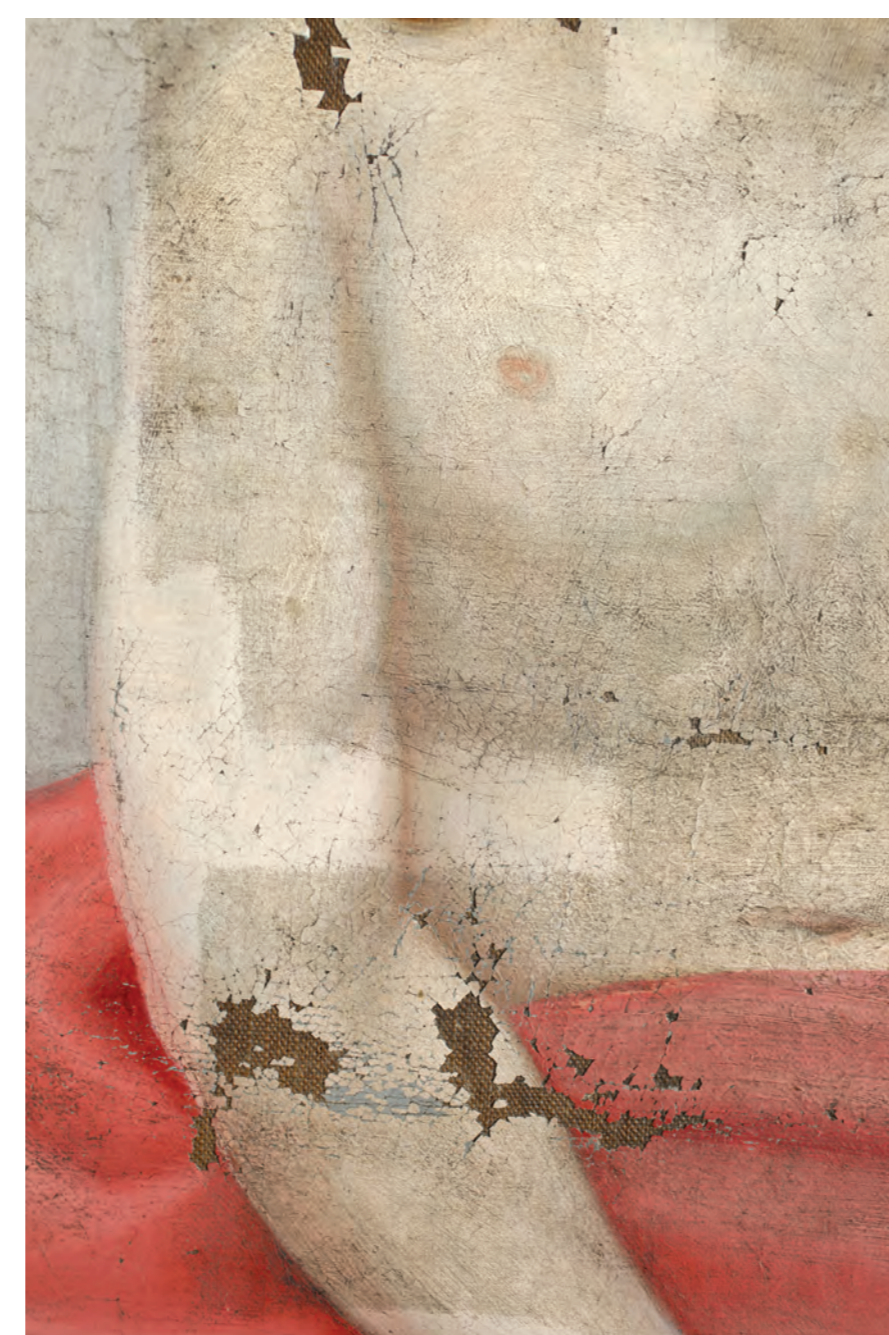
A detail during the process of conservation with partly removed varnish.

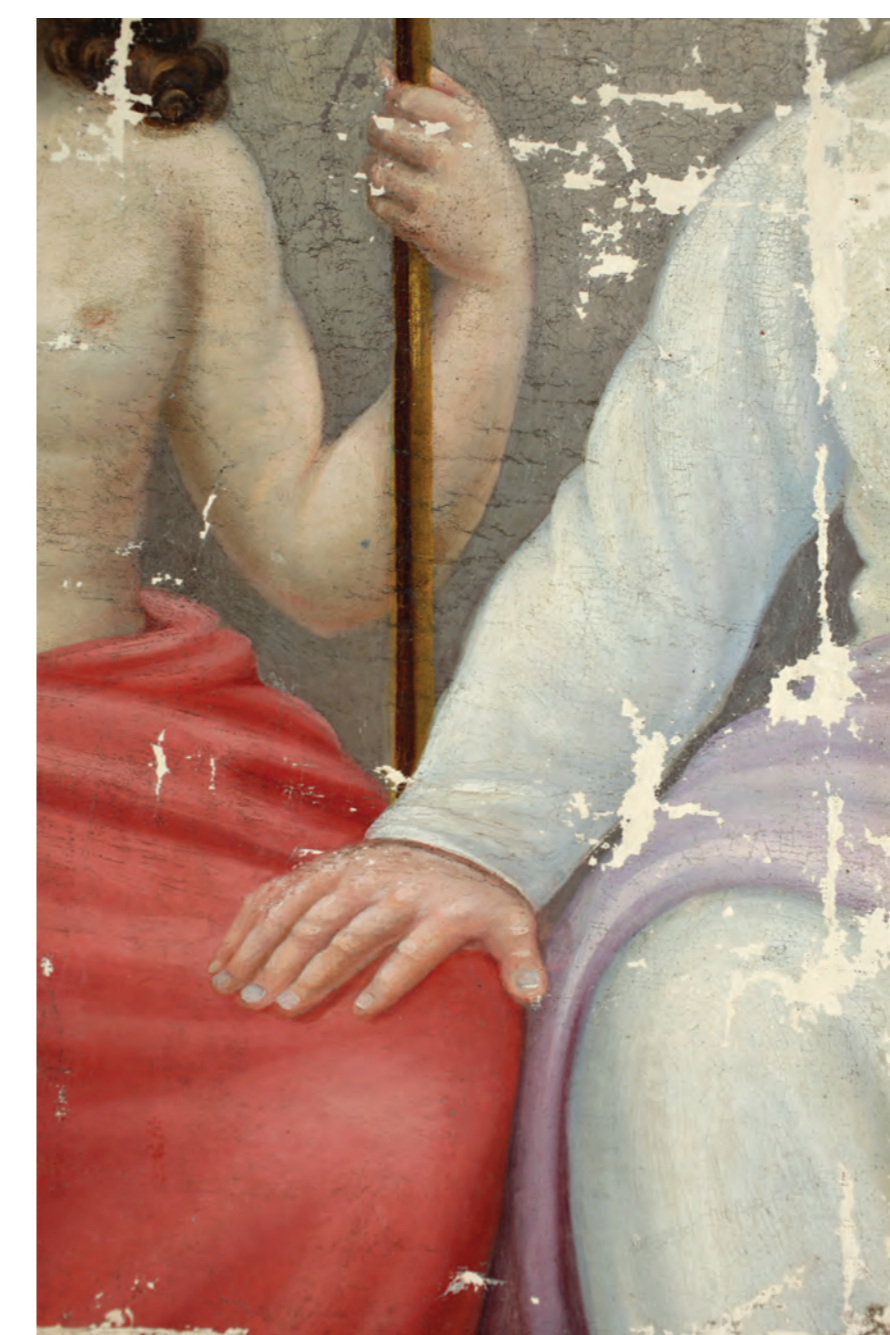
A detail during the process of conservation. Lost ground and flaking losses were filled with conservation ground and coated with varnish.

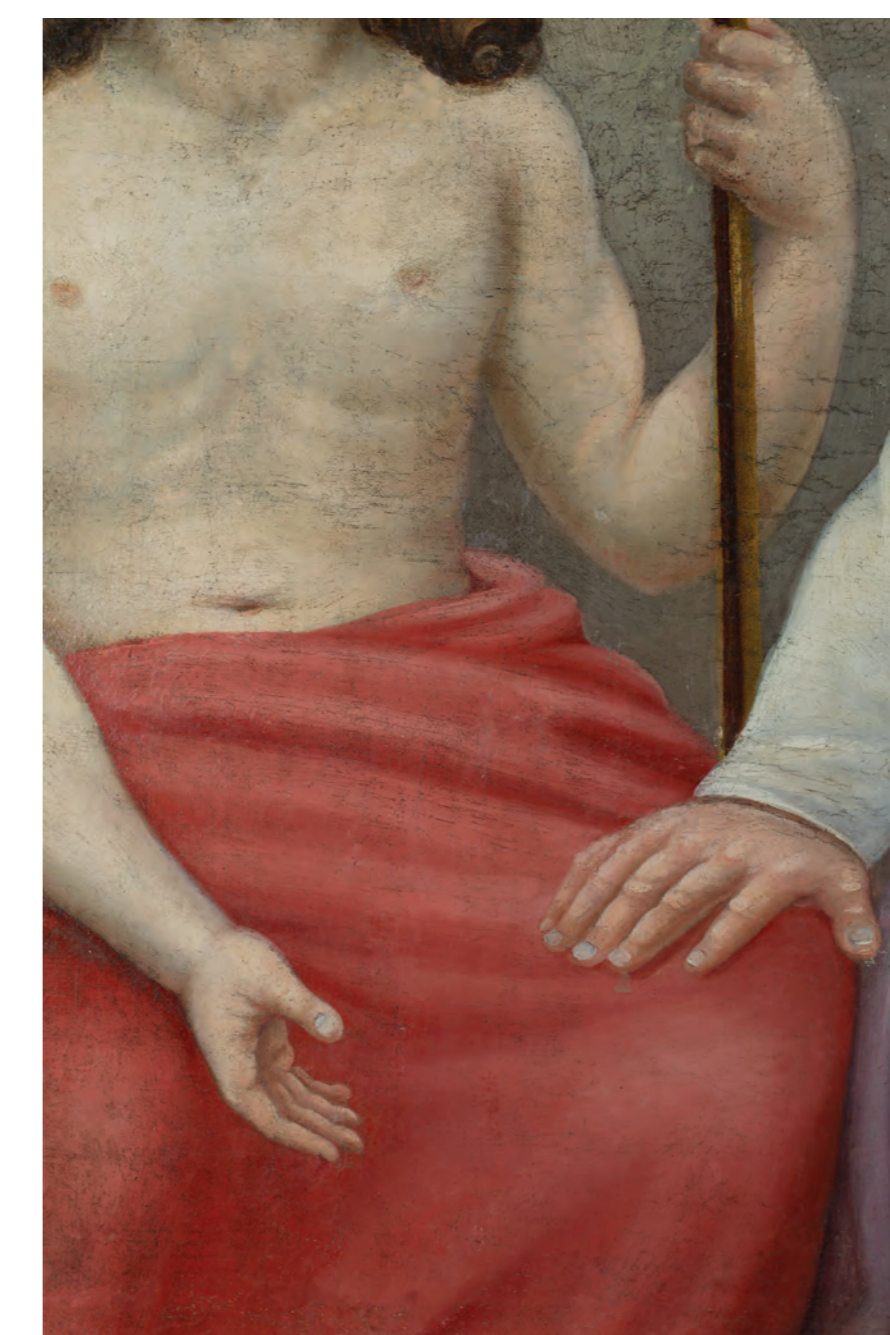
A detail after conservation.
