RESTORATION OF PAPER DOCUMENTS CONTAINING VARIOUS SEALS

EINĀRS SONDORS

DOCUMENT GV426 (50.3 X 34.7 CM)

DOCUMENT F5561-US3-GV373 (54.3 X 38.2 CM)

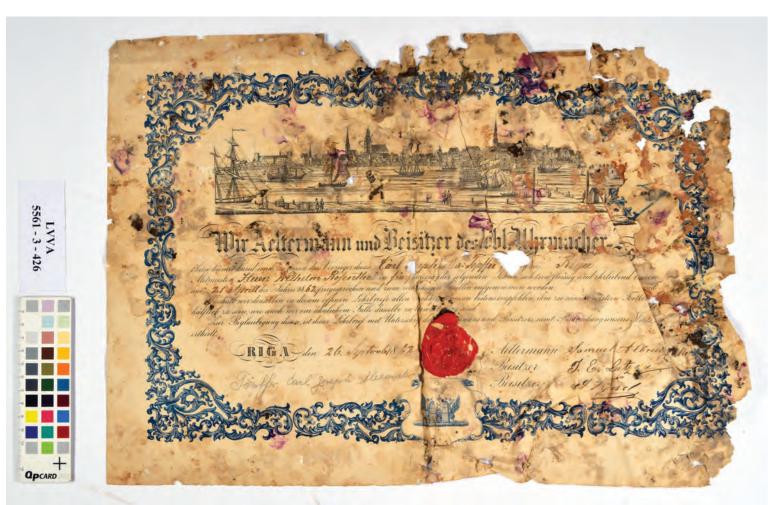
(Fig. 1) GV 426 Obverse prior to restoration

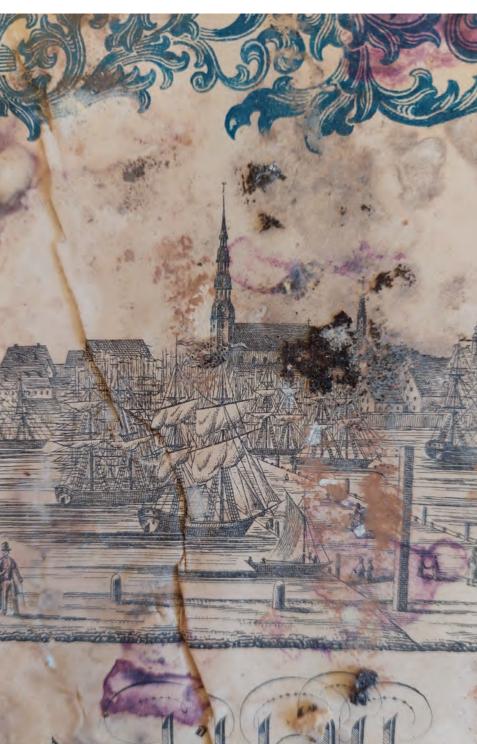
(Fig. 5) GV 426 Fragment prior to restoration, mould growth

Damage: a layer of superficial dirt, fold lines, yellowing of paper. Over time, exposed to moisture, resulting in staining and mould growth, particularly in GV426. The effect has contributed to colour changes, loss of fragmentary paper mechanical properties and material, etc.

During the restoration of GV426, the following were performed:
- dry cleaning, cleaning of mould growth with a soft brush on a cleaning

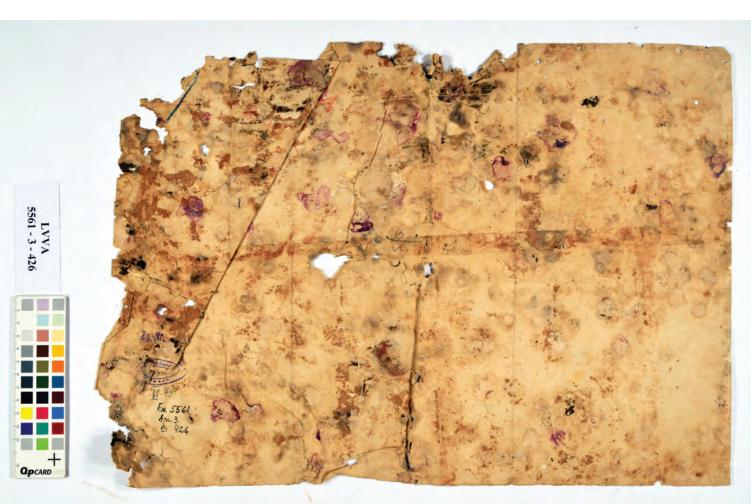
(Fig. 3) GV 426 Reverse prior to restoration

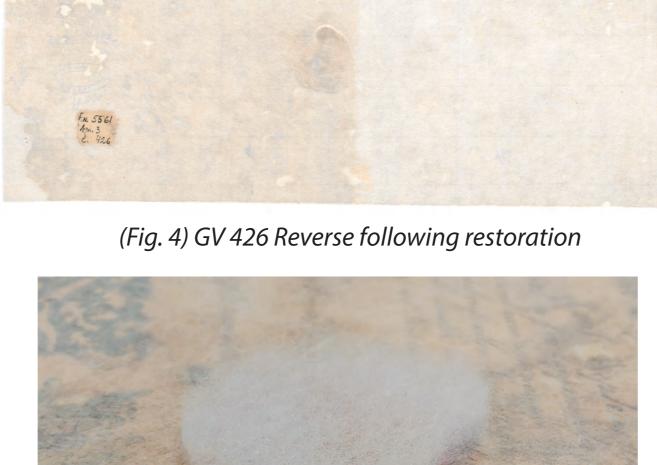
(Fig. 9) GV 426 Sintepon padding for the lacquer seal

Drying by pressing between layers of cardboard and non-woven polyester (GV426 - in a press, GV373 - locally). For the padding of the lacquer seal, a fragment of sintepon is used, which is placed over the seal between cardboard and polyester. After pressing, the Japanese paper is compared to the originals. Restoration of seals was performed separately. The documents were placed in an archival-quality corrugated cardboard folder for further storage and returned to the LVVA collection.

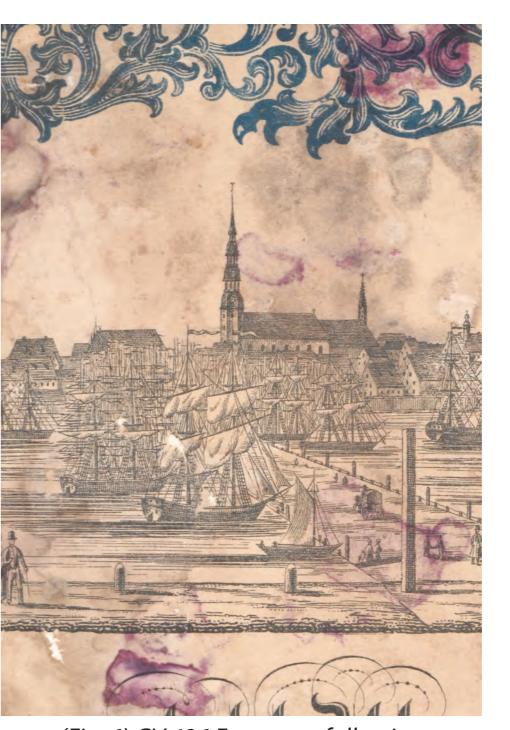
(Fig. 6) GV 426 Fragment following restoration

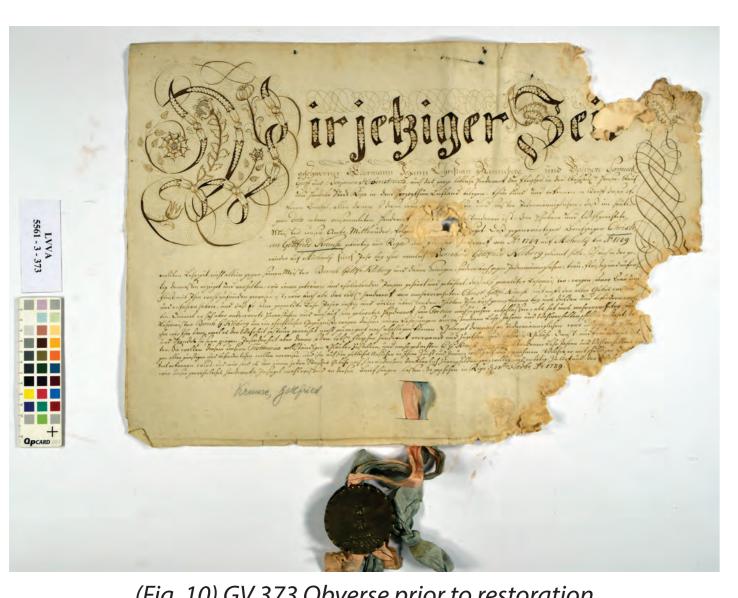
(Fig. 10) GV 373 Obverse prior to restoration

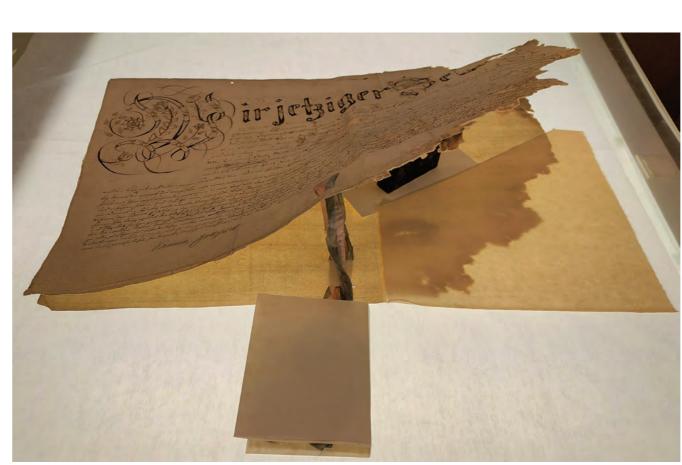
(Fig. 14) GV 373 Japanese paper fitting for loss filling

- fragmentary strengthening of paper and filling in of missing material with Japanese paper (Kizuki Kozu 6g/m², Bunko SHI 71g/m²) and 13% wheat starch glue from the inside.

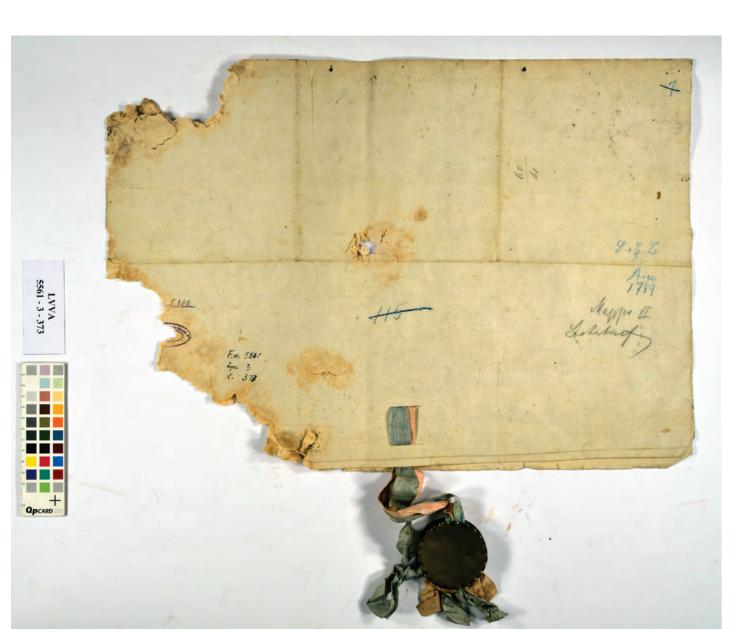
(Fig. 12) GV 373 Reverse prior to restoration

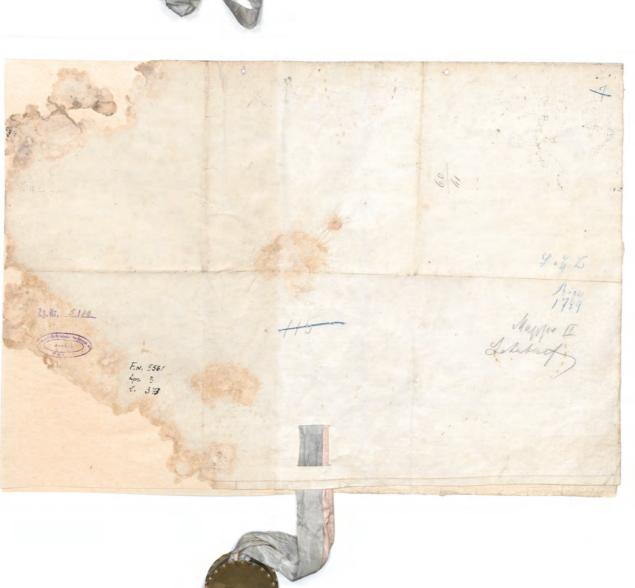
(Fig. 13) GV 373 Reverse following restoration

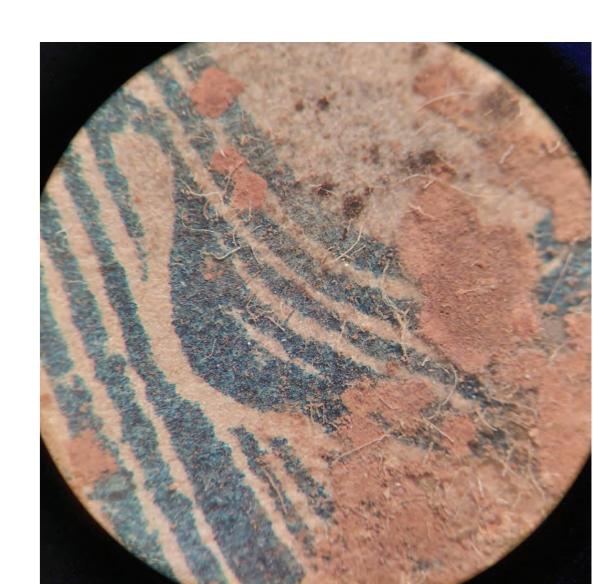
(Fig. 7) GV 426 Mould growth and visible separated paper fibre under microscope 20x magnification
