ENHANCED INVESTIGATION OF THE COMPOSITION OF THE VALMIERMUIŽA CASTLE TOWER GROUND FLOOR CEILING'S MONUMENTALLY DECORATIVE PAINTING

EVITA LAMASA, M.A.
Restorer
merkuss@gmail.com
Latvia

INGŪNA STROŽA, M.A.
Restorer
inguna.stroza@gmail.com
Latvia

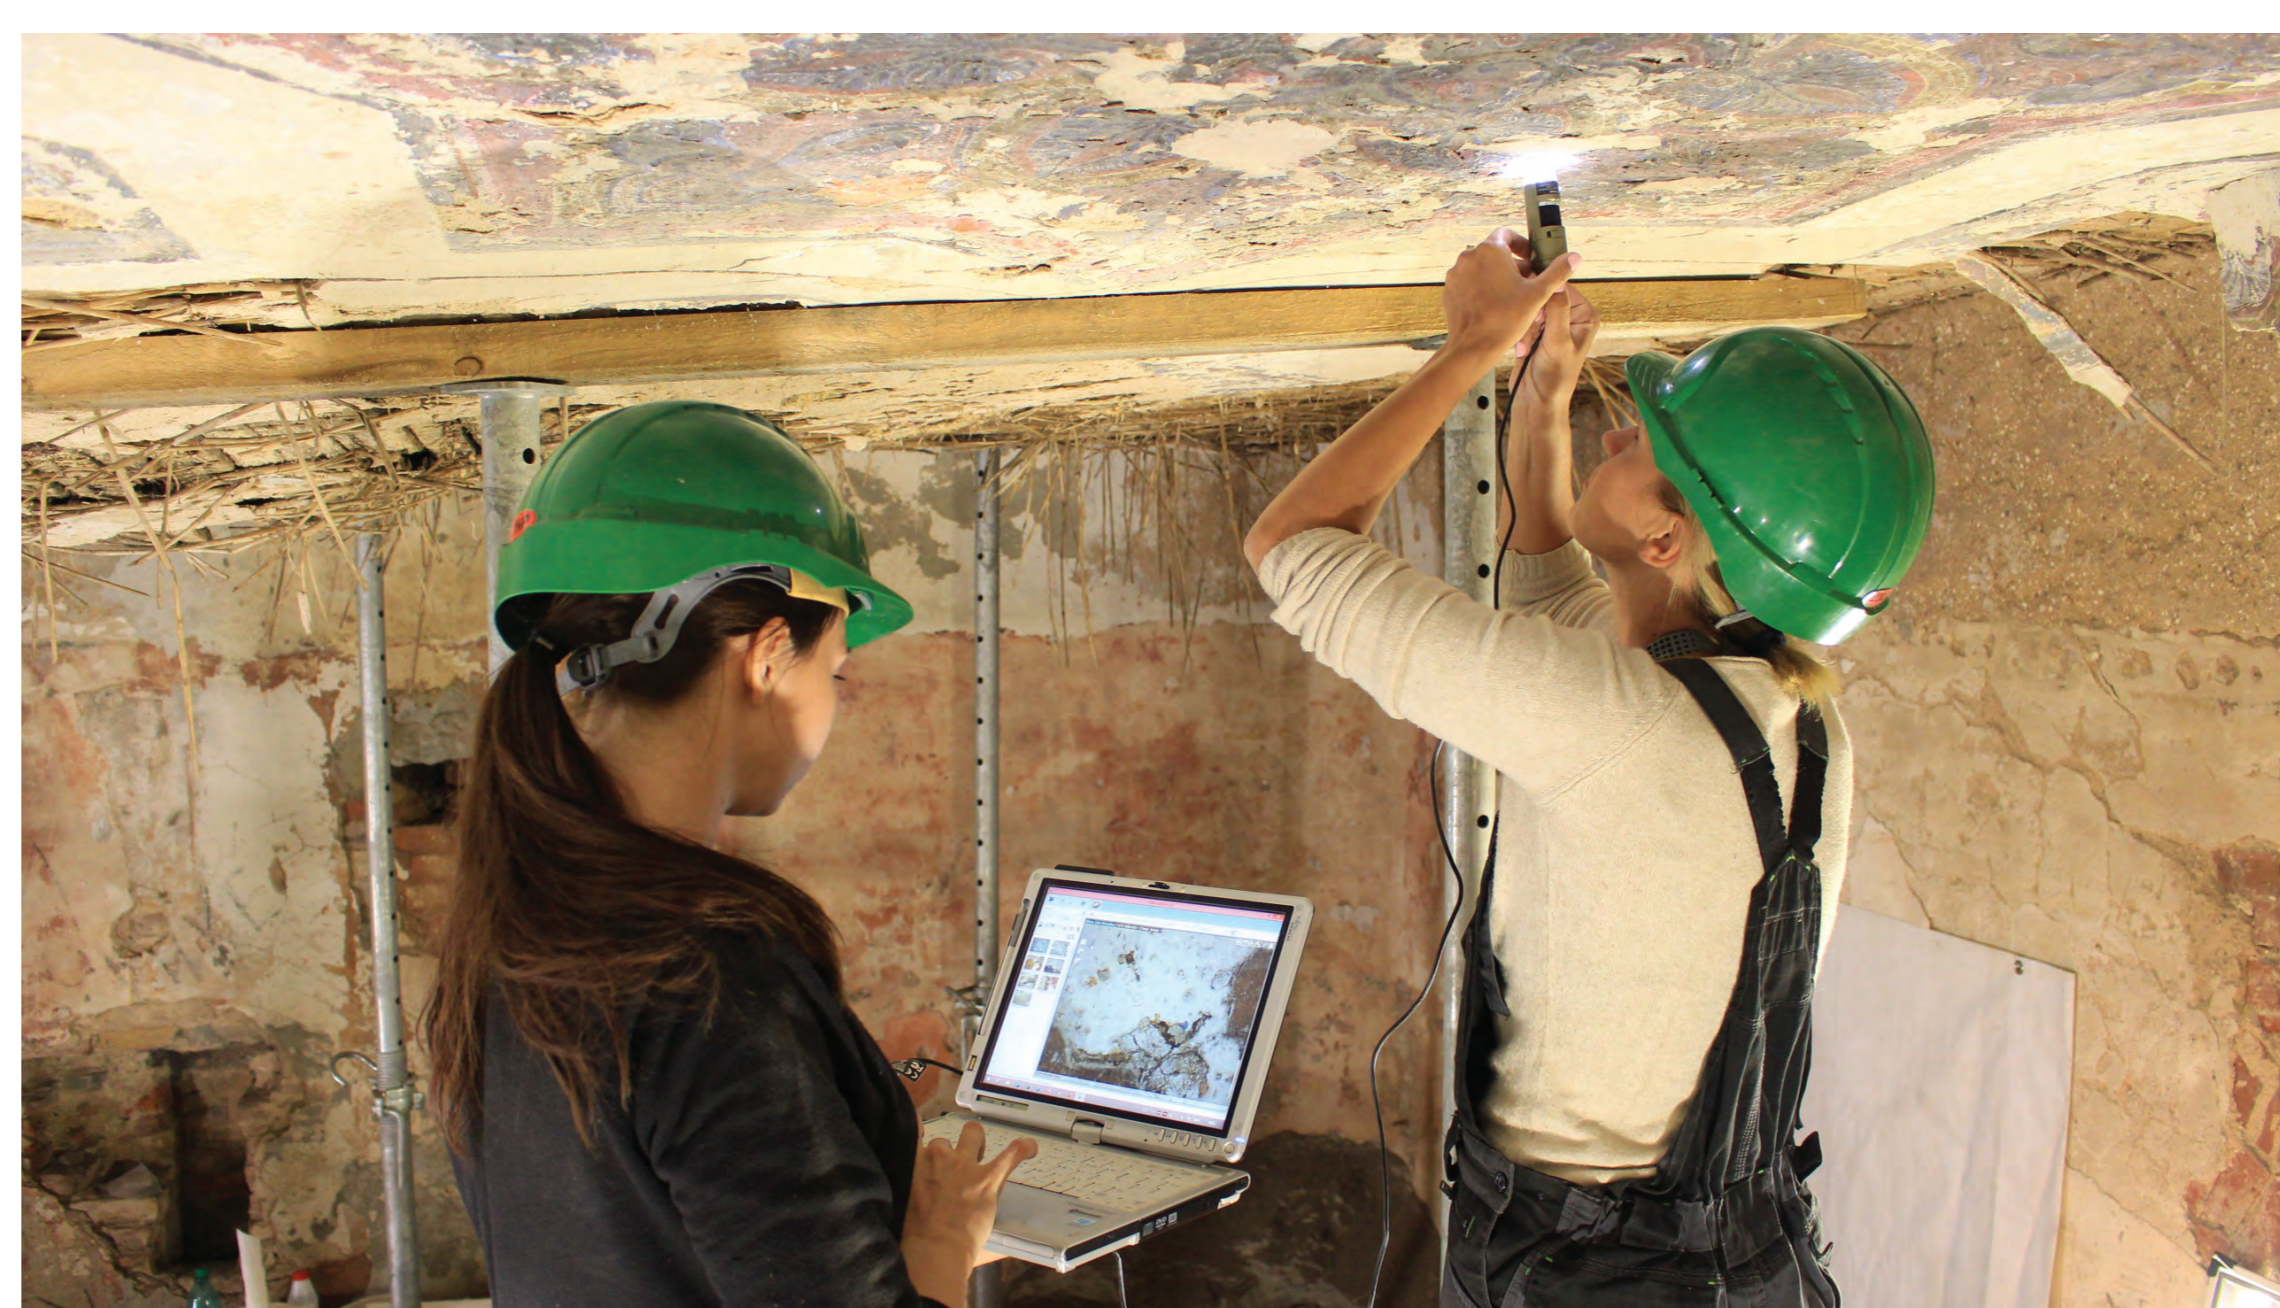
Fig. 3. Valmiermuiža Castle tower's ground floor ceiling's monumentally decorative painting microscopic study

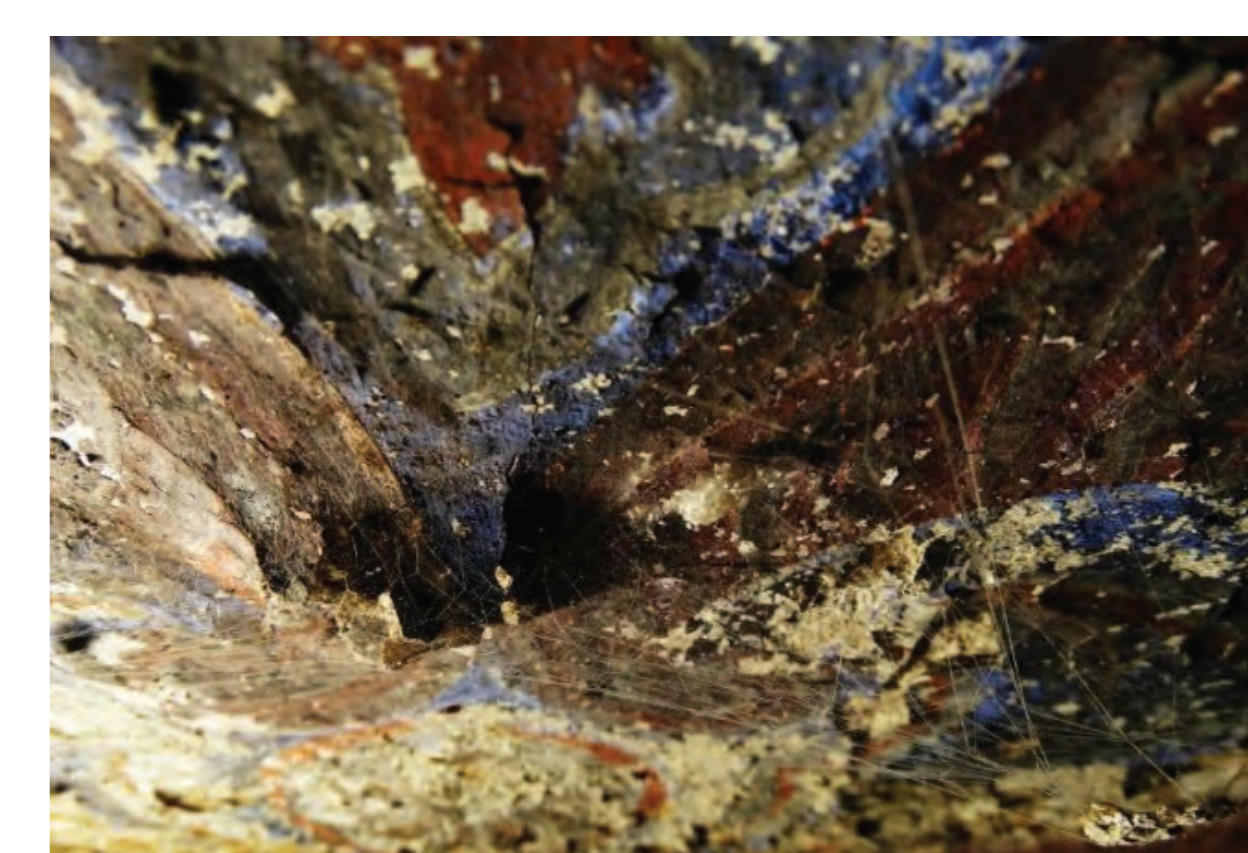
Fig. 4. Biological damage to the VII ornament of the monumentally decorative ceiling painting composition of the 1st floor of the Valmiermuiža palace tower

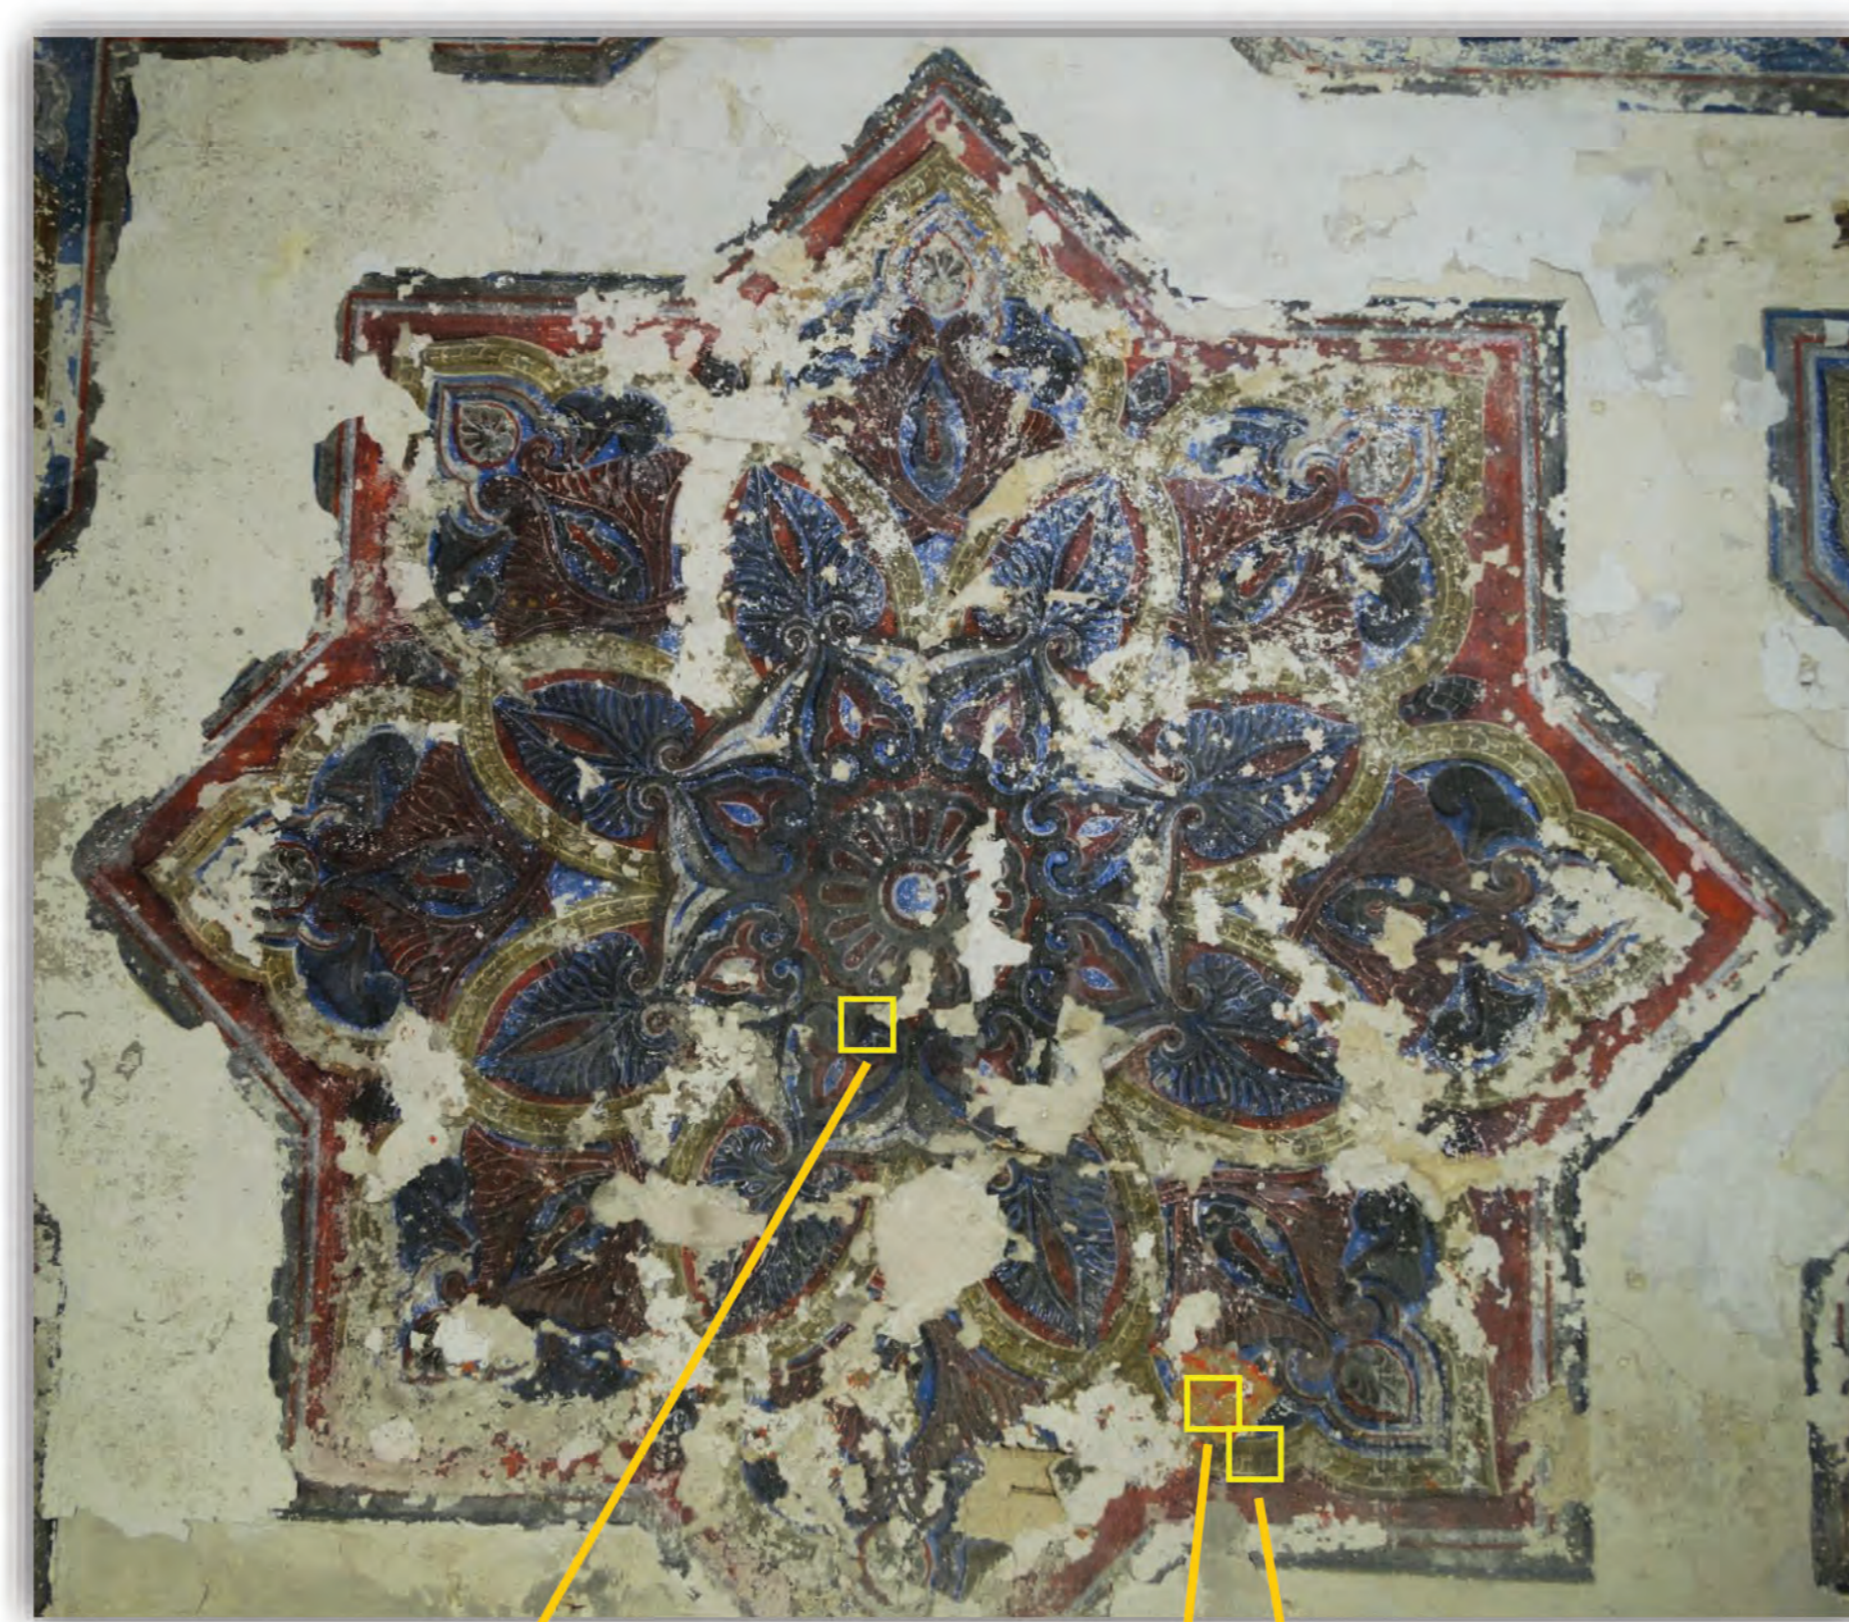
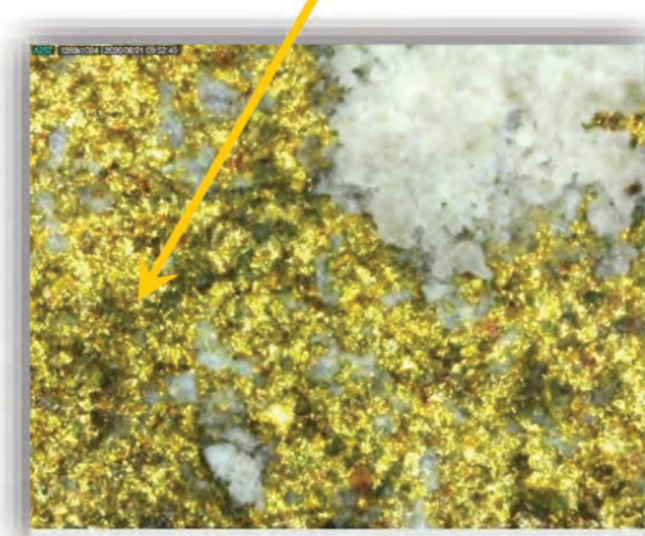
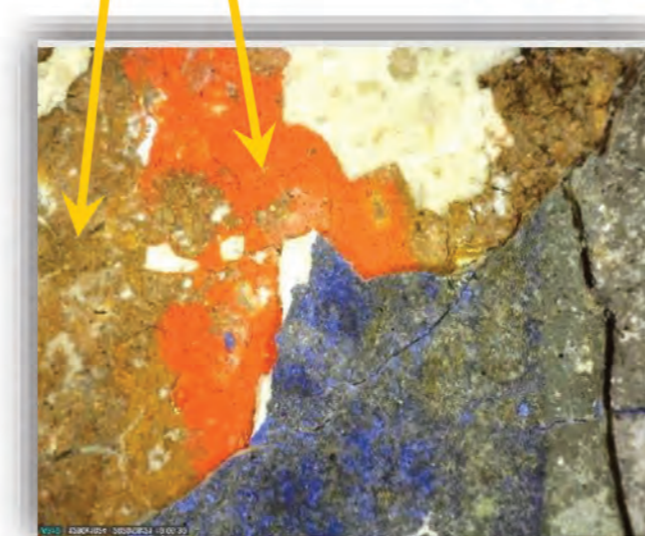
Fig. 5. VII ornament of the monumentally decorative ceiling painting composition

Microscopic investigation revealed that the black belts of ornamentation are of bronzing which has blackened, which was confirmed by the results of physical chemical analysis (Fig. 5). Traces of salt have formed on the surface of the painting from the effects of moisture and mould has progressed.

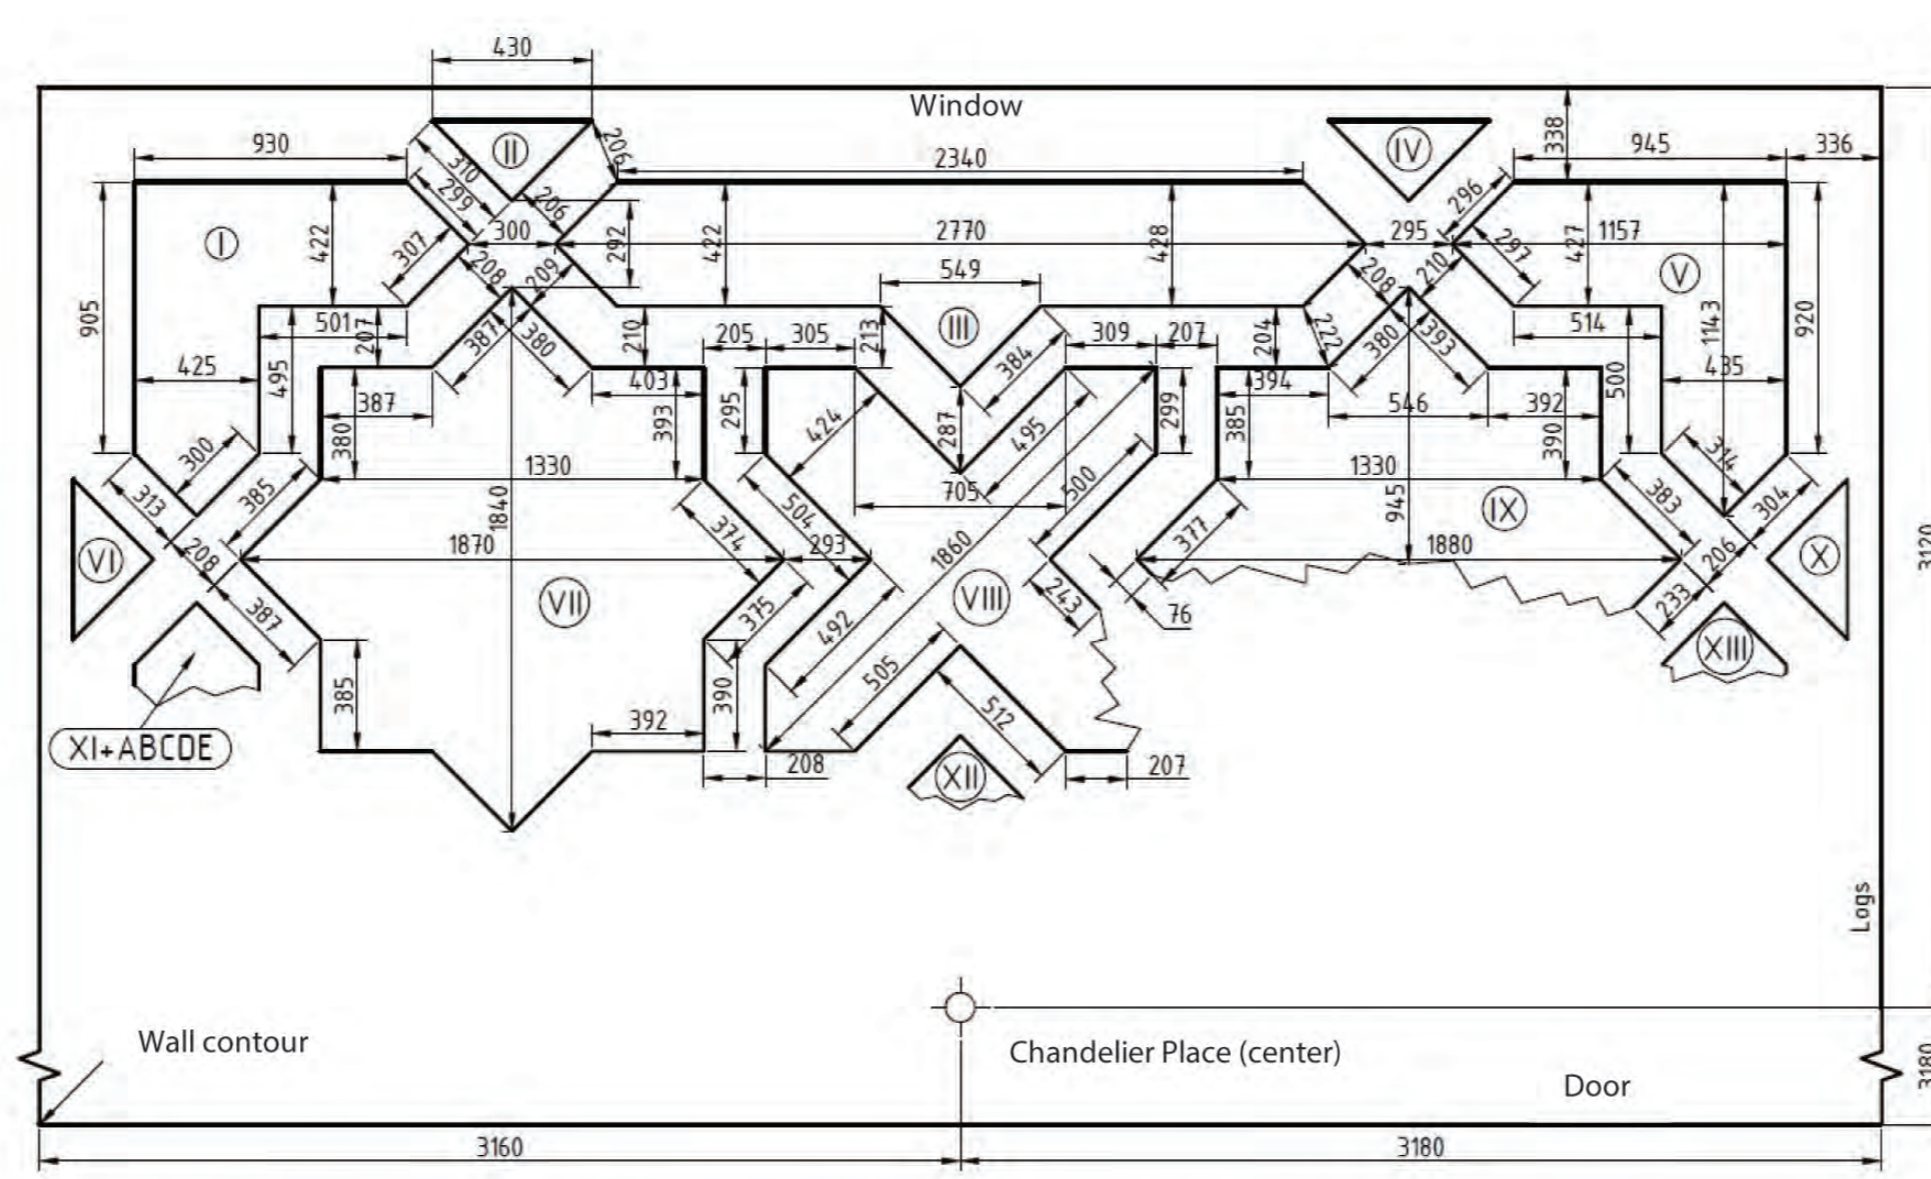
Fig. 2.1. The scheme with scales of preserved monumentally decorative ceiling painting composition ornaments

The entire paint layer is covered by a comparatively thick layer of grime. The overall loss of the paint layer on the ceiling is ~ 65 % (Fig. 2.1). The monumentally decorative ceiling painting is in an emergency condition - fragile, crumbling and breaking up into a fine craquelure. Under the impact of pressure, the paint chips have become detached from the base and become rolled-up, forming scales.
