RESTORATION OF A WAGON

KRIŠJĀNIS RIMŠĀNS

Metalwork restorer-specialist
krisjanis.rimsans@lnvm.lv
National History Museum of Latvia
Pulka Street 8, Riga

INTRODUCTION

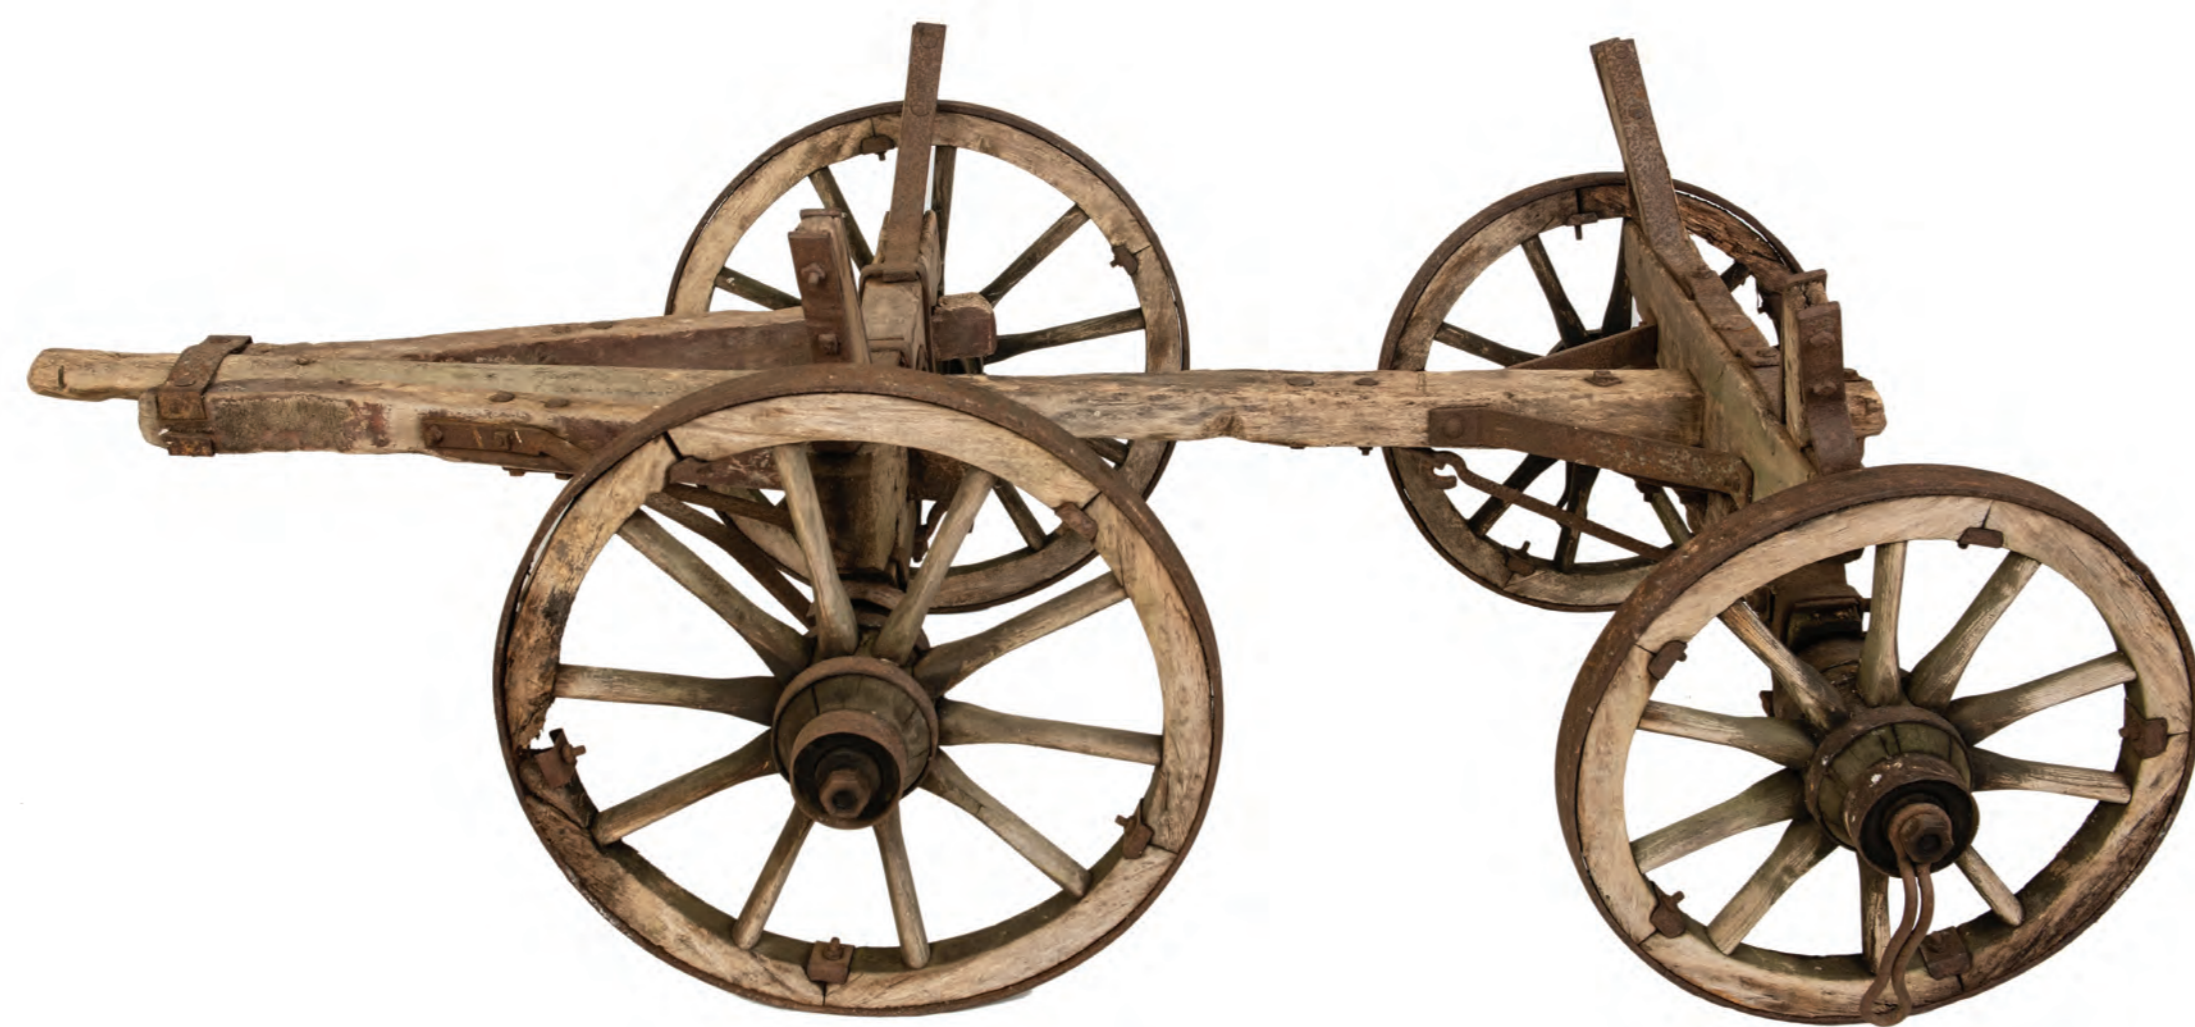
The item had a thick layer of various dirt, whereas the hubs of the wheels and parts of the axles, had a thick layer of black grease. Wood had deteriorated and was damaged in many places by the swelling of iron corrosion products. Parts of the wheels - spokes and felloes had been heavily damaged by the influence of moisture, and three bolster stakes had broken off. Metal parts had a thick incrustation of iron corrosion products, which had seriously swelled at contact points with wooden parts.

13. Wagon before restoration

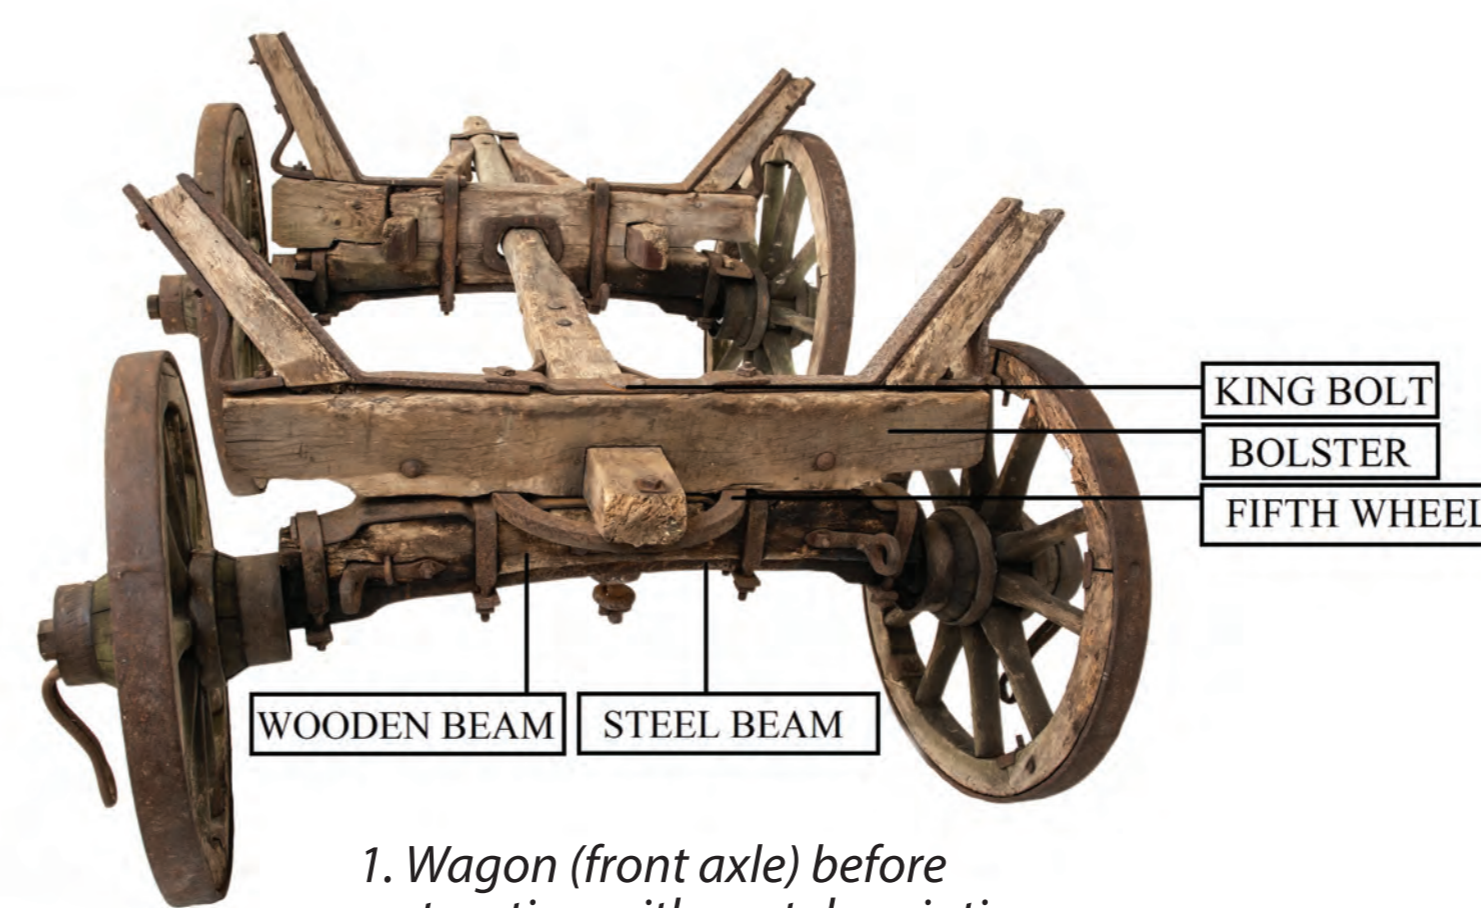
1. Wagon (front axle) before restoration with part descriptions

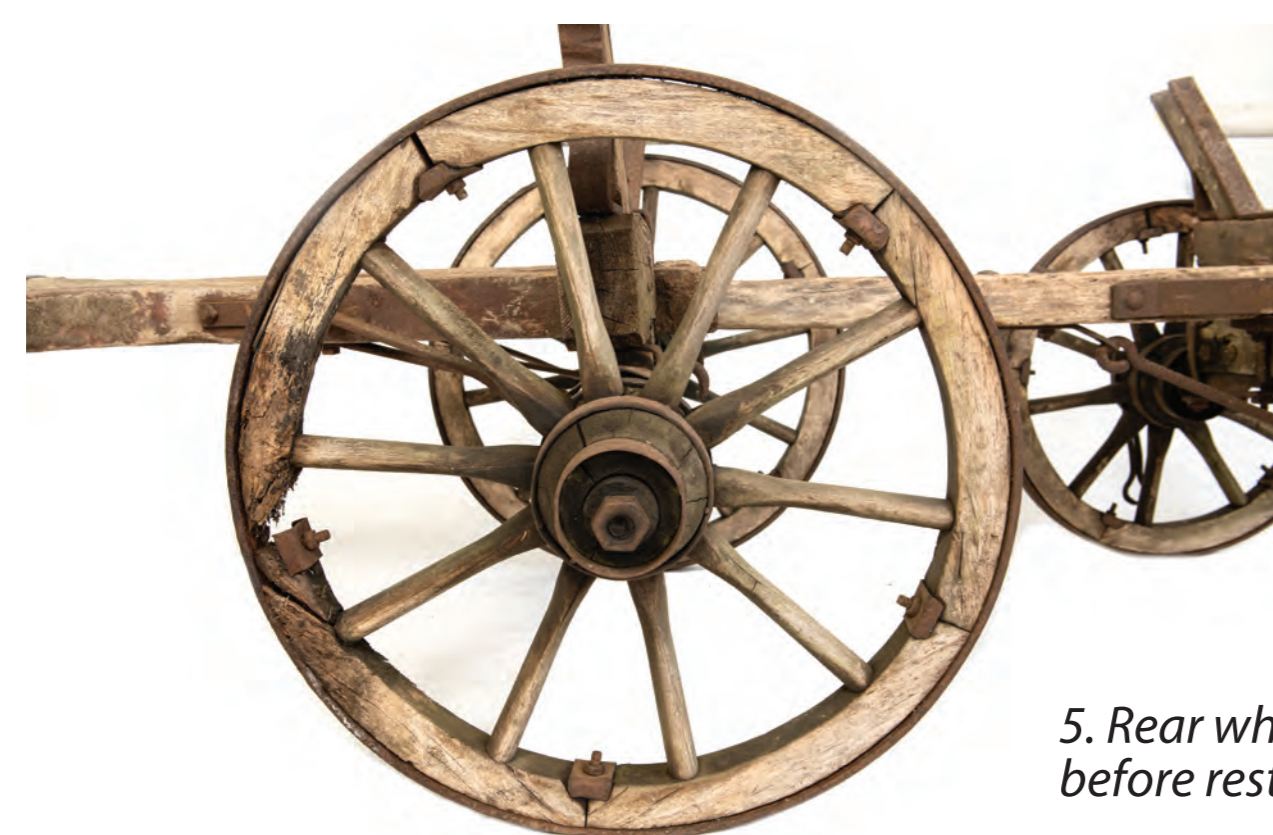
5. Rear wheel before restoration

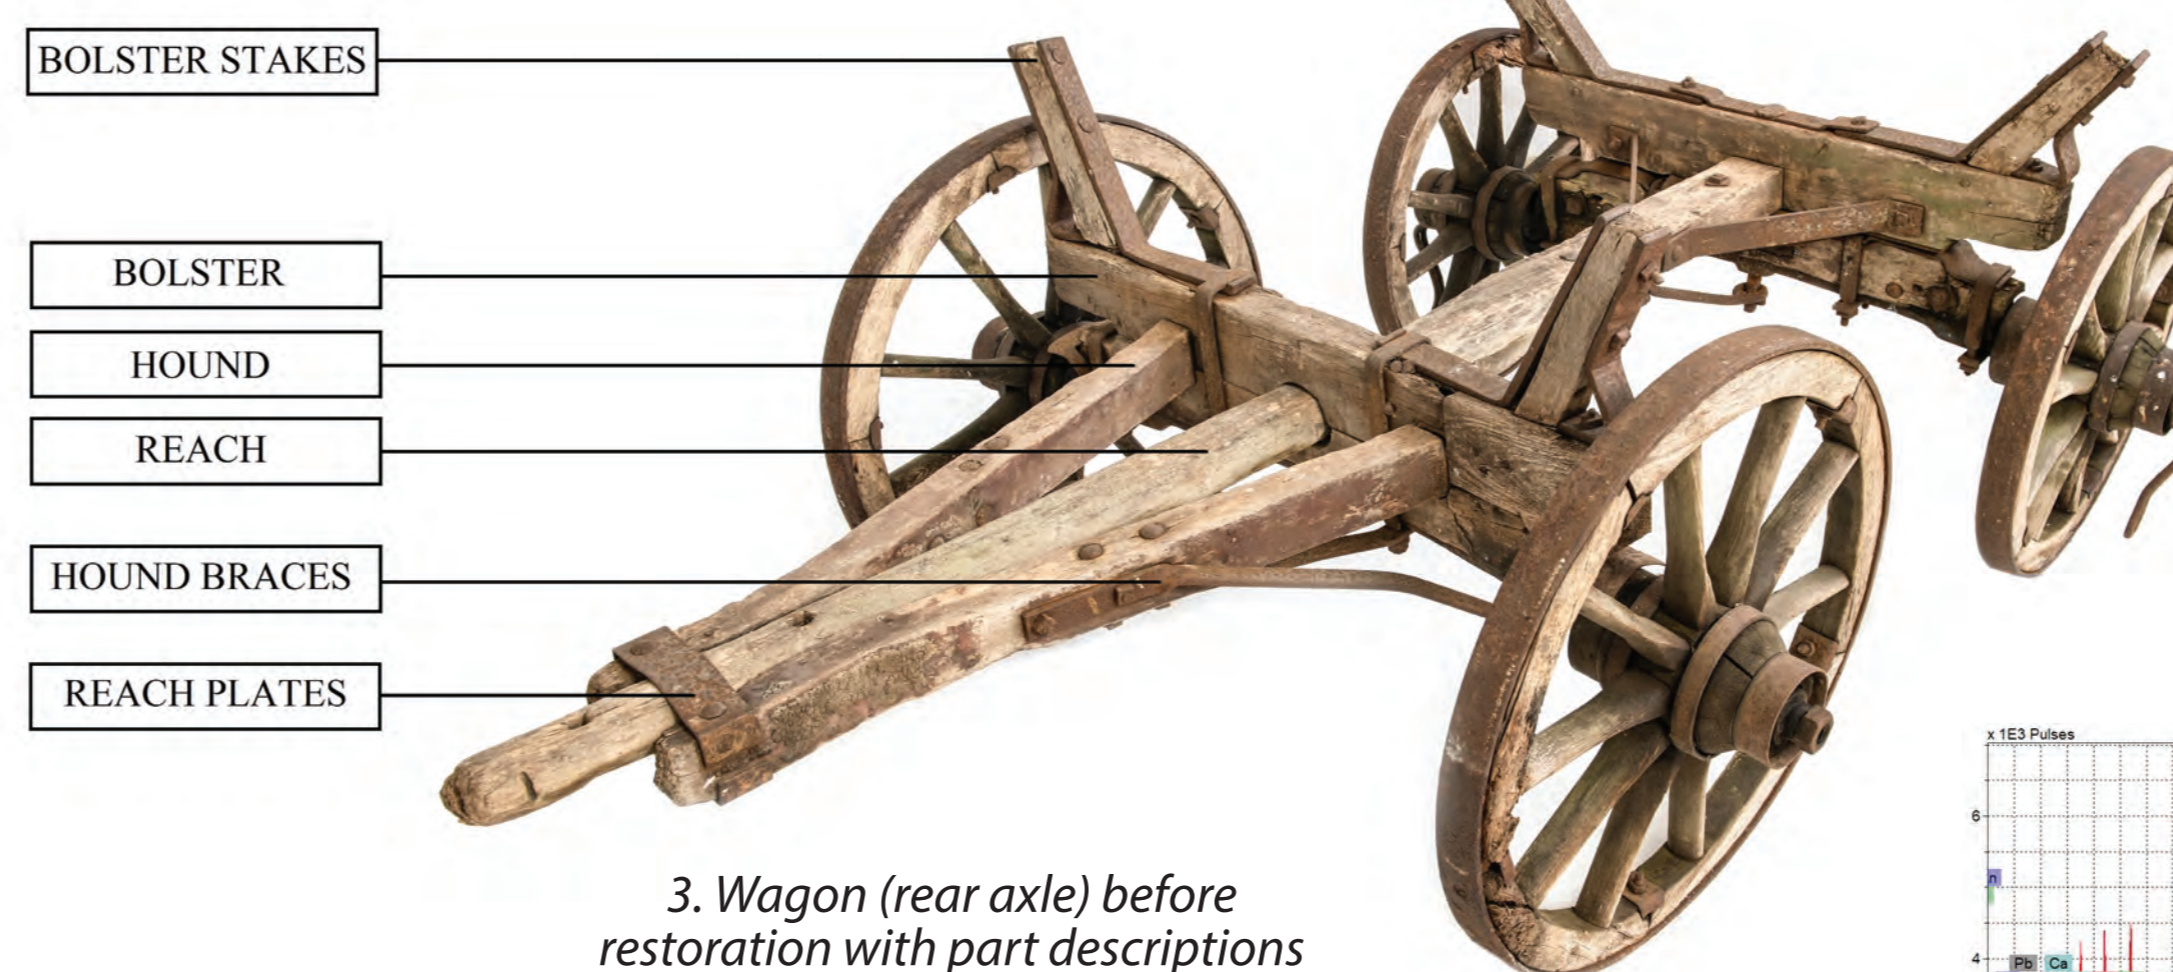
3. Wagon (rear axle) before restoration with part descriptions

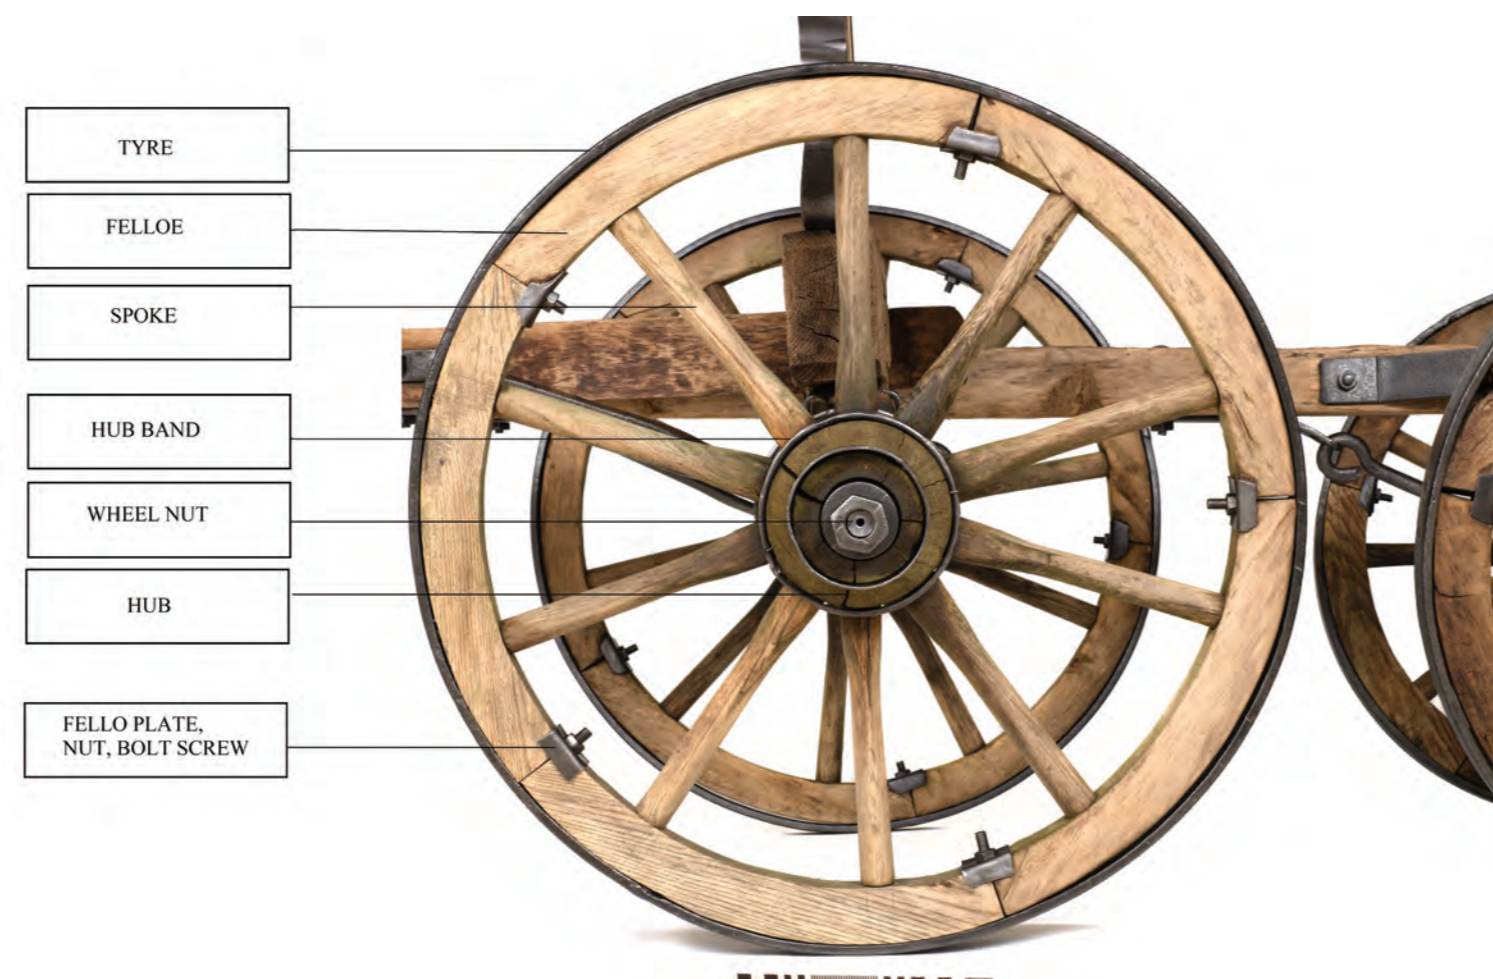
6. Rear wheel after restoration with part descriptions

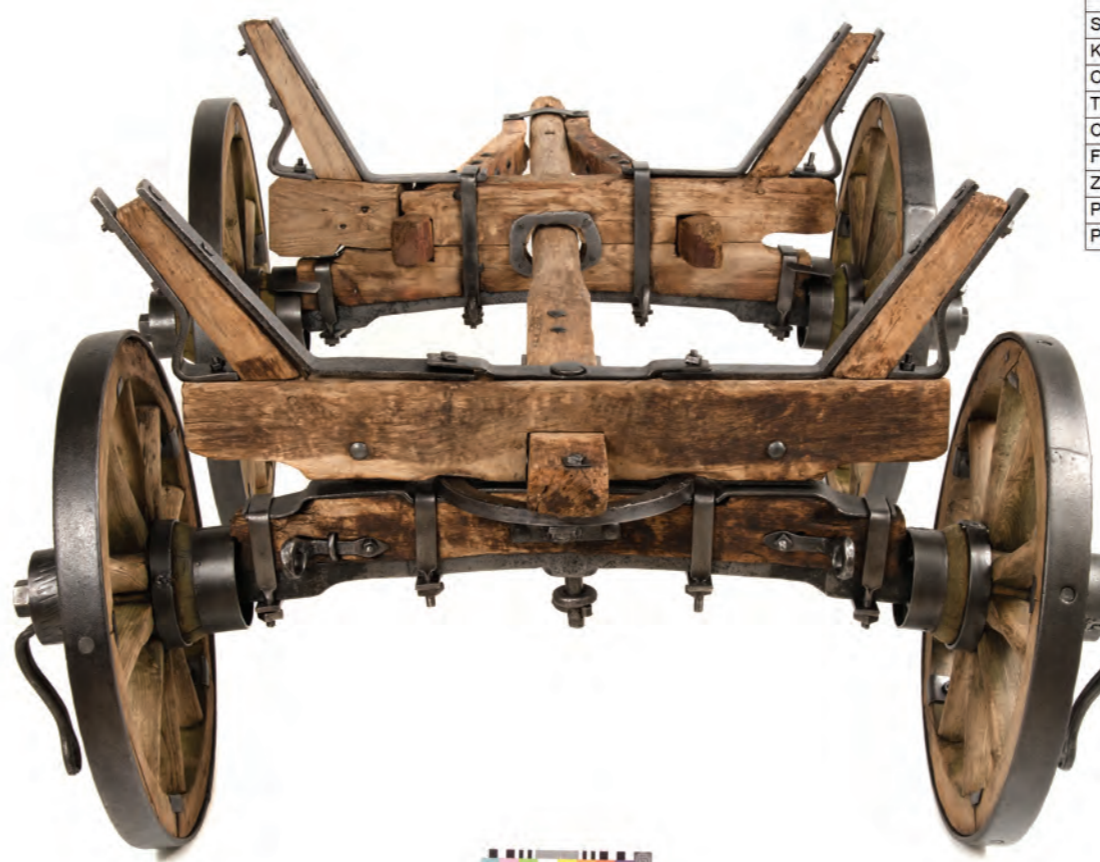
2. Wagon (front axle) after restoration

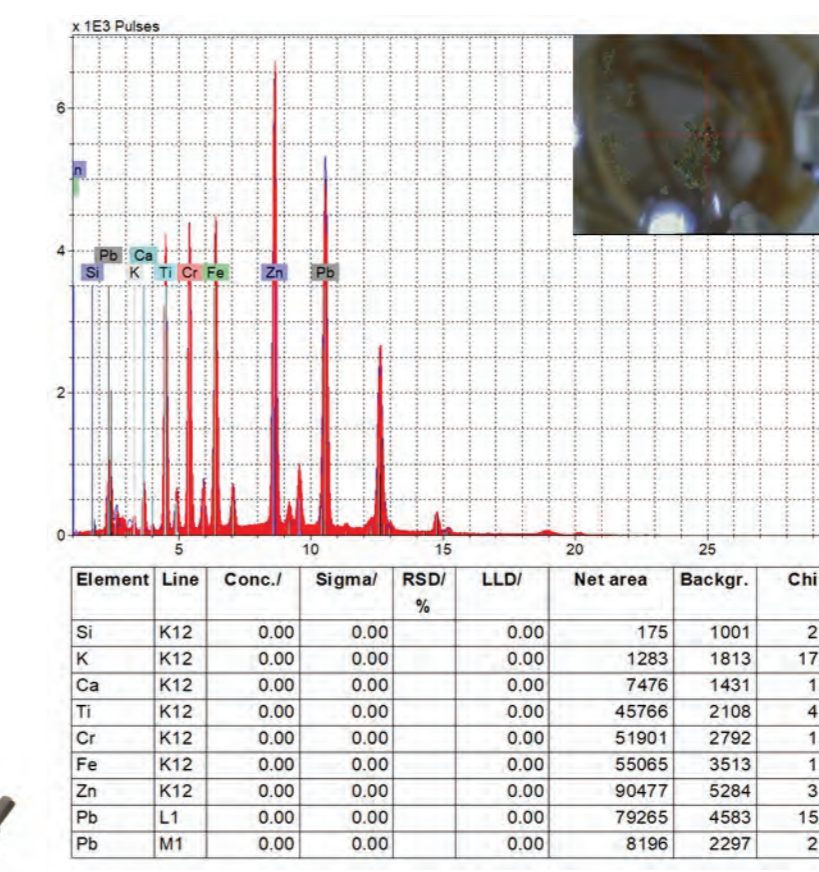
12. XRF analysis of green colour substance

A layer of green colour substance was found on the surface of the wheels. It was problematic to conclude whether the green colour substance layer is a layer of paint or biological origin material (e.g. algae). During examination in the NHML laboratory, it was determined that green colour substance layer is a mixture of two pigments - yellow pigments and iron-containing green pigment. Using XRF analysis, additionally were found zinc, lead, chrome and titanium.

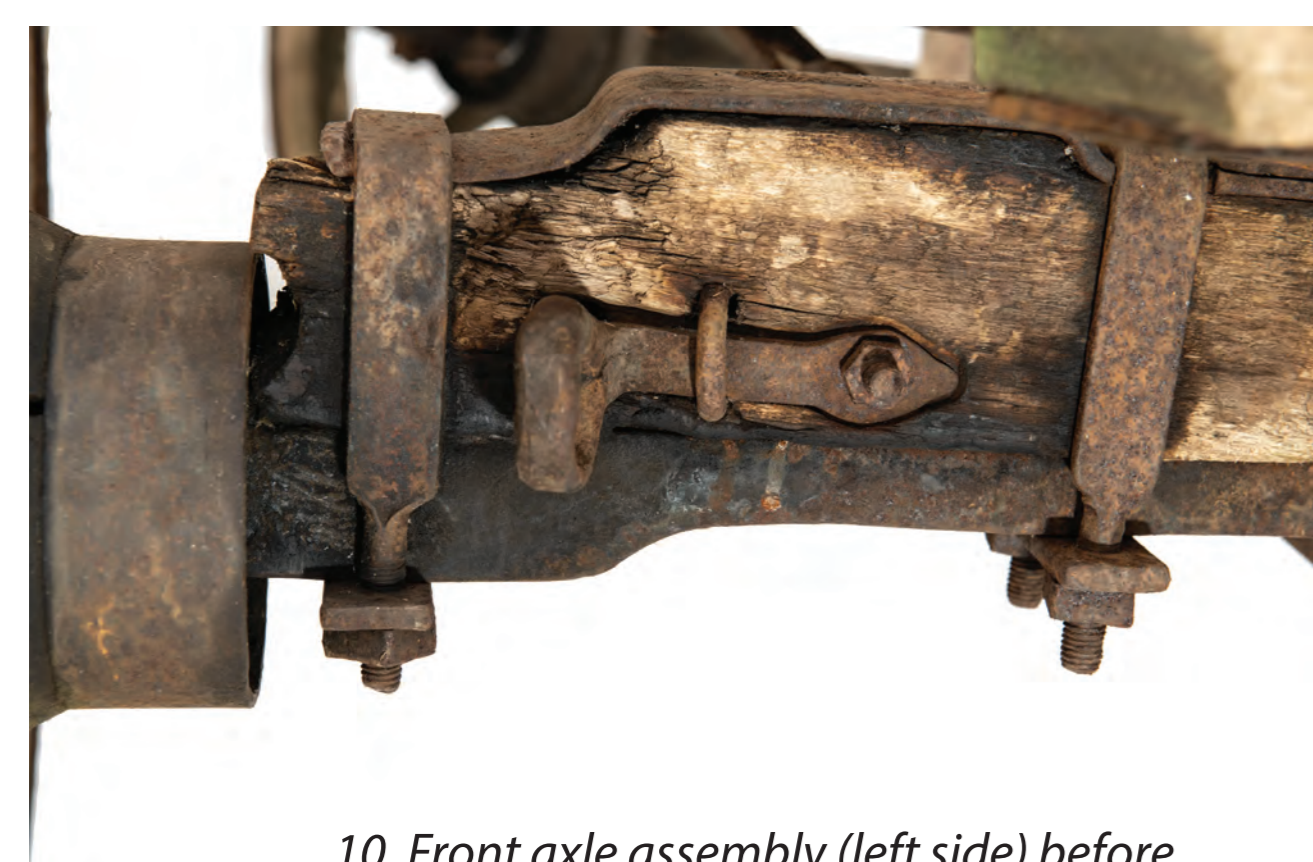
10. Front axle assembly (left side) before restoration

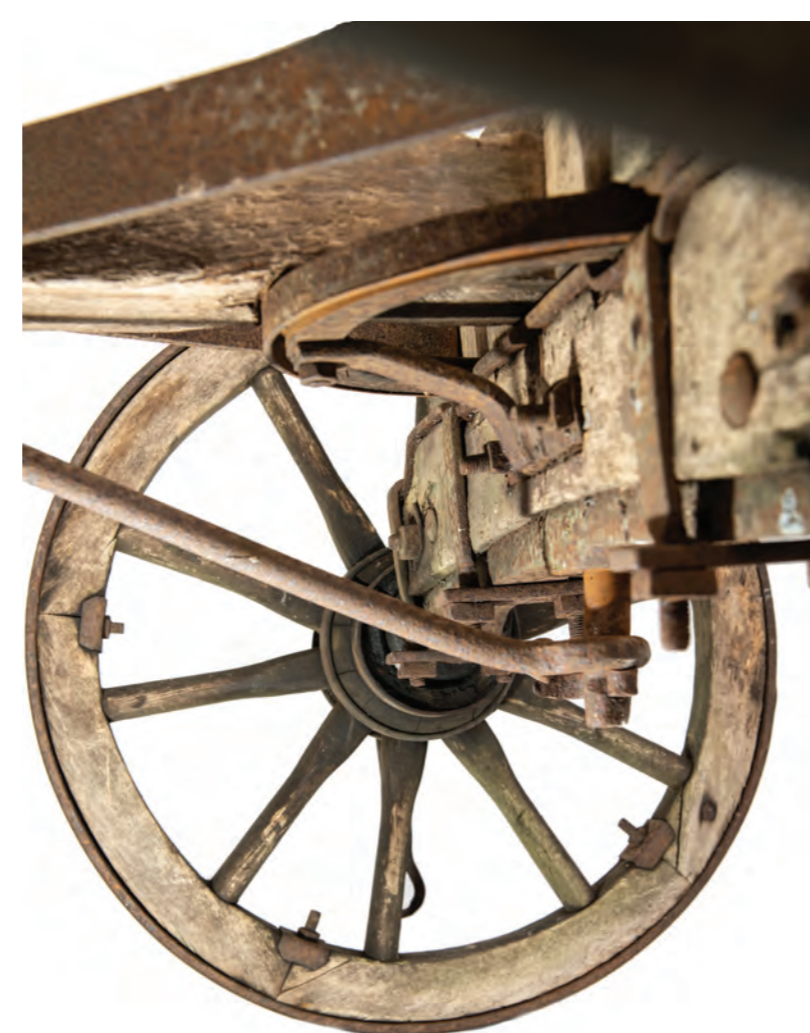
8. Front axle assembly before restoration

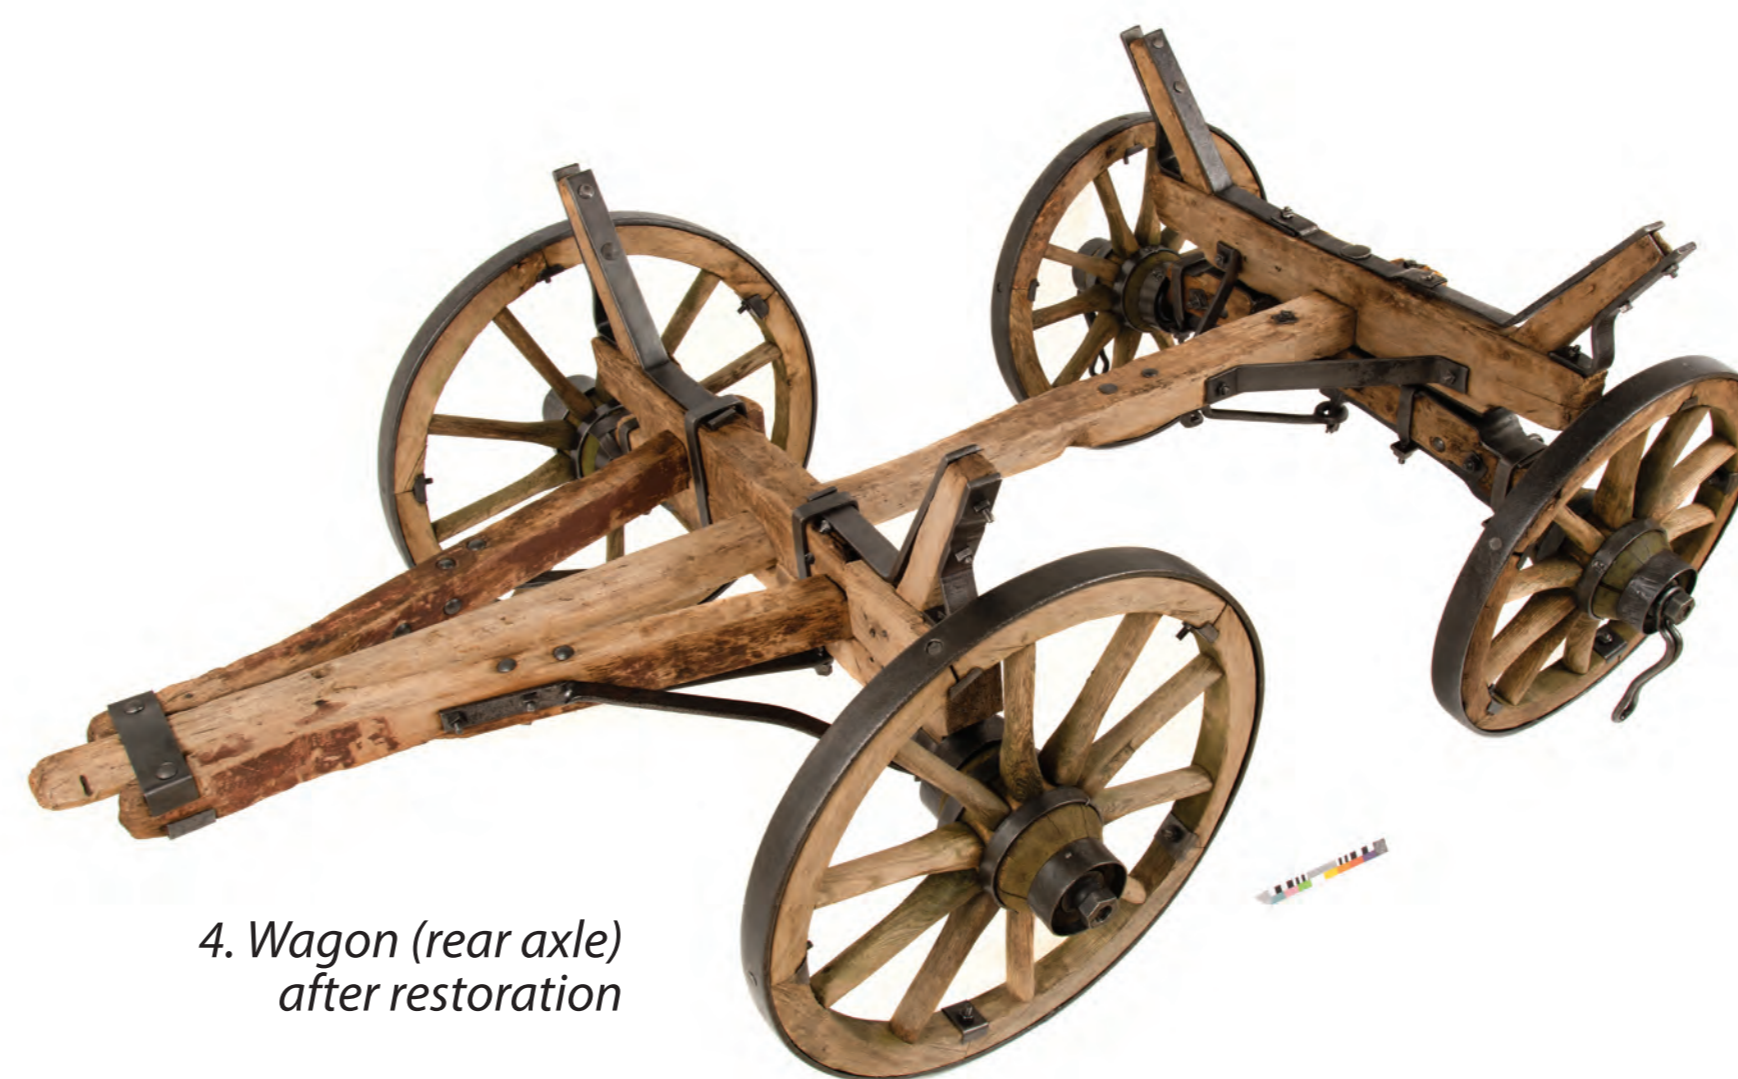
4. Wagon (rear axle) after restoration

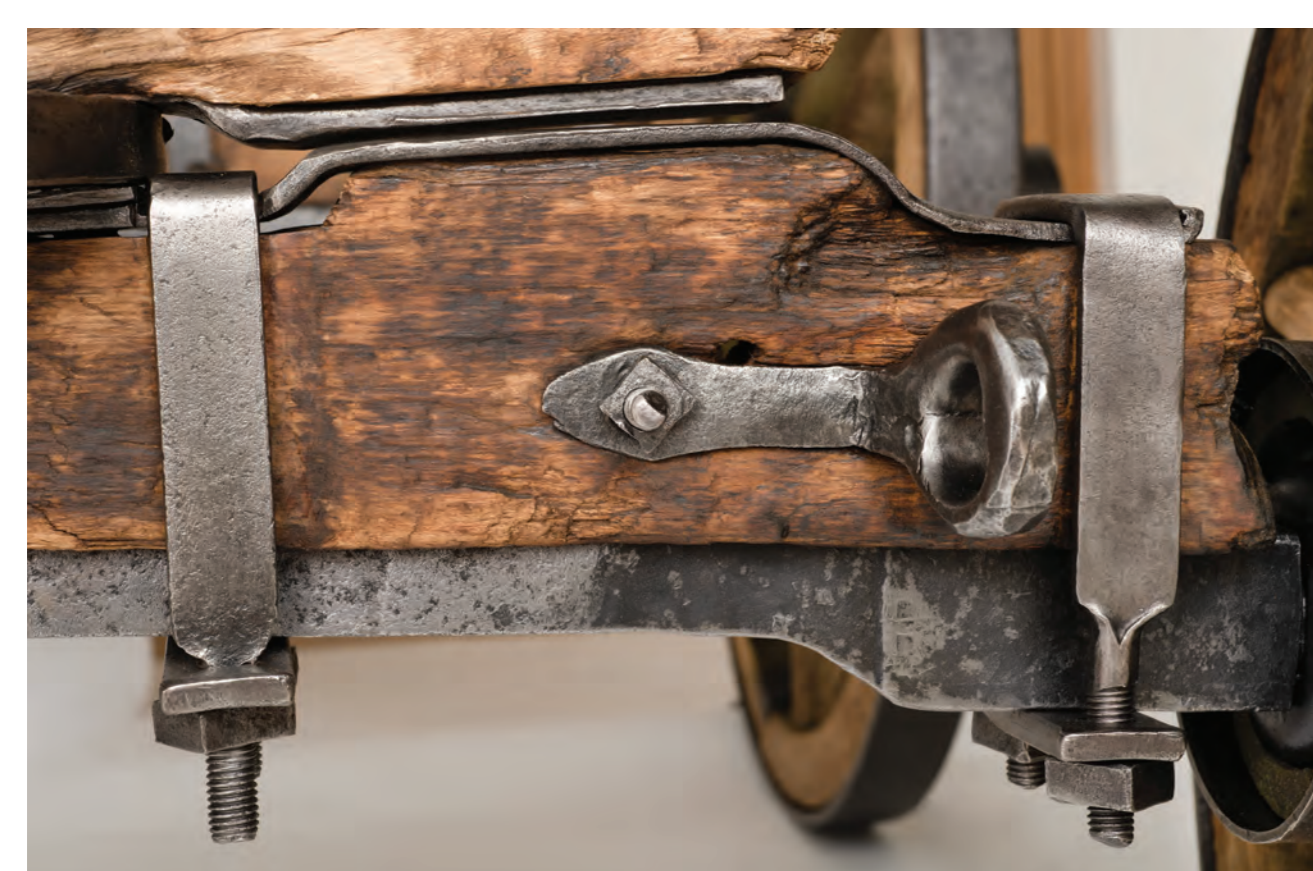
11. Front axle assembly (right side) after restoration

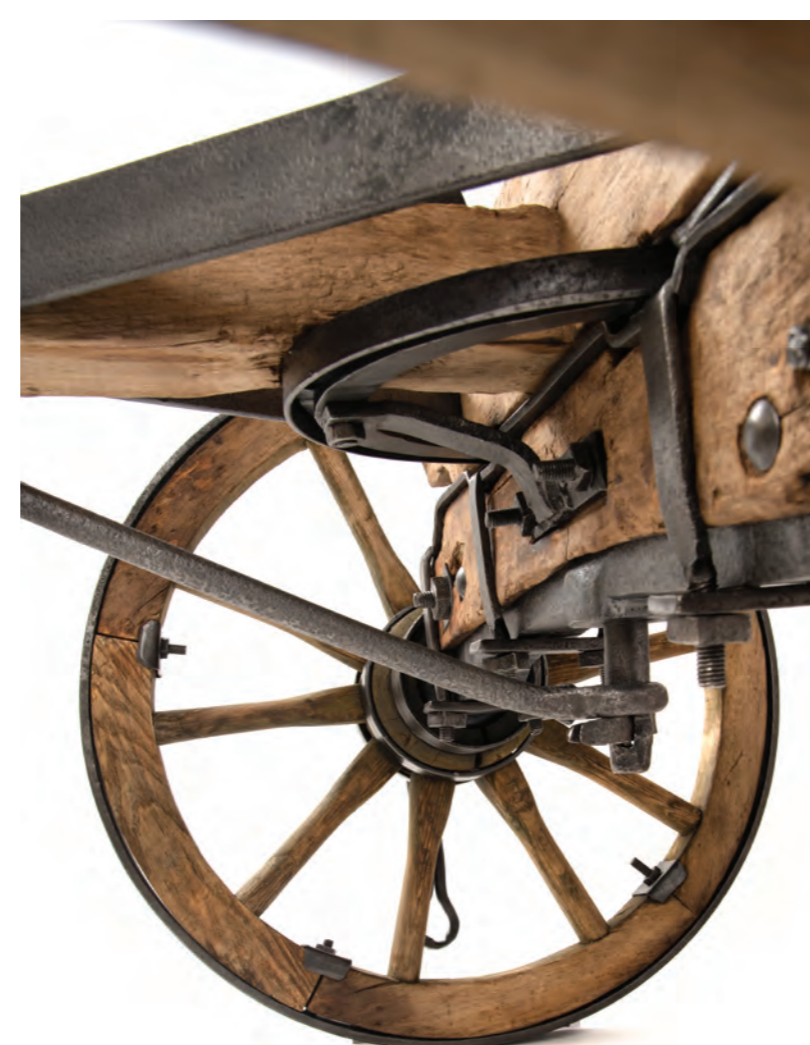
9. Front axle assembly after restoration

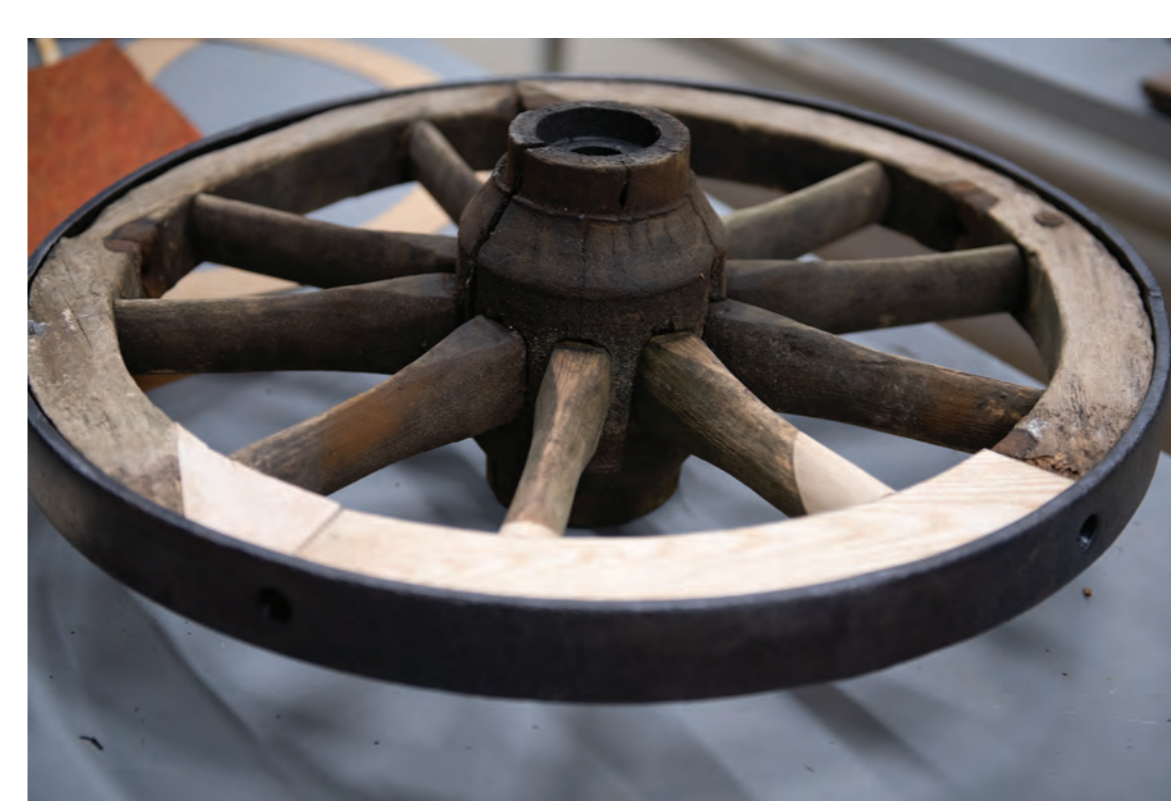
7. Front wheel during restoration
