RESTORATION OF A VITRINE

VILNIS LĪDAKA

The Scientific Restoration Department of Rundāle Palace Museum

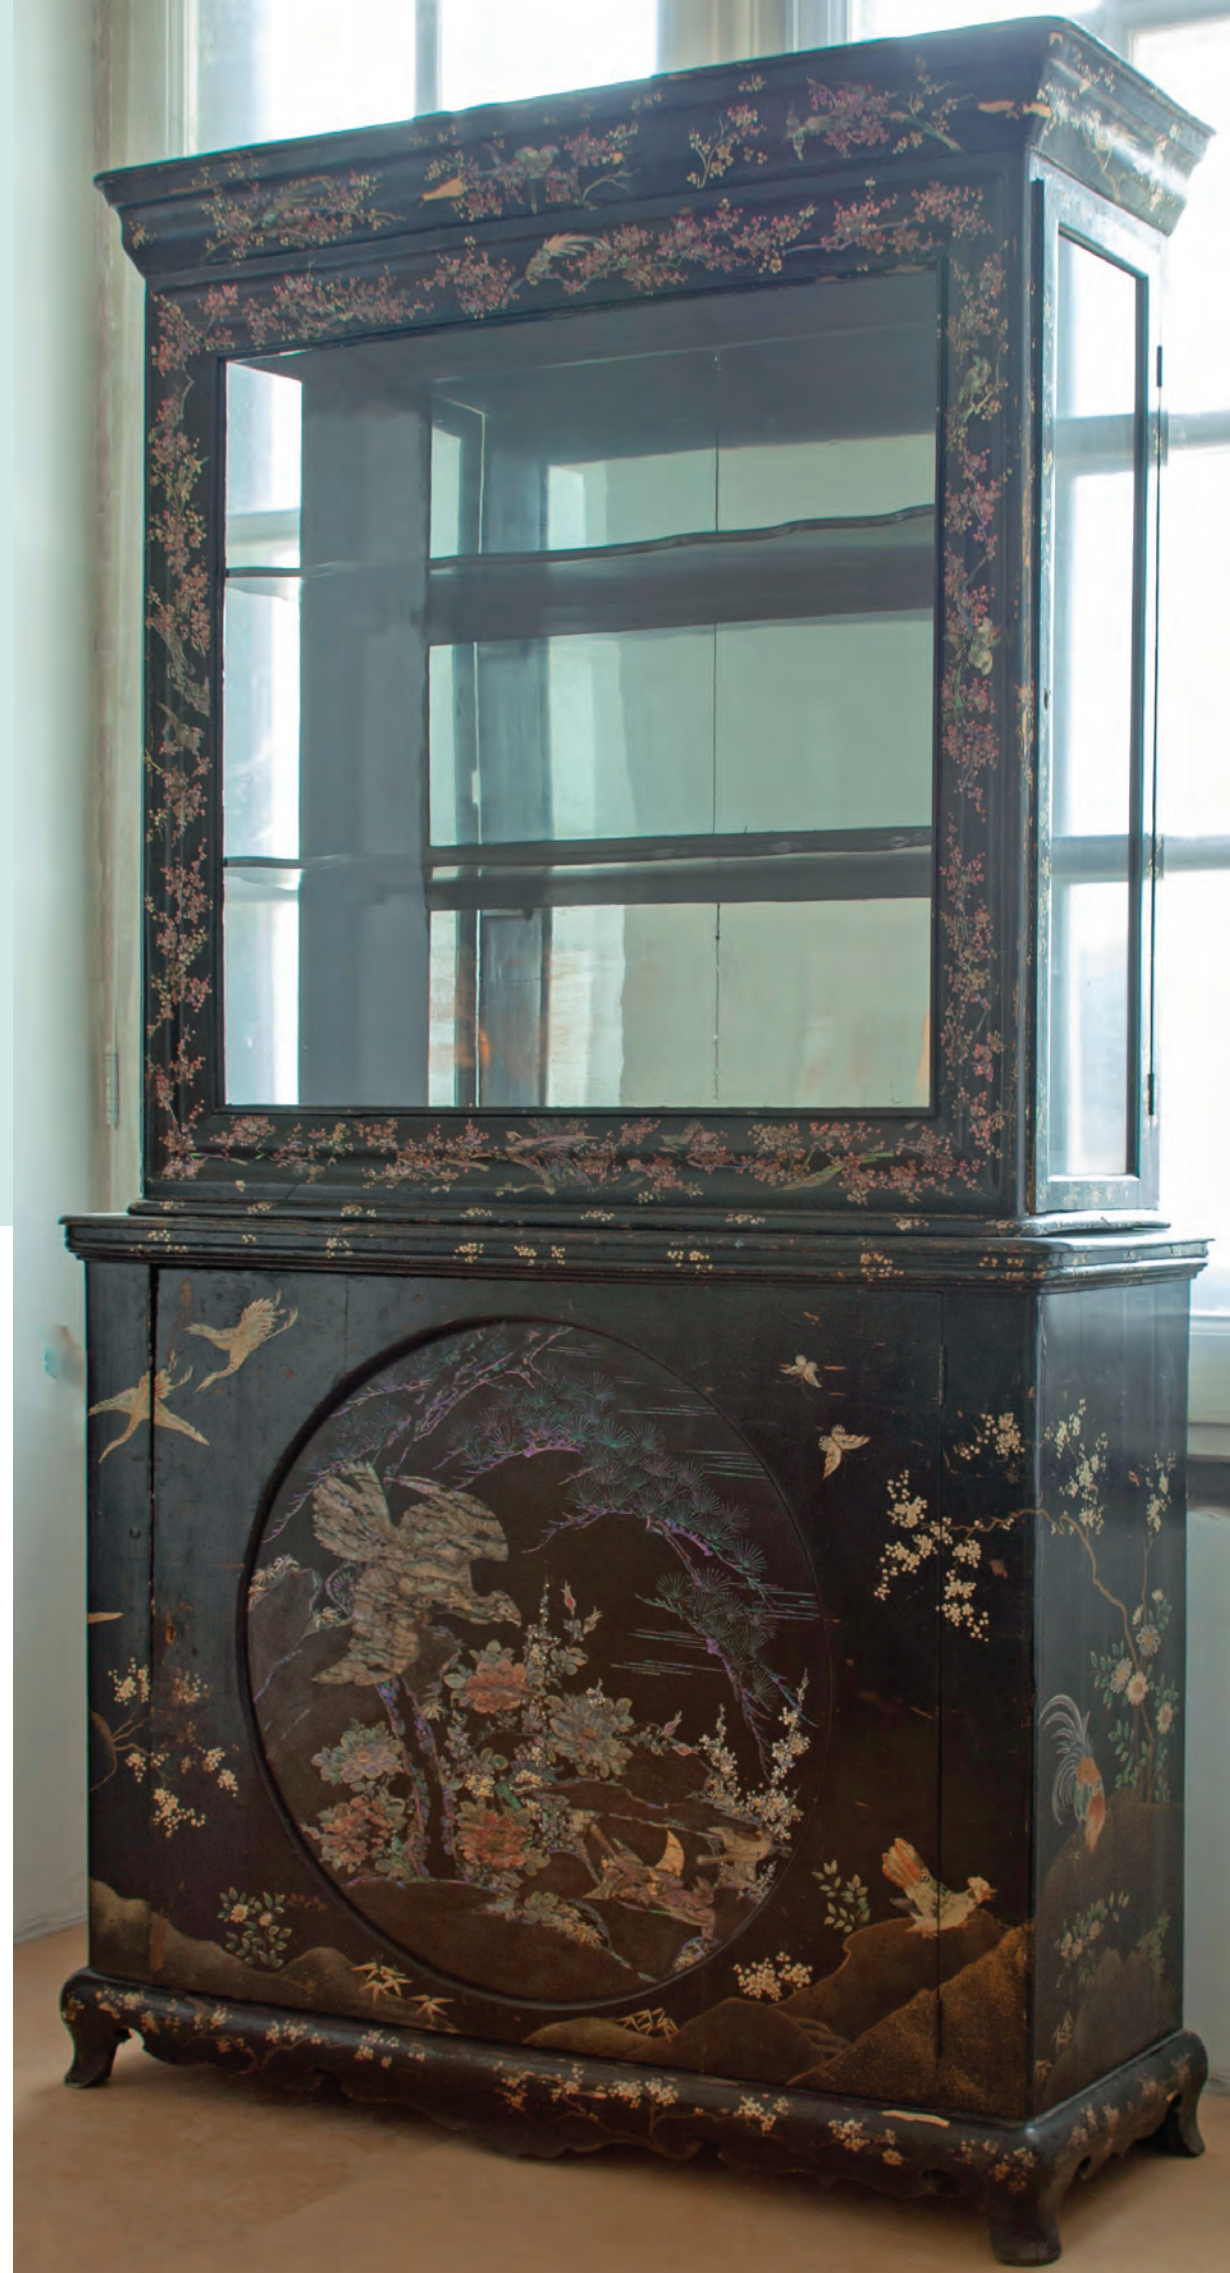
Vitrine's finish is in a bad condition. The varnished surface is mechanically damaged with pronounced scratches and extensive loss of black varnish. The cabinet's construction and surface is deformed; there are cracks in places where the wooden details are glued together. The decor with mother-of-pearl inlay has a loss of fragments; this is due to glue degradation.

Vitrine before restoration.

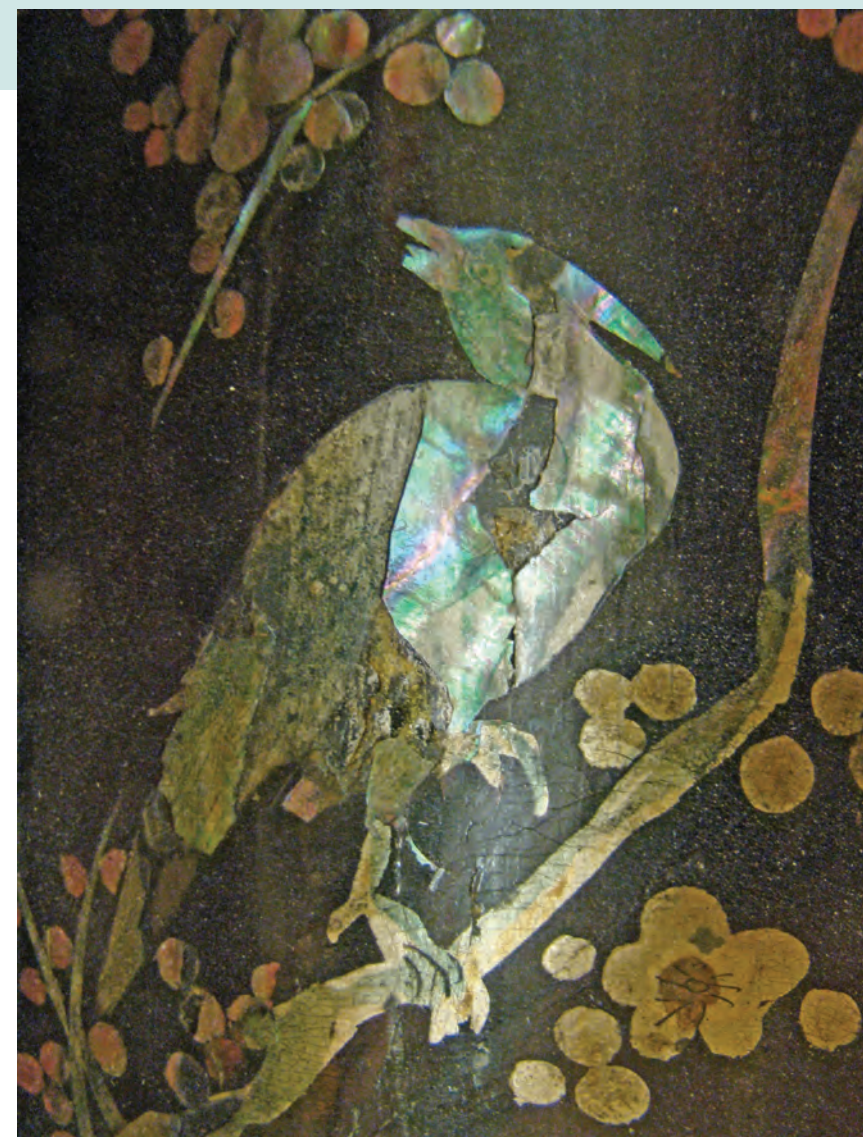
Fragment of the vitrine before the restoration.

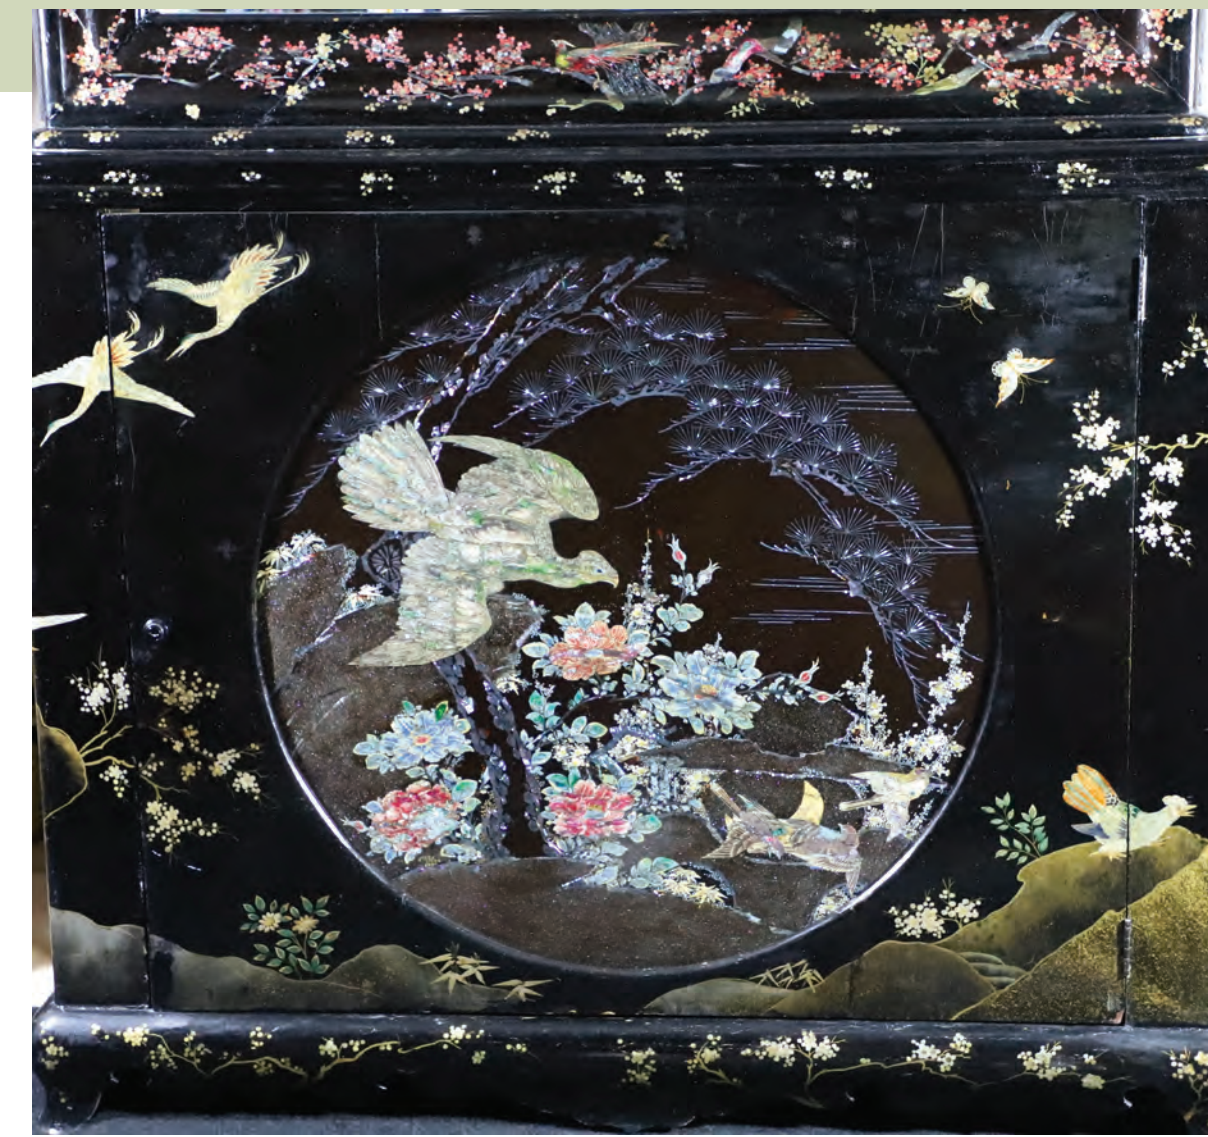
Fragment of the vitrine after restoration.

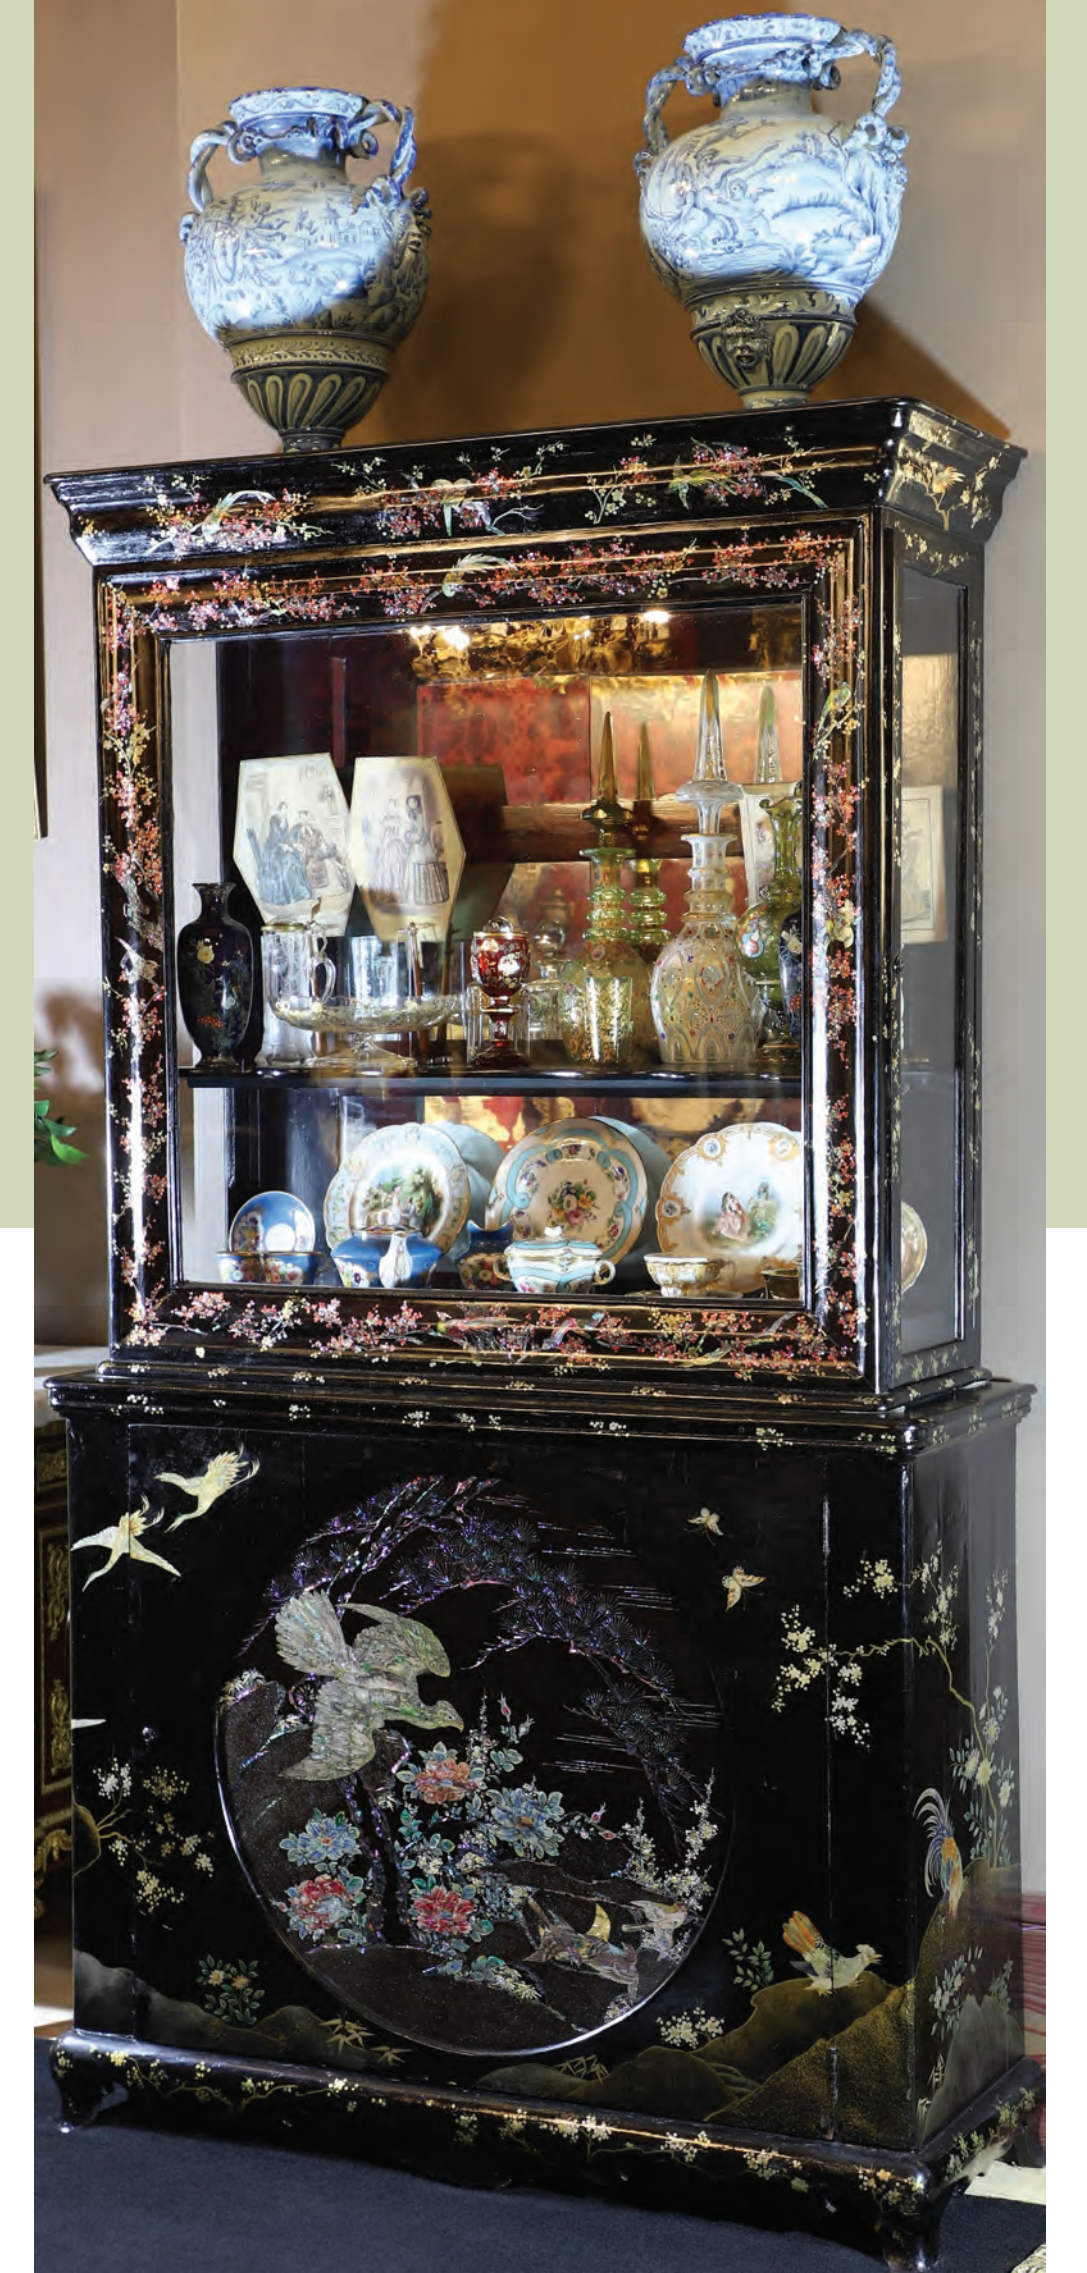
The cabinet-vitrine after restoration.

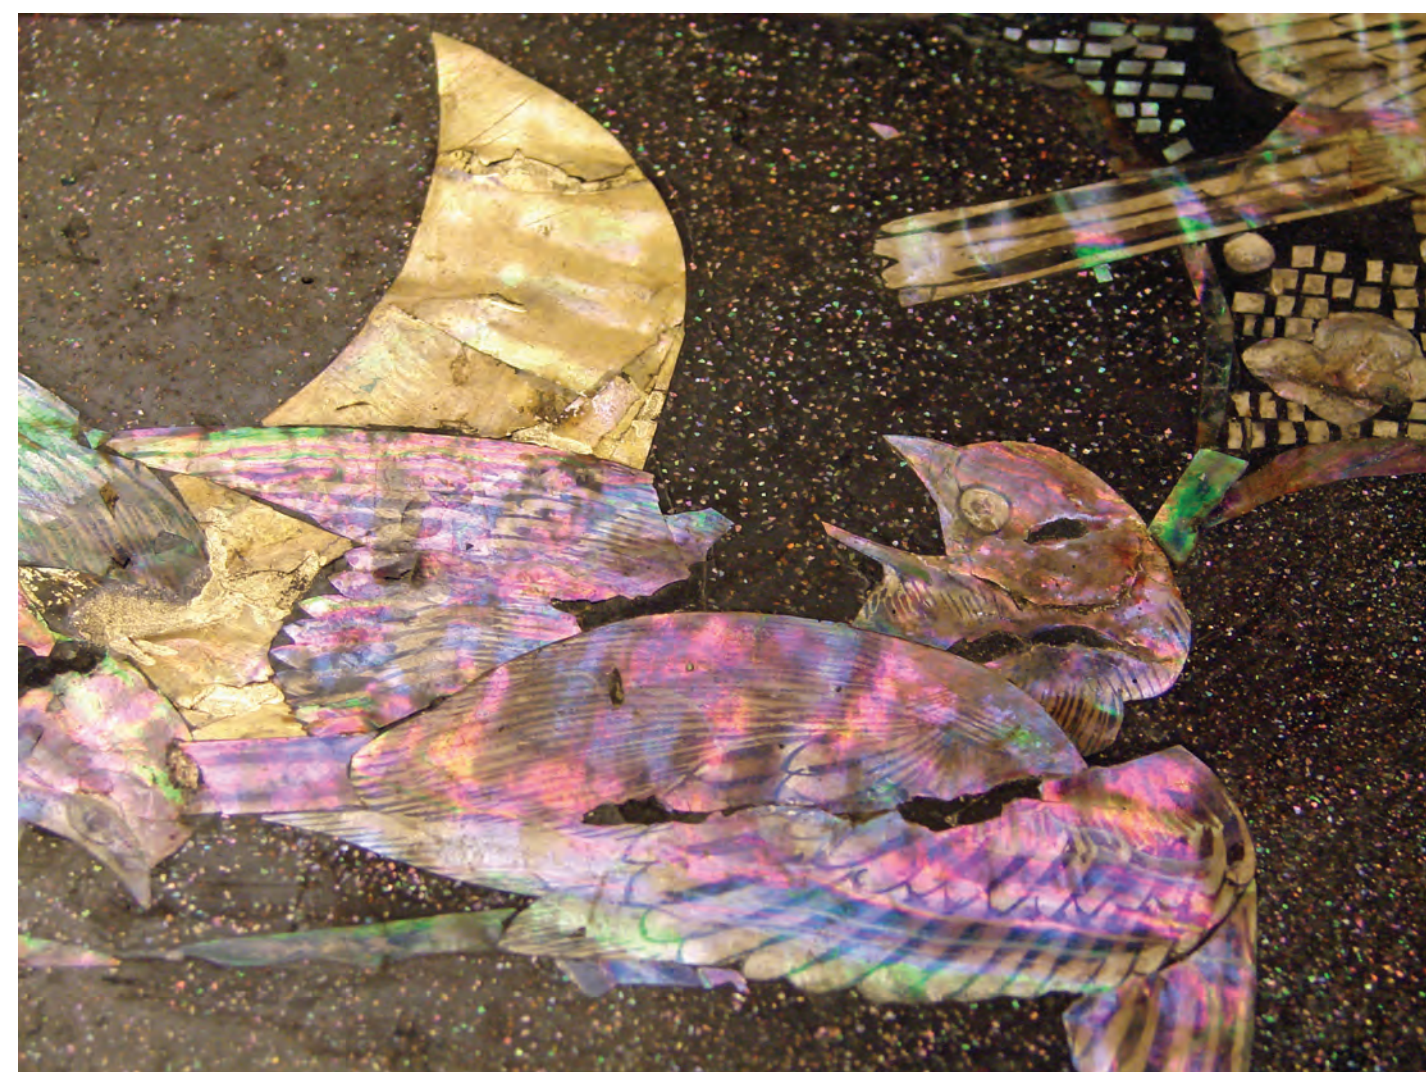
Fragment of the vitrine before restoration with the decor delamination and loss.

- The mother-of-pearl plates that had separated from the base were strengthened with Titebond glue, then inpainted using alcohol-based wood stains of suitable tone added to a solution of shellac and ethyl alcohol, varnished with a "Borma Wachs" solution of shellac and ethyl alcohol.

- Areas of loss were filled with "Bormawachs Bio Holzspachtel" black-toned filler, surfaces were polished with fine-grained sandpaper.
- The drawing was restored to the extent possible and losses of inlay elements were restored with thinned mother-of-pearl pieces. The mother-of-pearl plates were pre ordered from "Dictum" catalogue. They were separated by fibre in small fragments, the surface was treated and the plates were glued in areas of loss using Titebond glue.

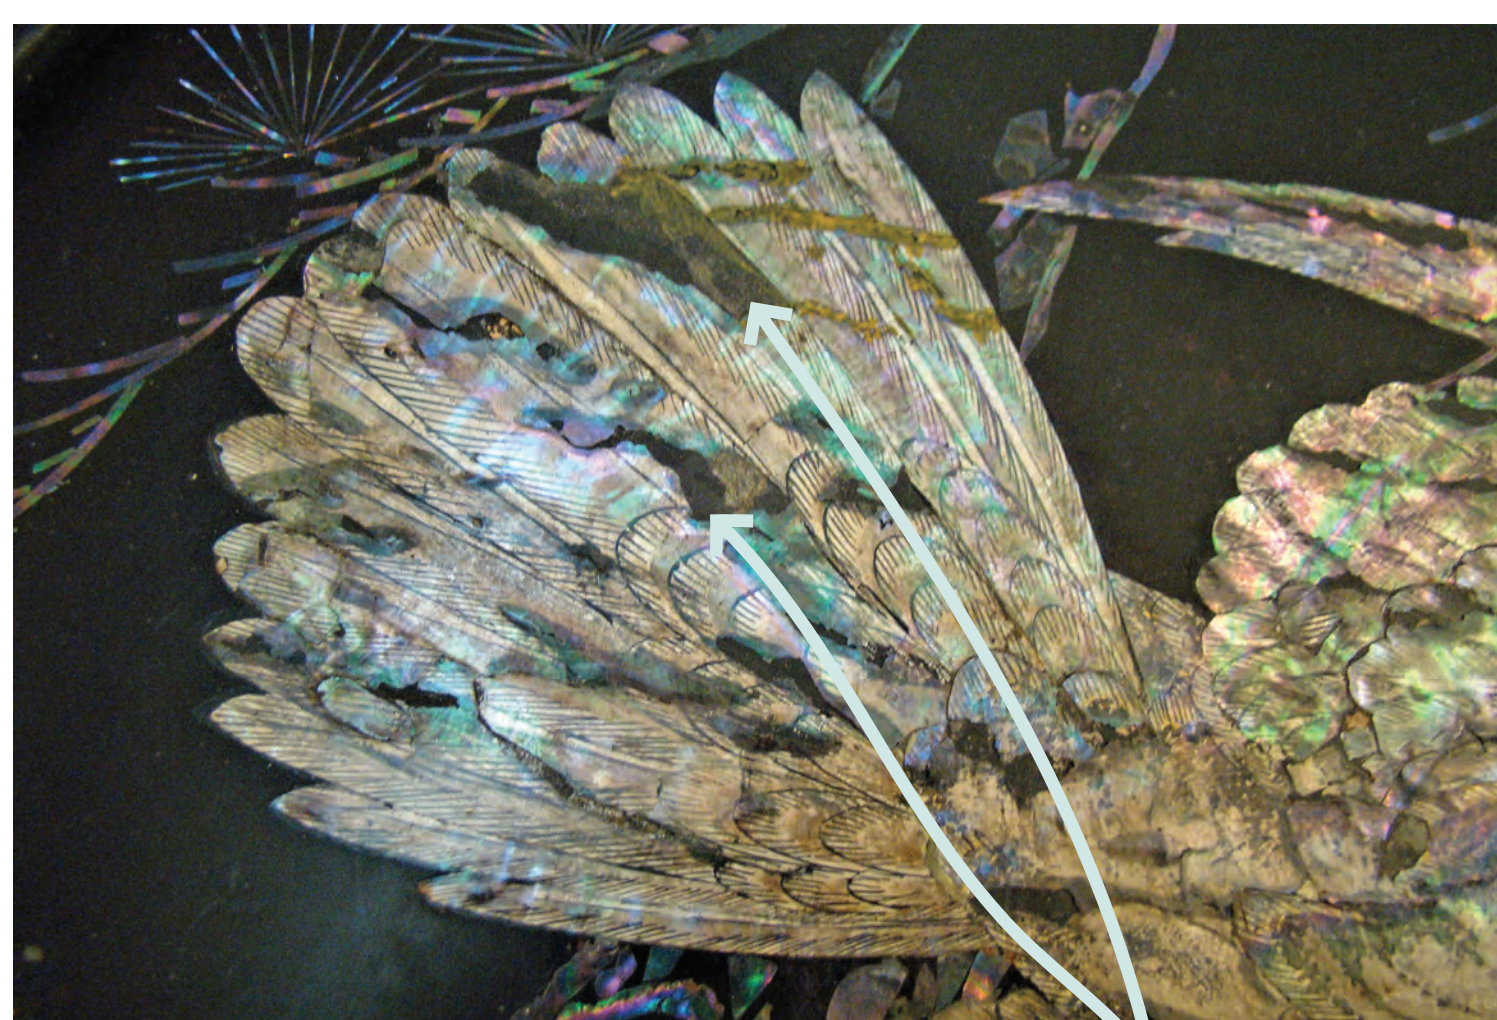
Fragment of the vitrine before restoration Loss of decor.

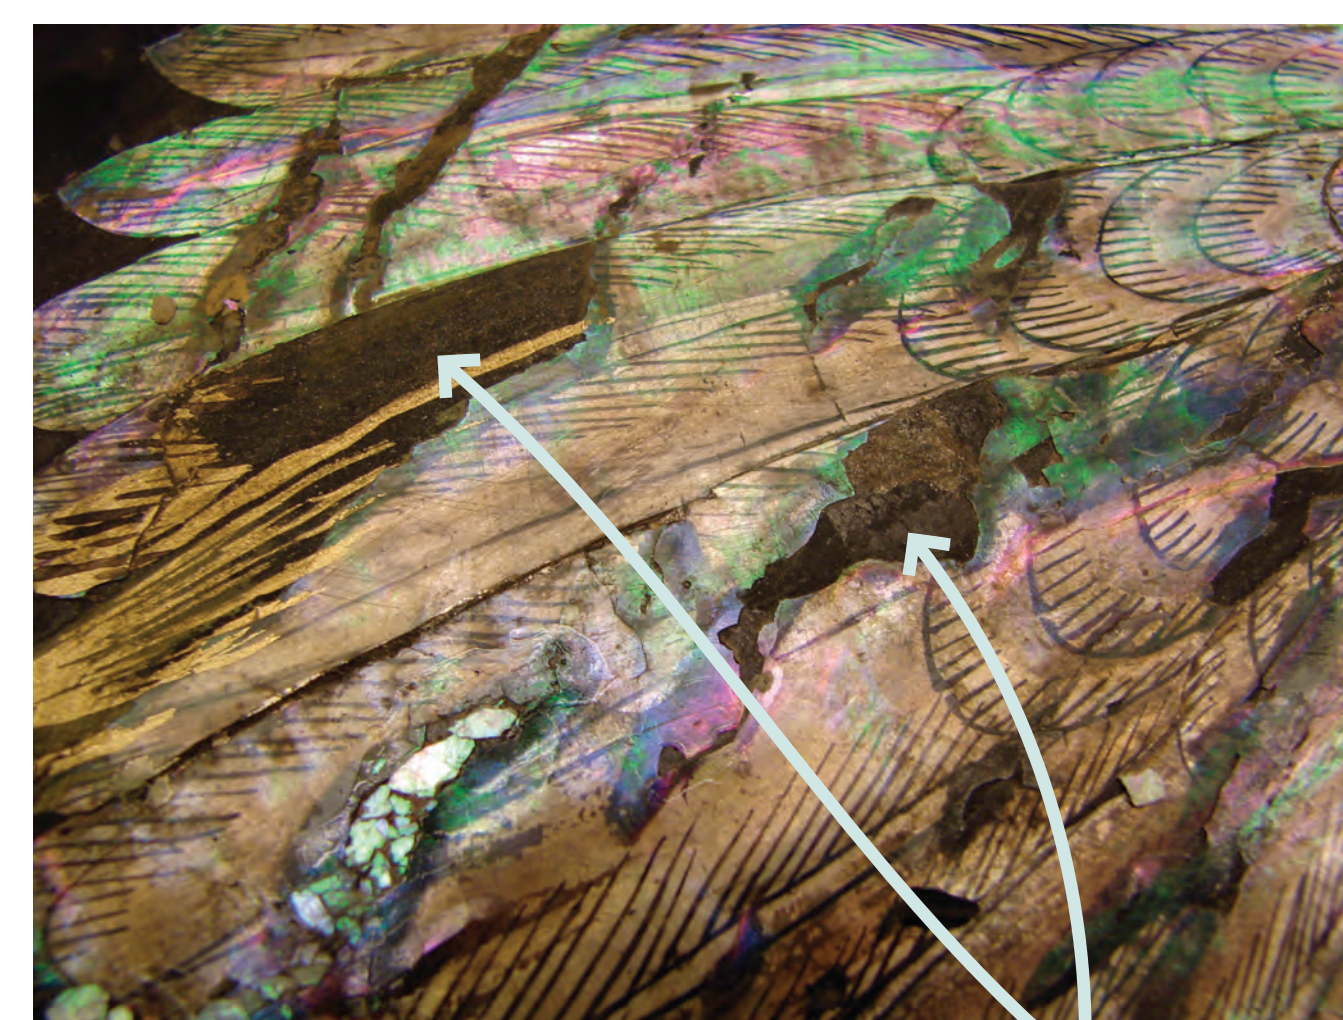
Fragment of the vitrine before restoration Loss of decor.

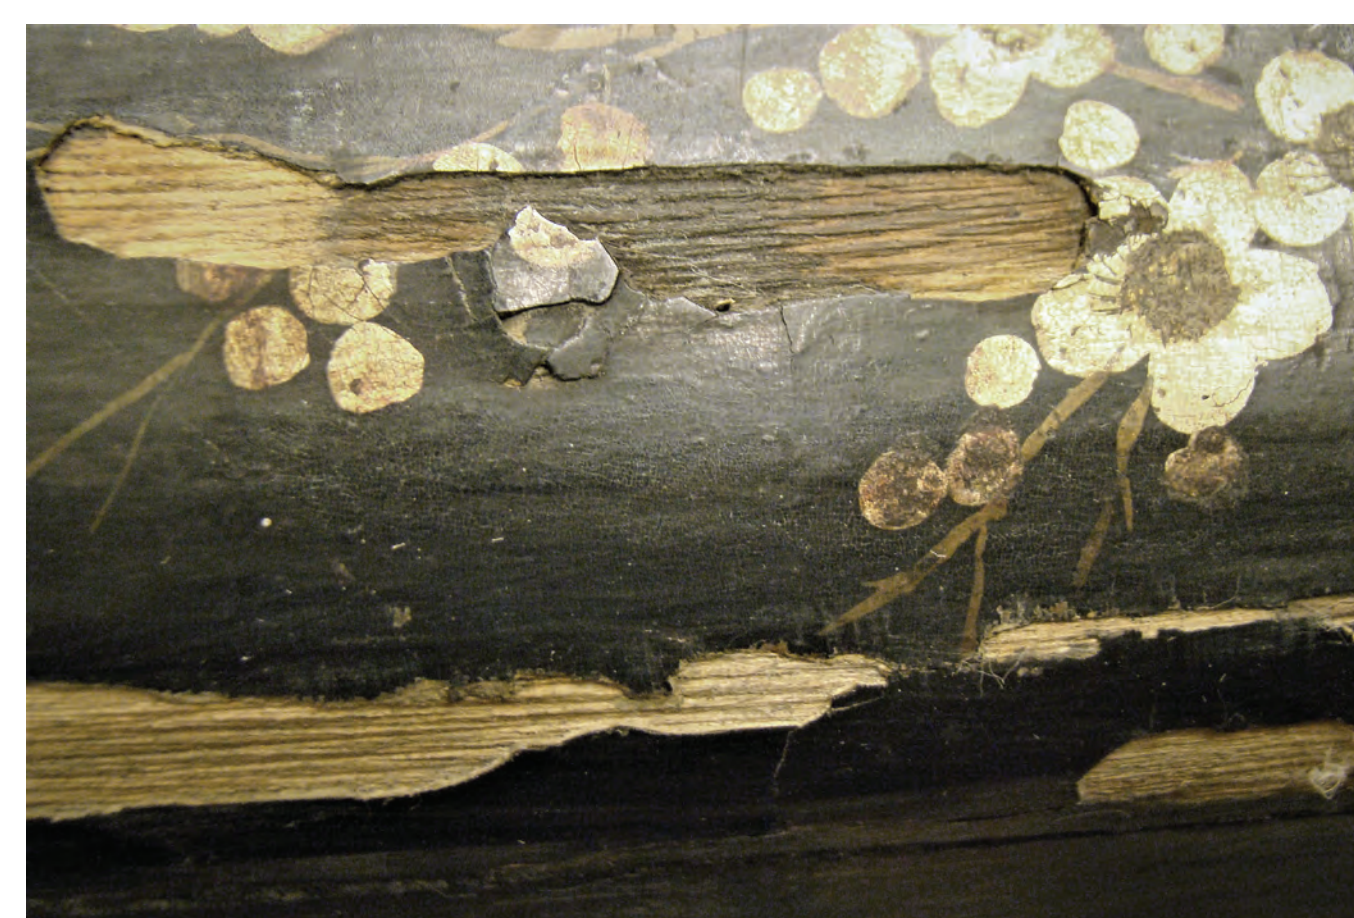
Fragment of the vitrine before restoration with the decor delamination and loss.
