RESTORATION OF 18TH CENTURY BAROQUE STYLE CHAIR FROM MAZSALACA'S ST. ANNE'S LUTHERAN CHURCH

OWNER/CUSTODIAN: MAZSALACA'S ST. ANNE'S LUTHERAN CHURCH
DATE/MATERIAL: 18TH CENTURY, BAROQUE STYLE. BIRCH WOOD, UPHOLSTERY - HAY, LINDEN HATCH, HORSE HAIR, IRON NAILS
WOODWORKING TECHNIQUES: CARVED, SAWN, HAMMERED, TURNED, UPHOLSTERED, THE WORK OF A COUNTRY CRAFTSMAN
SIZE: 1,15M x 0,52M x 0,5M
TIME OF RESTORATION: 09.2021 - 05.2022
STATUS: CULTURAL MONUMENT OF NATIONAL IMPORTANCE NR.4519

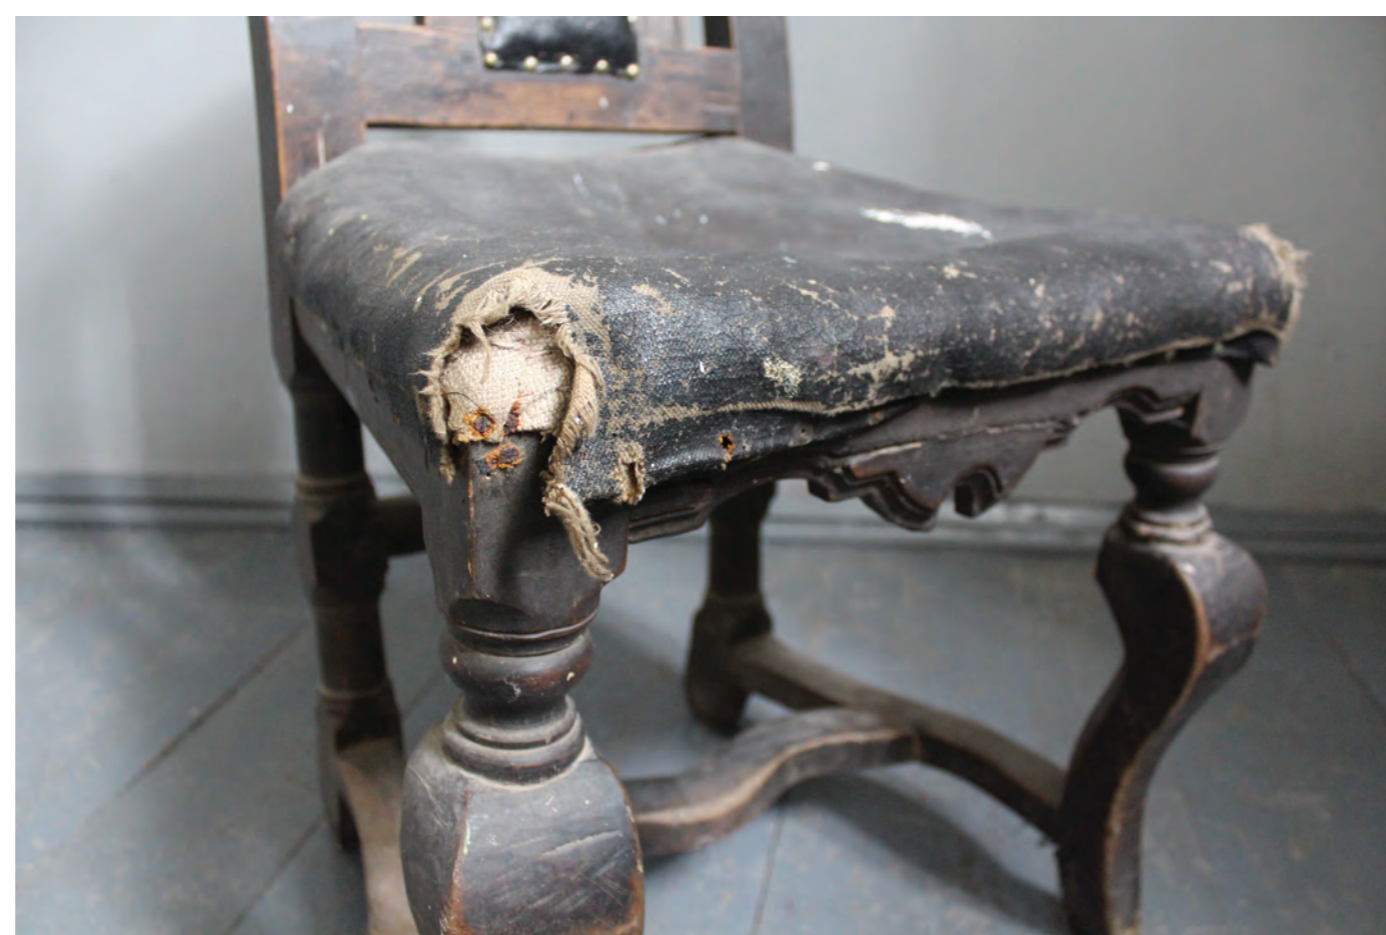
Fig. 13

The chair's current upholstery was added later in the 20th century, most likely between the 1950s and 1970s, therefore it is not the original (see figures 13 and 15). This is proven by the dermatine material and decorative nails discovered on the chair, both of which were typical at the time. Hay, linden hatches, and horse hair make up the upholstery, which is wrapped with canvas. It's possible that a farmer or craftsman crafted the chair. Reasons being signs conventional woodworking instruments are visible on the surface (such as an axe, planer, drill, chisel, saw, and wood lathe) (see figure 17).

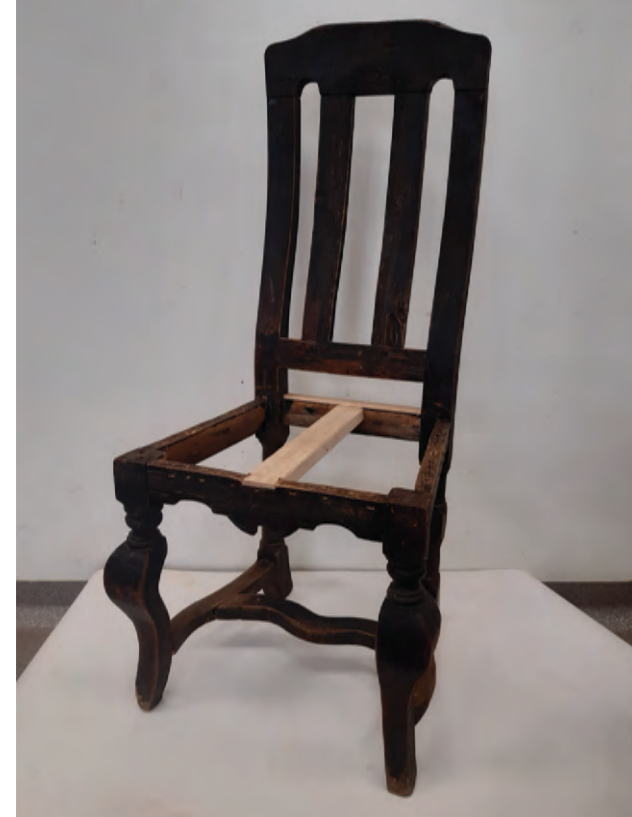
Fig. 3

The chair has another spruce detail (see Figure 3) connecting the front and back of the chair, that can be seen after removing the secondary upholstery. There is no such example like this in existence.

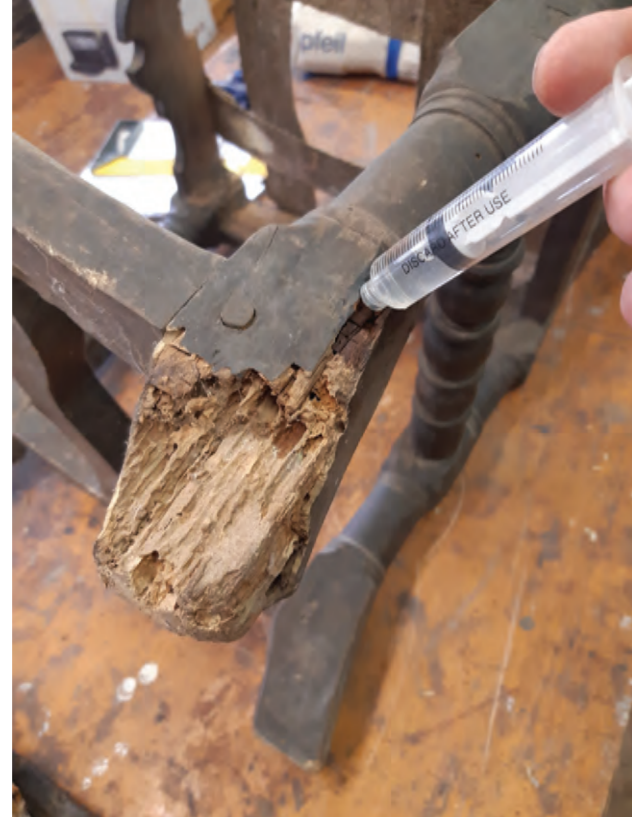
Fig. 4

The chair's lower legs sustain the most damage since they were kept improperly, which resulted in damage to the wooden base at the ends of the legs. The possibility exists that the chair was in a shed where its legs came into contact with moisture. These circumstances have facilitated the development of wood degradation at the chair leg ends (see Figure 4).

The legs of the chair get repaired. A 15% solution of Paraloid B-72 thermoplastic resin diluted in ethyl acetate is used to impregnate wooden pieces. A strong piece of birch is inserted to replace the lost wood component. The wooden component is shaped, cut, and polished before being bonded to the end of the chair leg. The same mixture used for the wood impregnation is mixed with black-tinted wood dust and poured into the hollows of the wooden components. After being cured for 36 hours, the bulk is chiseled into shape (see figures 4, 5 and 6).

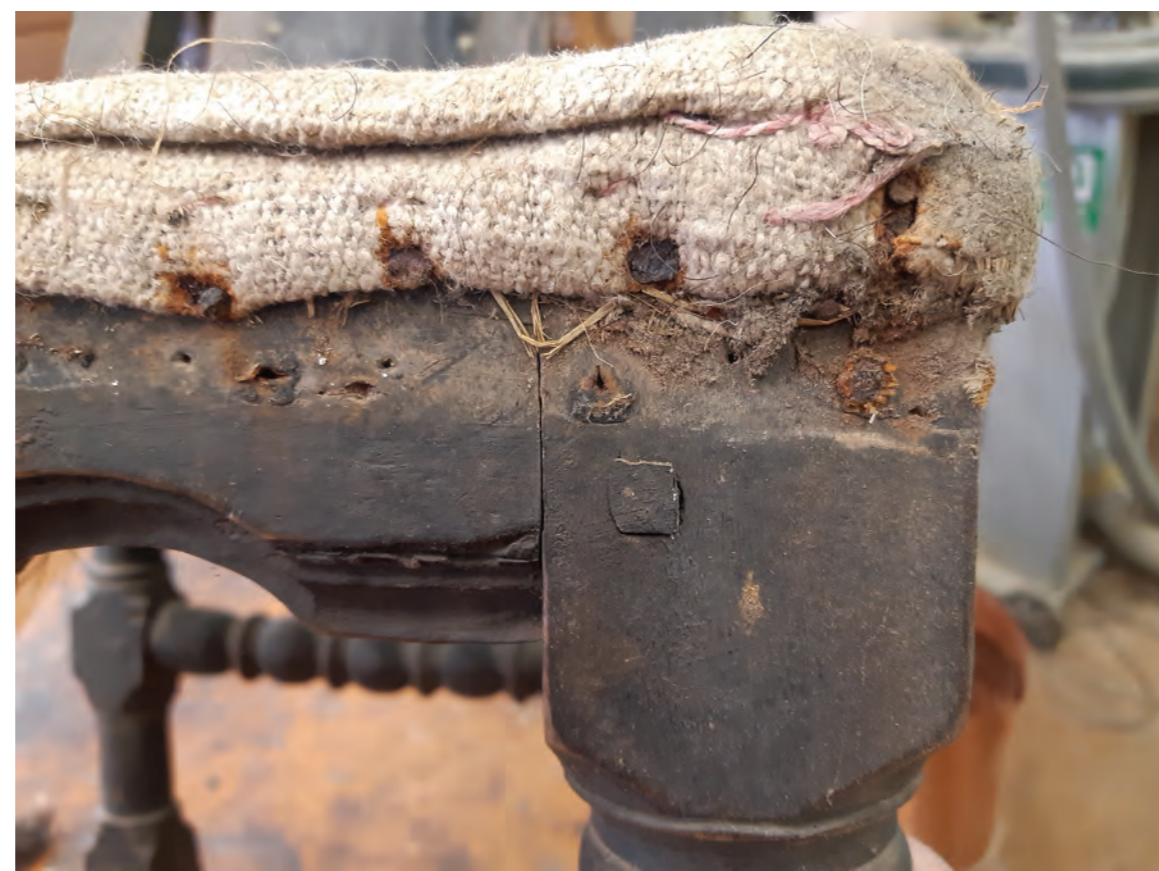
Fig. 15

A Closer Look at the Chair Reveals that The Seating Area and the Back Have Both Undergone at Last Two Upholsteries. In the back, Just the Remnants of the Nails used for the supplementary upholstery are VISIBLE. More Nail Feet Are Found in the Seat Portion. The Current Nails are Highly Rusted and Forged (See Figures 7, 8 and 15).

IT IS A DECIDED TO MERELY REPLACE THE UPHOLSTERY IN THE SEATING AREA:

1. Secure the burap to the Chair Seat's Outer Edge.
2. Replace the Old Upholstery with New Hay, Linden Hatches, and Horse Hair.
3. A UV lamp is used to be used the Filling Pad Before it is Used.
4. Lay A Layer of Burlap on Top of the Upholstery and Secure It With Furniture Clips All The Way Around The Chair.

The final process involves applying a black natural leather material and using ornamental furniture nails to secure it around the edge. What nails and upholstery material were originally in the chair's seat are unknown. It's probable that woolen cloth, linen cloth, or genuine leather were utilized, and iron nails made by a blacksmith were used to fasten the covering around the circumference.

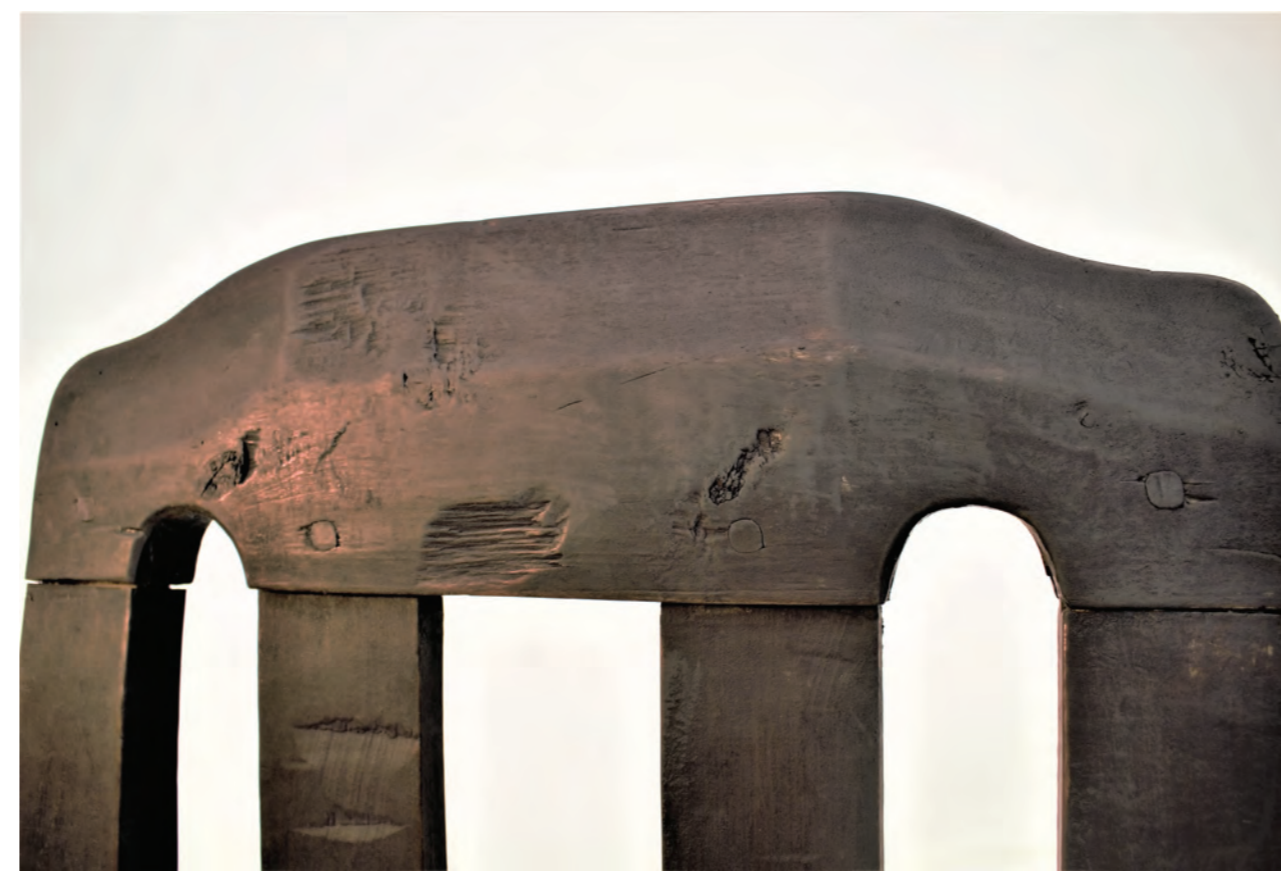
Fig. 16

The chair eventually ends up at St. Anna's Evangelical Lutheran Church in Mazsalaca sometime in the early part of the 20th century. The chair is enormous, hefty, and fashioned in the baroque style and built from birch wood. The chair's wood surfaces show signs of tool use (axe, saw), and the surfaces are rough to the touch (see Figure 16).

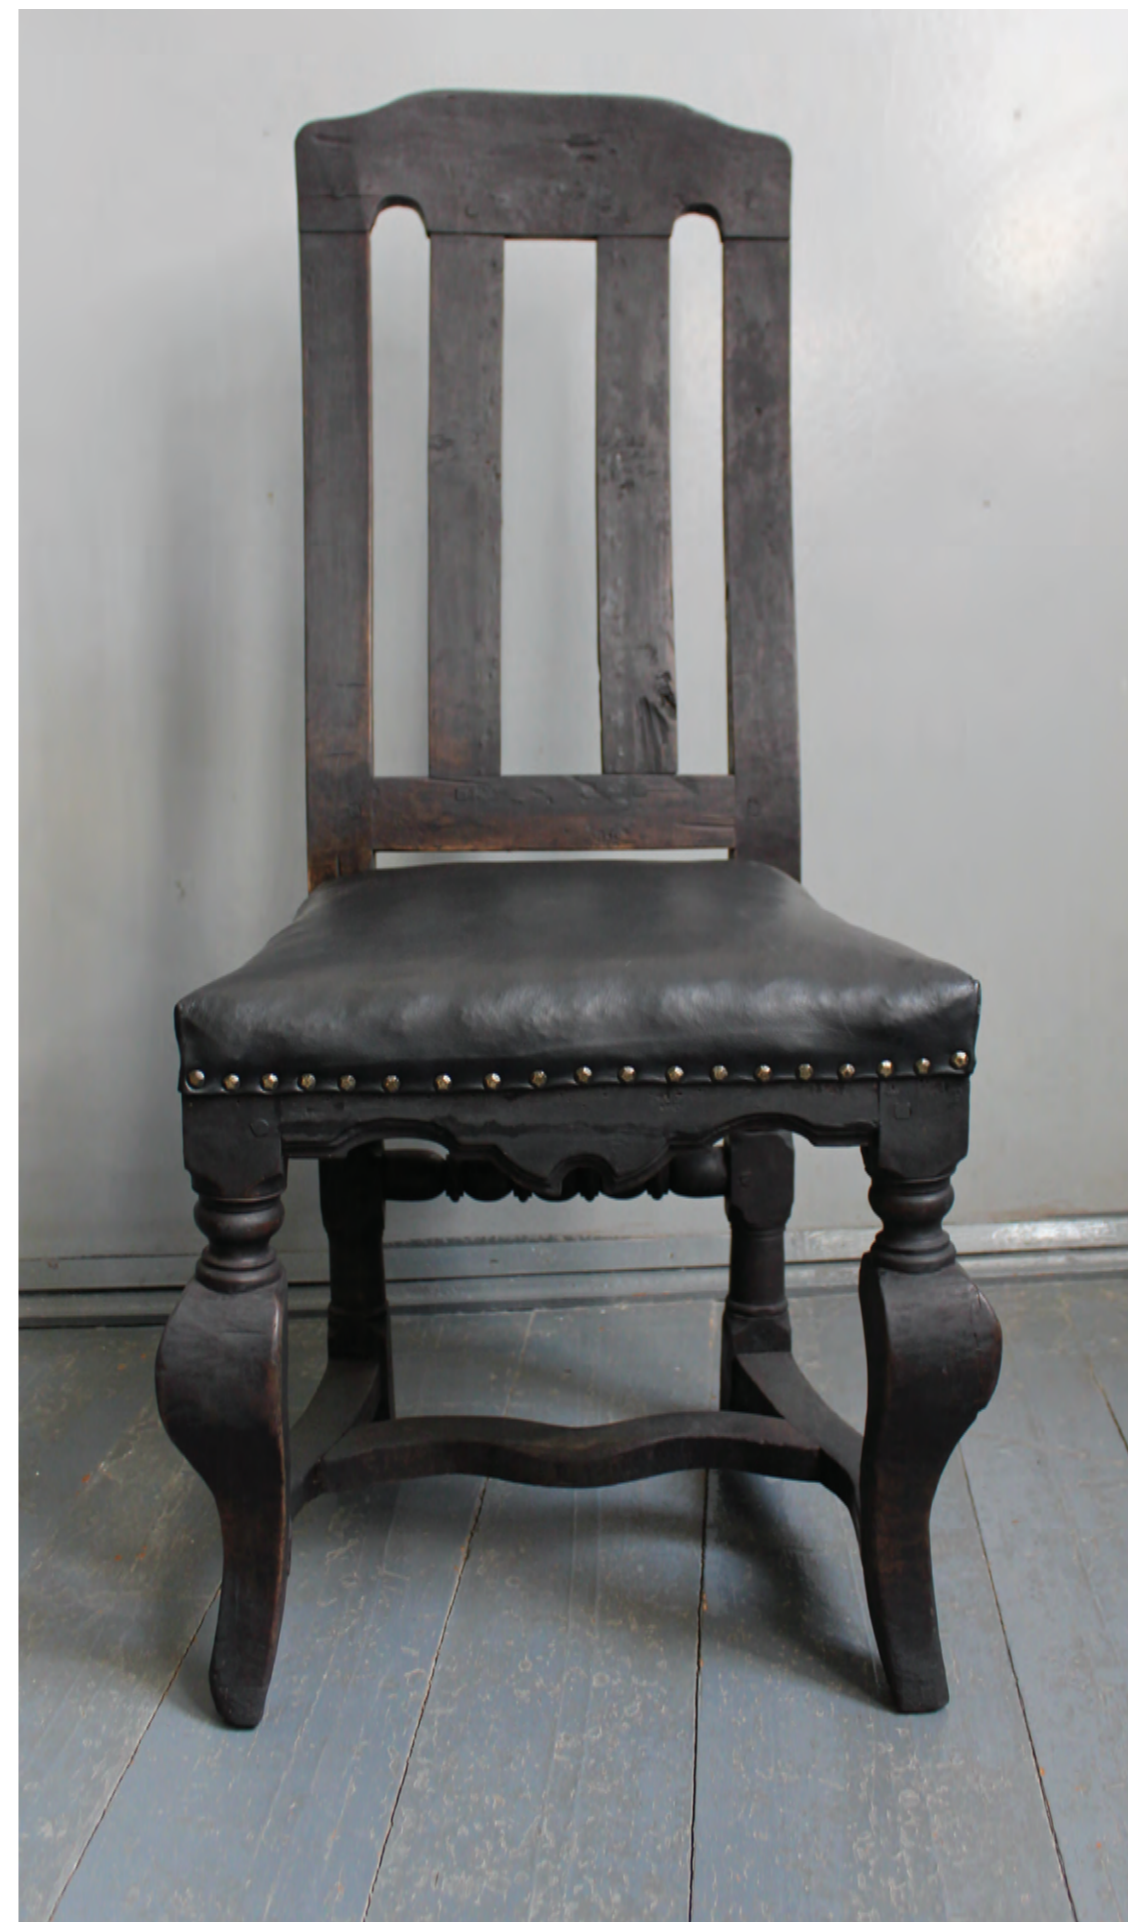
Fig. 20

The strength of the chair joints has been improved, deterioration to the wooden components has been halted, the surfaces have been tinted, and the wallpaper has been repaired. Now, the church has the chair on display (see figure 20).
