RUNDĀLES PILS MUZEJS

THE GREEN HALL OF THE PUZE MANOR HOUSE: RESTORATION OF THE PAINTED WOODEN WALL PANELS WITH SILVER LEAF WOOD CARVINGS

THE CONDITION BEFORE RESTORATION

RESTORATION PROCESS

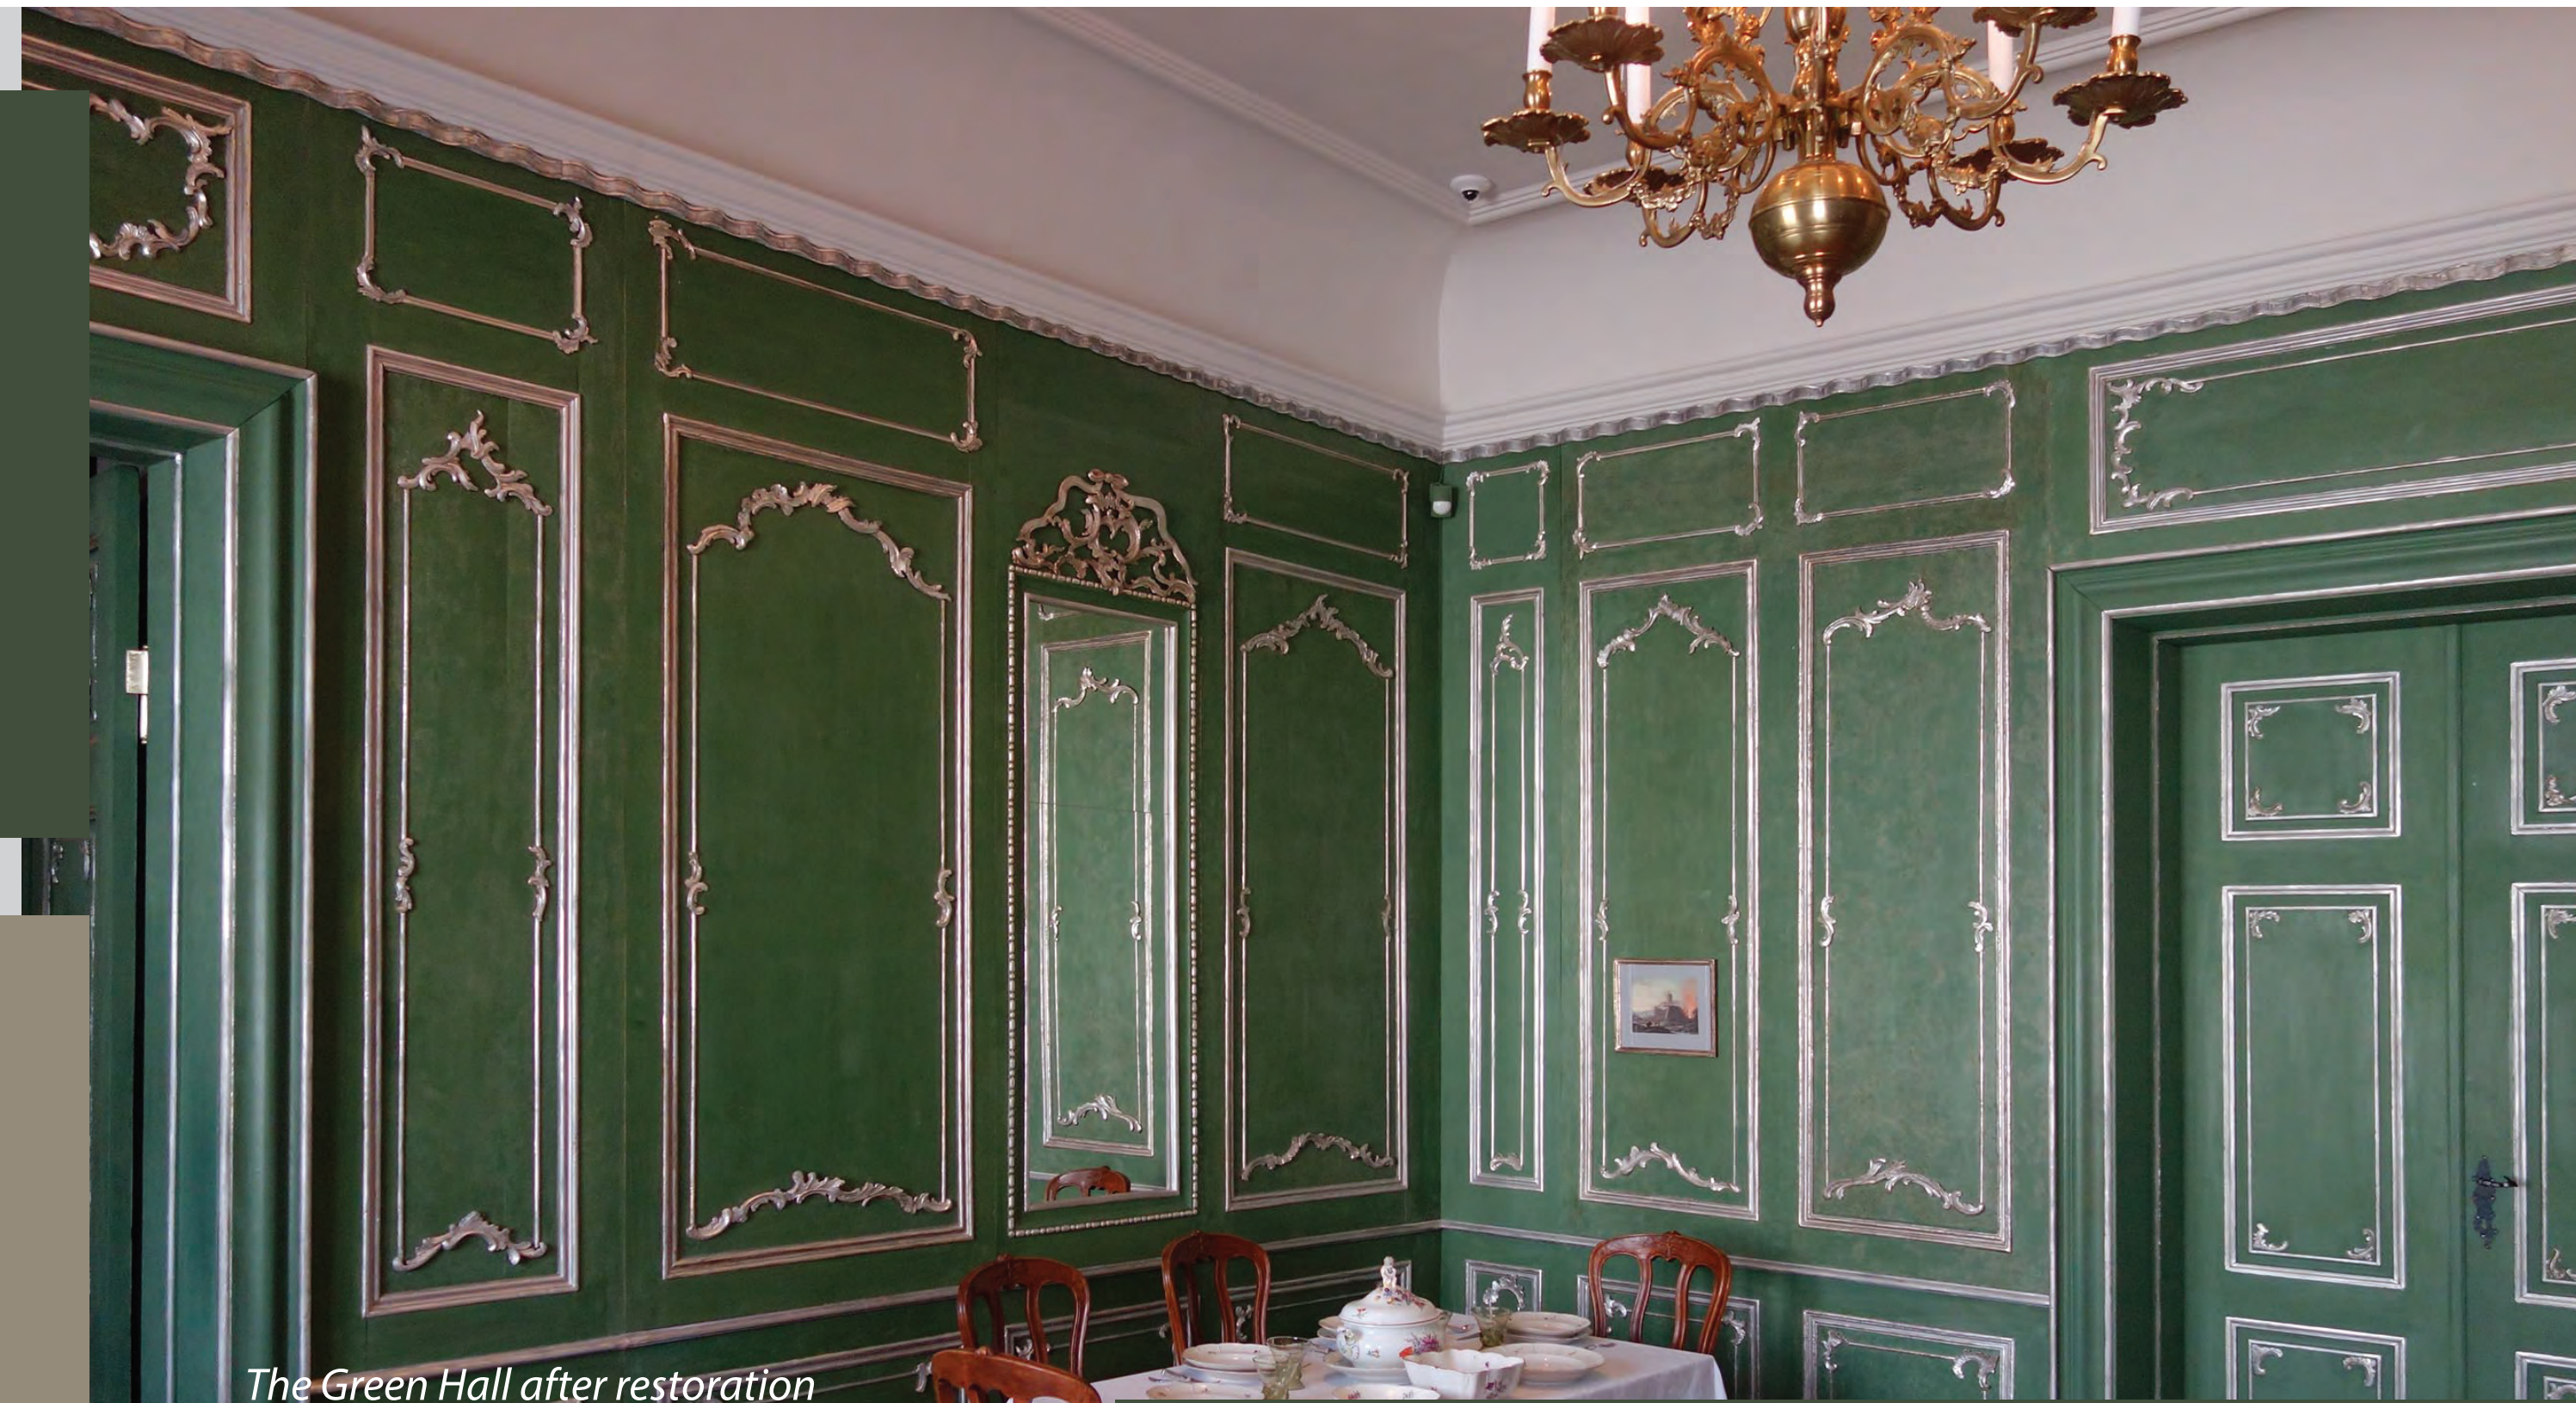
The Green Hall after restoration

The woodworms' damaged parts were consolidated with 30% solution of Paraloid B72 (acrylic polymer) in Acetone, which was injected into the deepest areas by a medical syringe. This process was repeated two times. The very damaged or lost fragments of wood panels and wood carvings were replaced with new ones in a shape of original.

The woodcuts had been twice silver leafed - originally in the 1770s and then during repairs in the 1840s. Later at the end of the 19th century, the woodcuts which had an unevenly oxidized silver surface had been coated with the dark brown water-based paint to imitate oxidized silver.

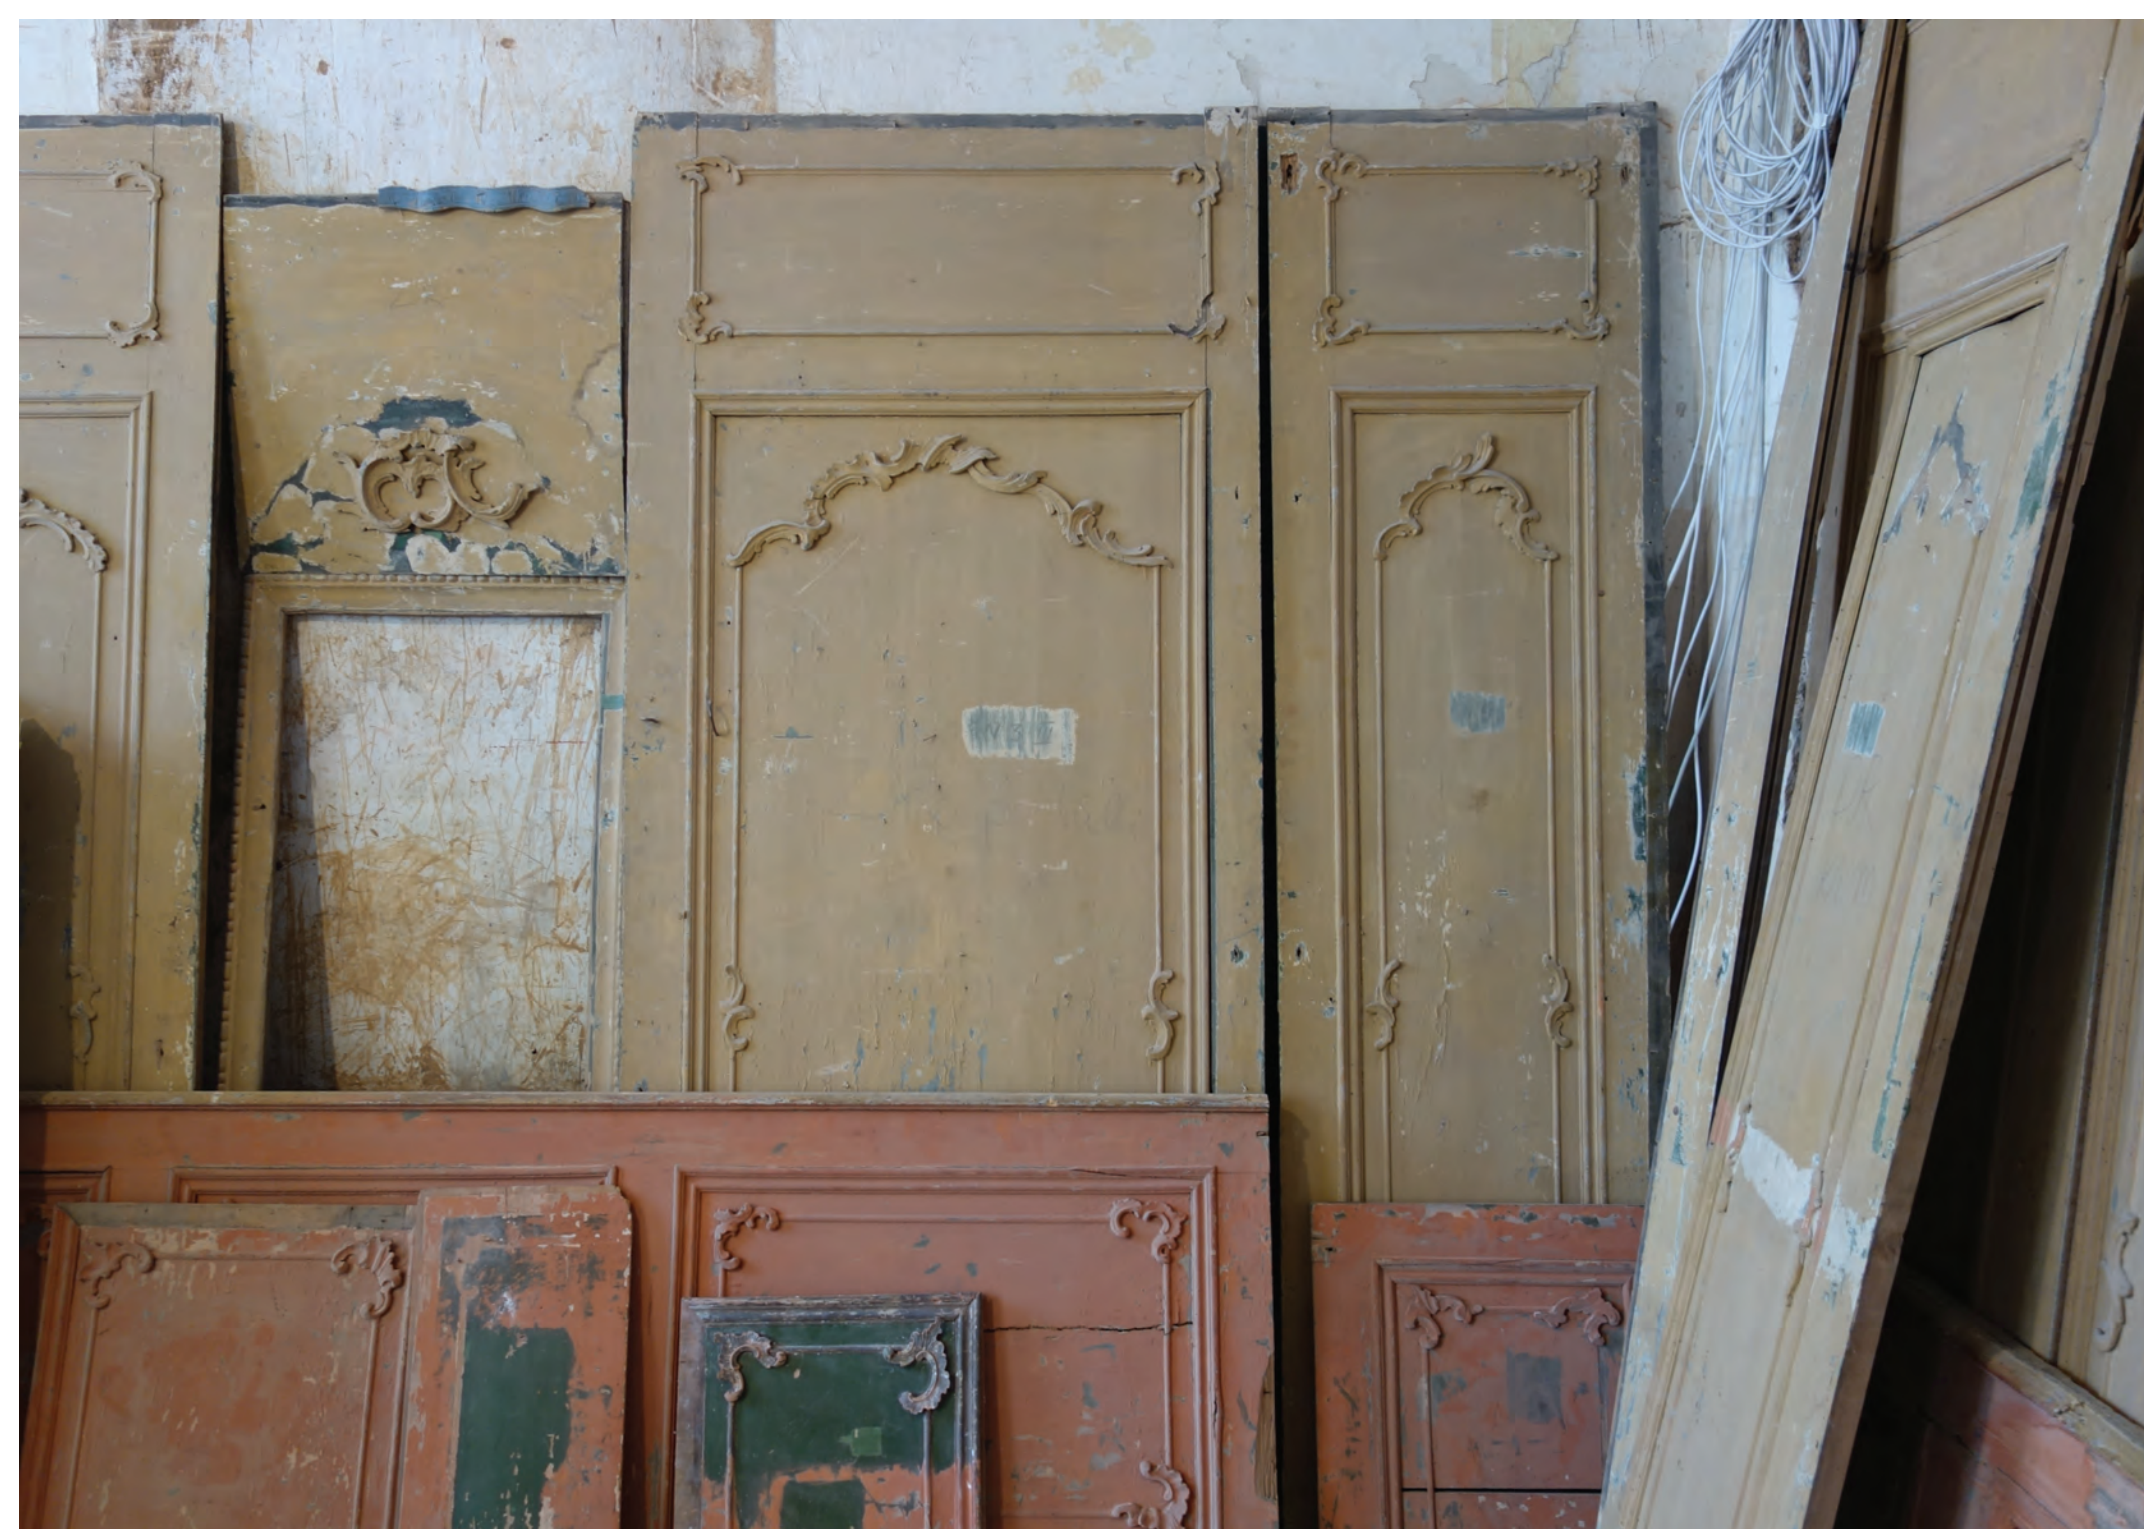
Wood wall panels before restoration. Over-coating removal tests on the wood panels.

Distilled water compresses were used to remove the adhesive-based paint layer.

The repainted green oil paint layer was removed mechanically with a scalpel without damaging the original paint layer.

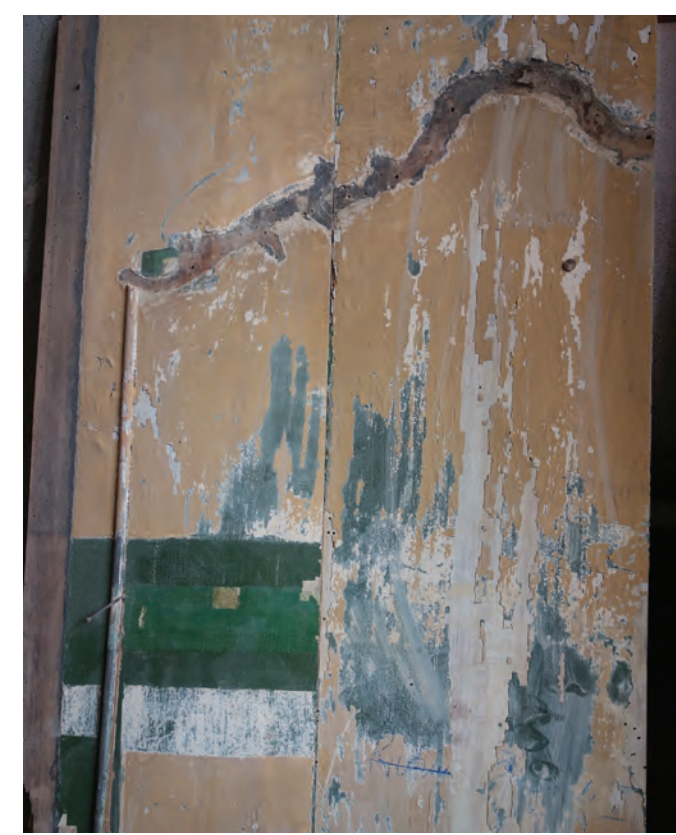
A part of the panels was in very poor condition. The wall panels had greatly suffered from woodworms, which were eliminated in 2005 by fumigating the exhibits with methyl bromide. This project was carried out by the German company "Romer BioTec GmbH" with the support of specialists from the Latvian State Institute of Wood Chemistry. Consequences of the long-lasting activity of the woodworms were structural changes in wood with large losses of coating and paint, reaching up to 30% for some wall panels.

Part of the wall panel before restoration damaged by woodworms, and the macro photo with woodworm caverns

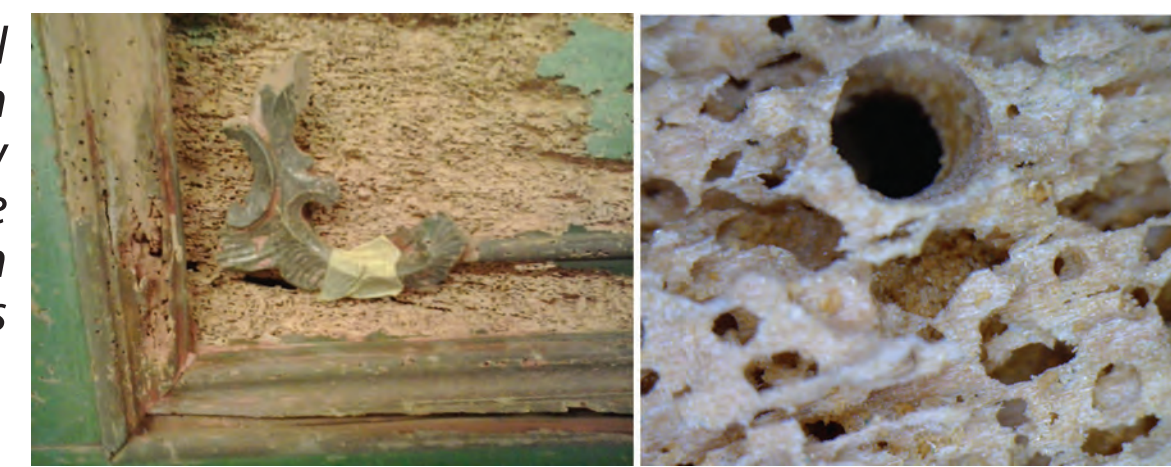
Investigation of woodcut surface coatings.

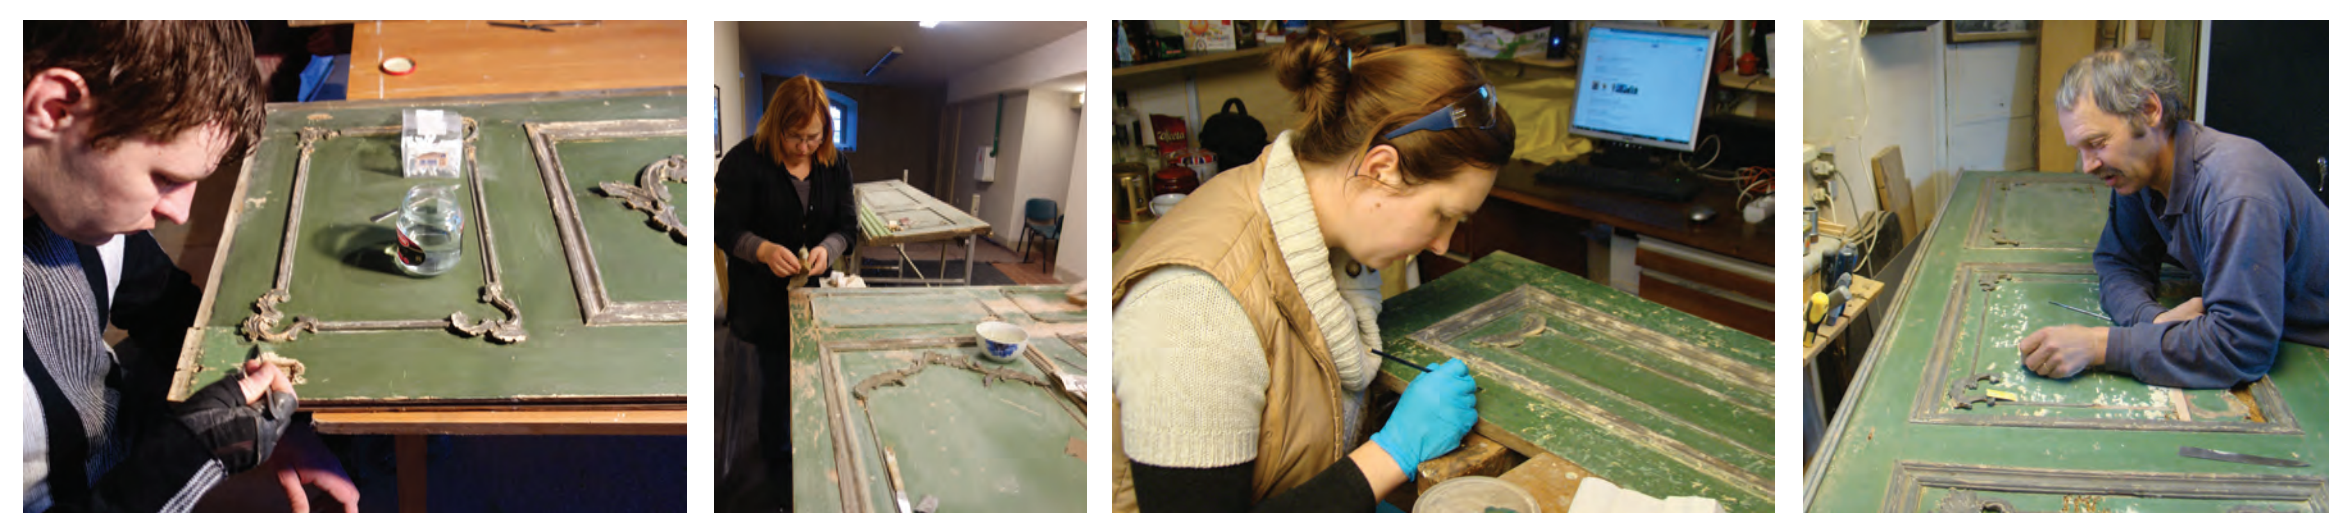
Restoration of the wall panels by master conservators of the Rundāle palace museum.

After conservation of the original coating and removal of overpainting, the primer composition – chalk with 4% PVA (Polyvinyl Alcohol Adhesive) – was applied to supplement the lost original priming. Tinting of the priming areas was performed with oil-based paint in the colour according to the original composition presented in the analyses.

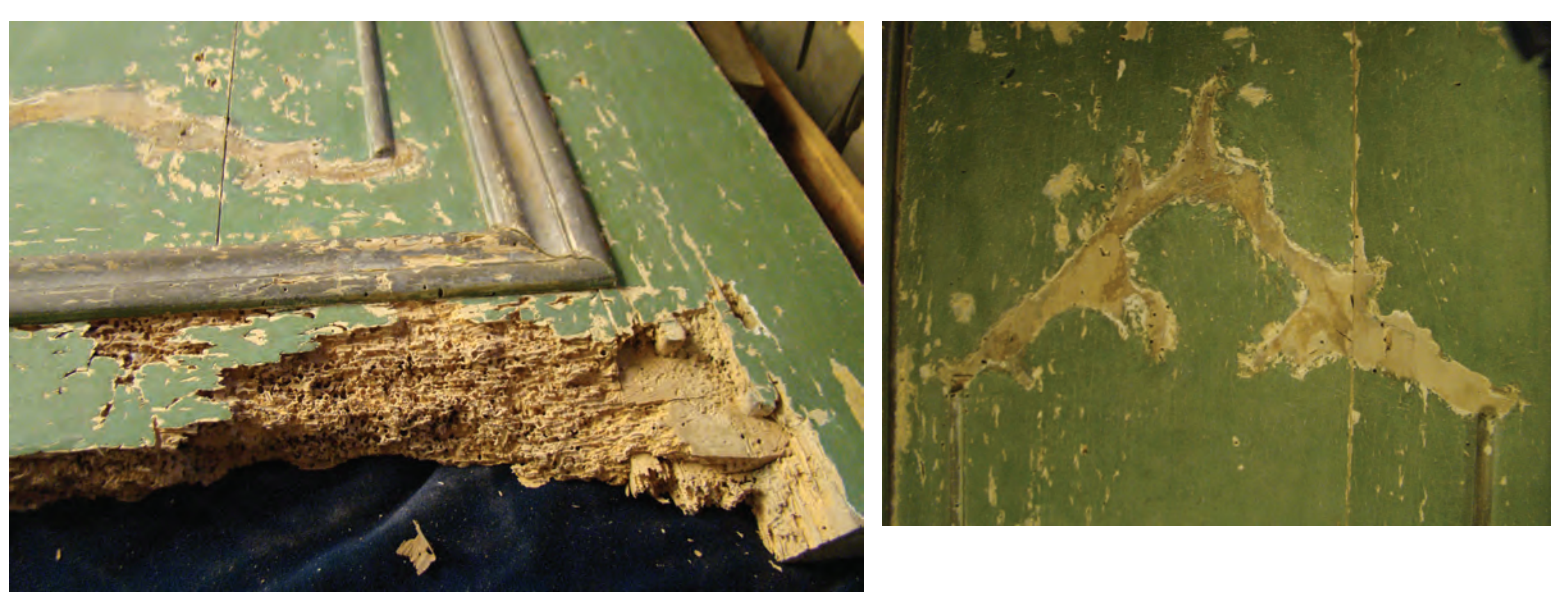
Reconstruction of the lost woodcut after the visible contour left from the original on the surface of the wall panel. Vilnis Lidaka, senior master conservator of interior design items.

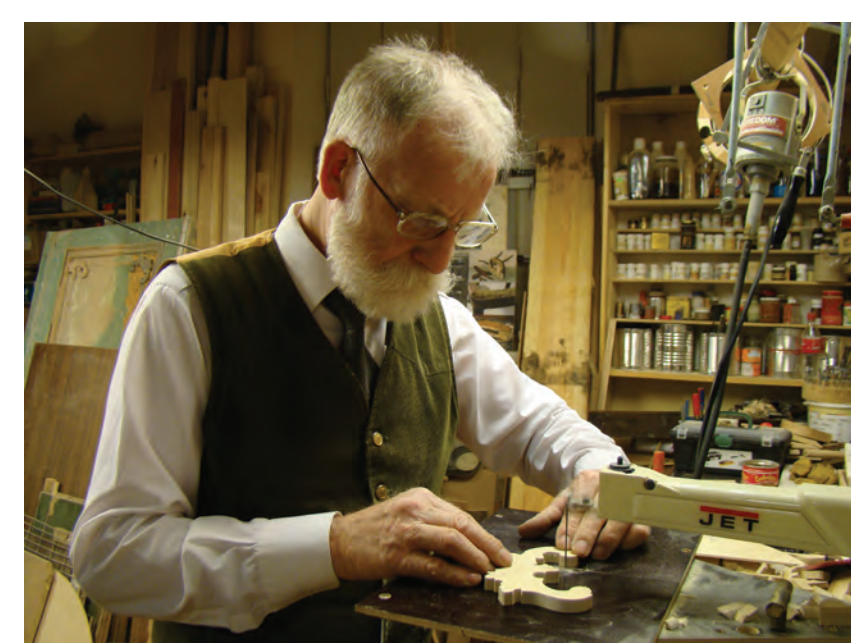
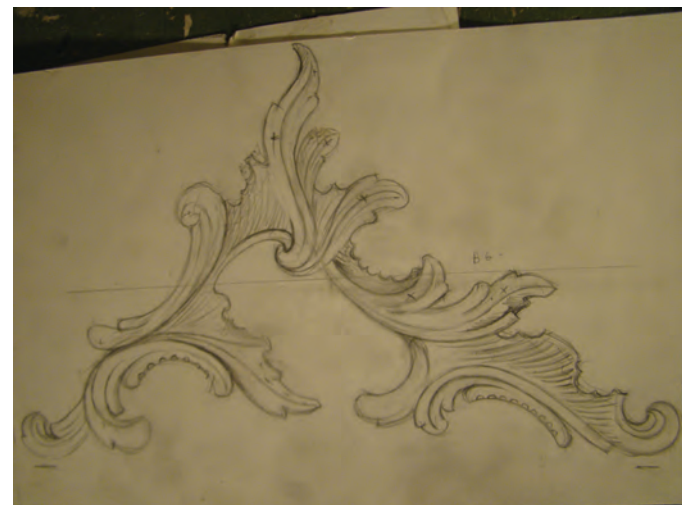
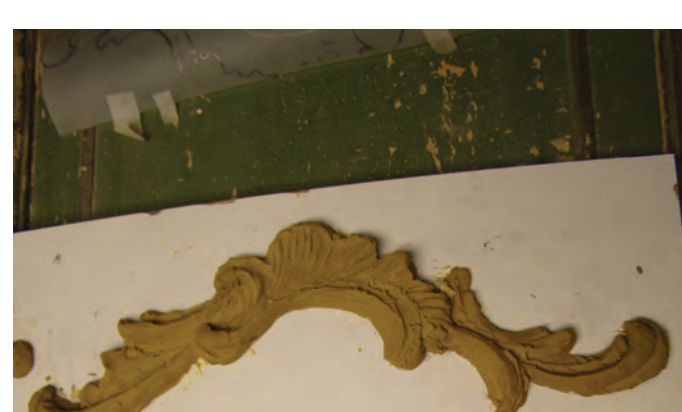
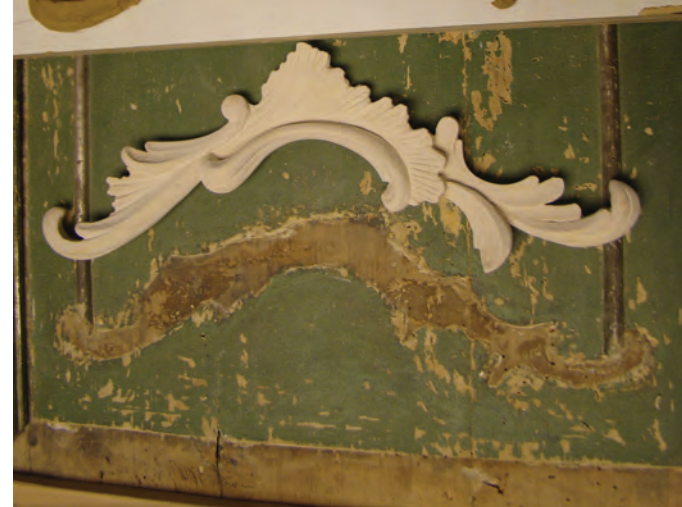
Reconstructed woodcuts for the wall panel

Woodcuts, wood profiles and other silver-coated wood parts, which had lost the silver coating, as well as newly made woodcuts were silver leafed and some parts were treated with silver powder mixed into gum arabic. To eliminate the sheen of the newly applied silver, the surface was retouched. Then the silver surface was covered with a protective varnish (bleached shellac ethyl alcohol solution), applied at least two times to cover all of the new silver surfaces.

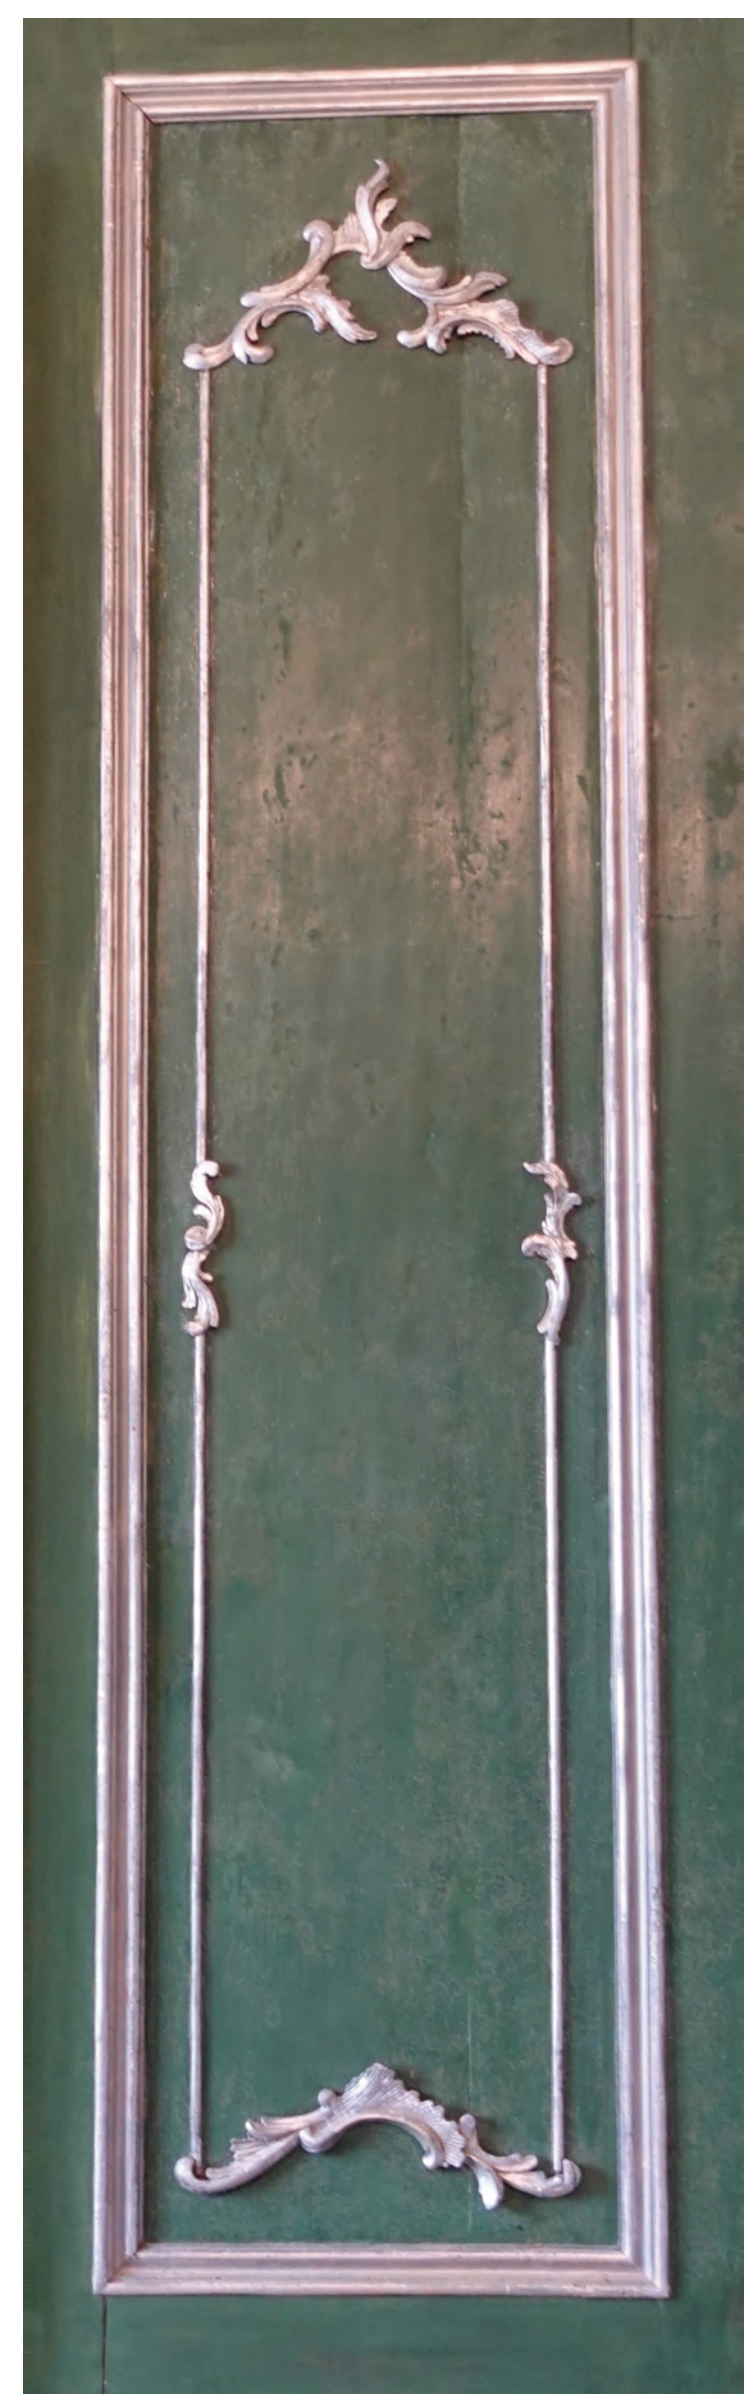
The wall panel after restoration.

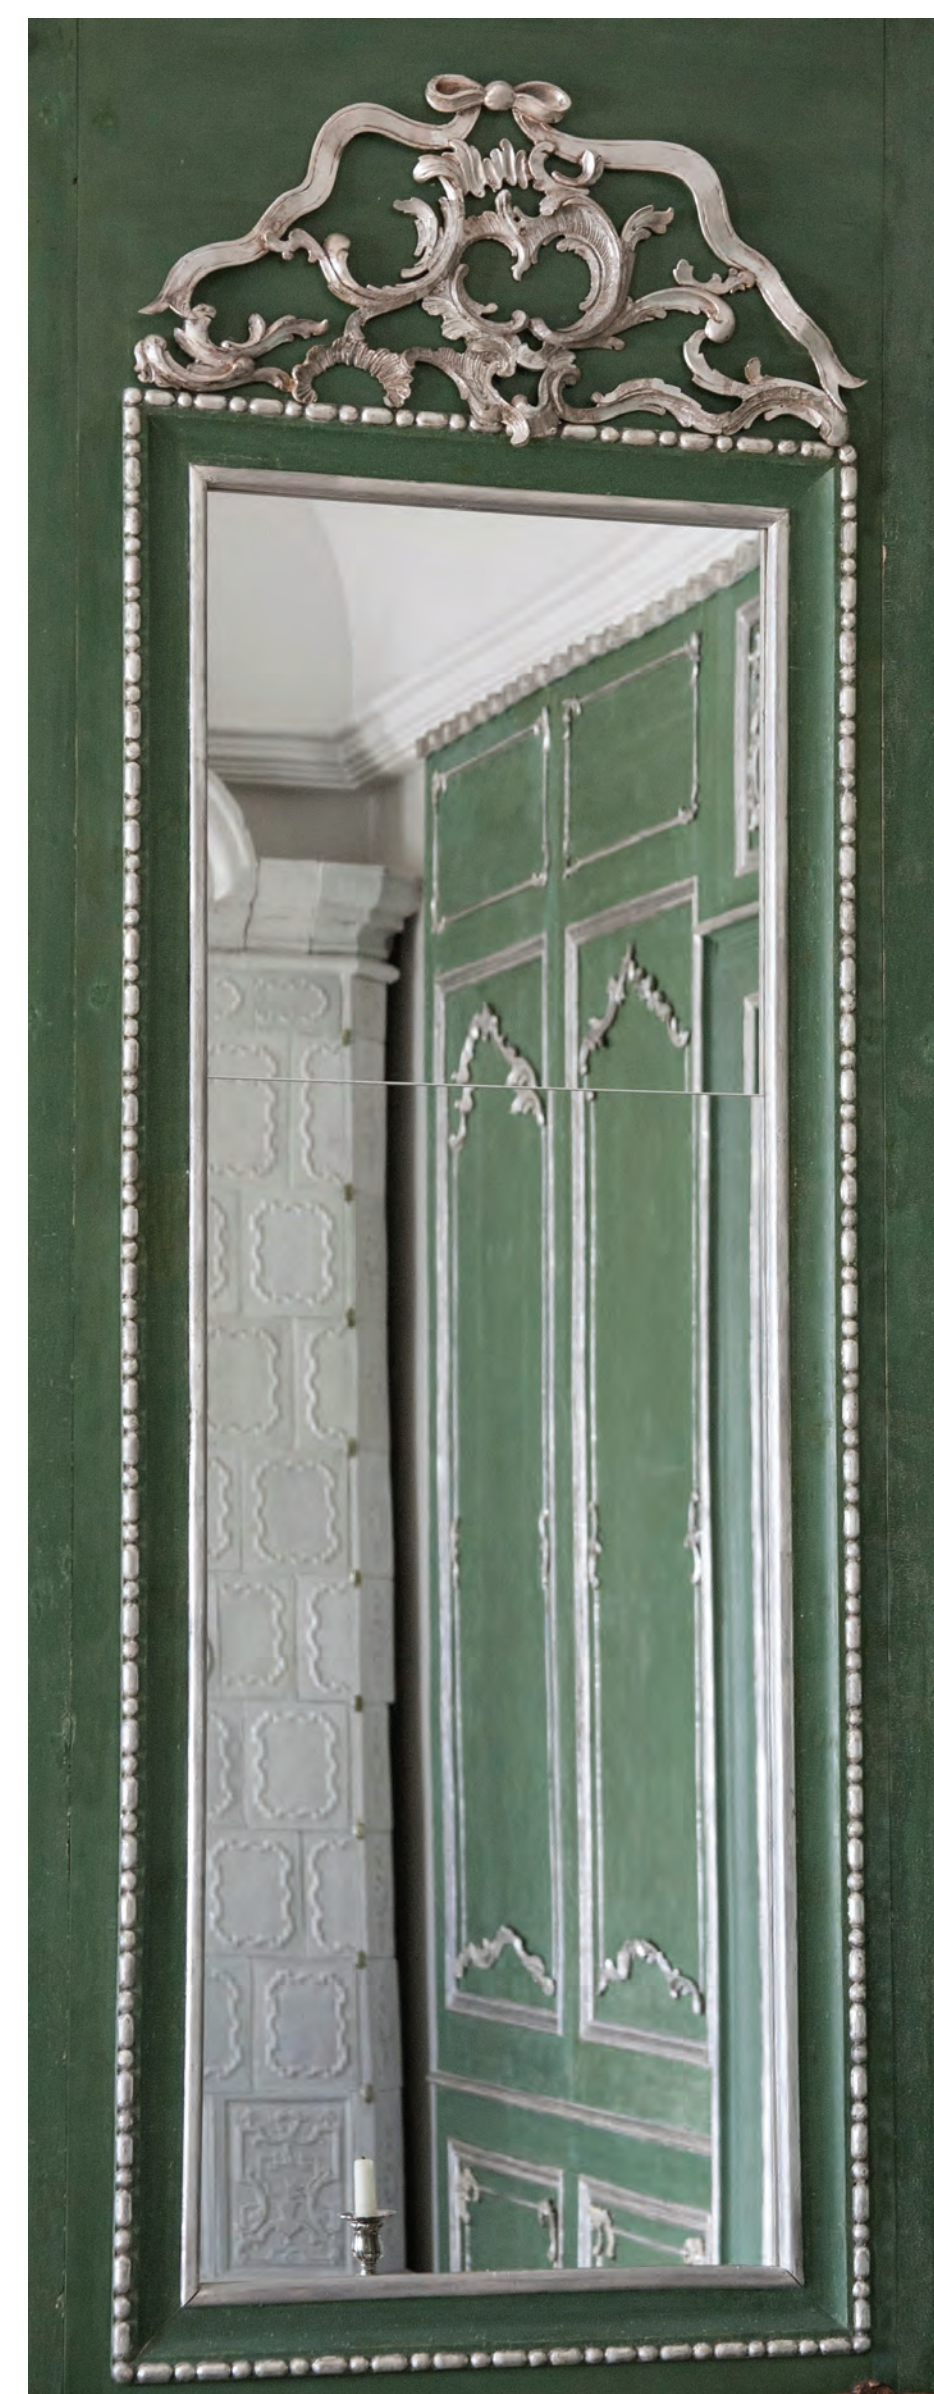
Decorative wood-carving on the top edge of the mirror frame after restoration

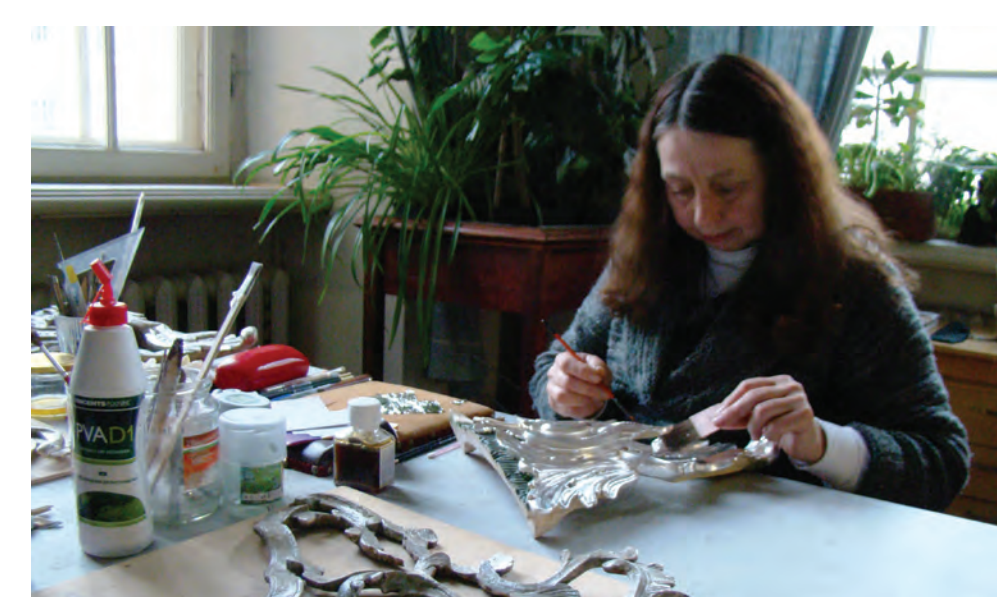
Restoration of the polychromic woodcut. Inese Indrikova, master conservator of polychrome wood.

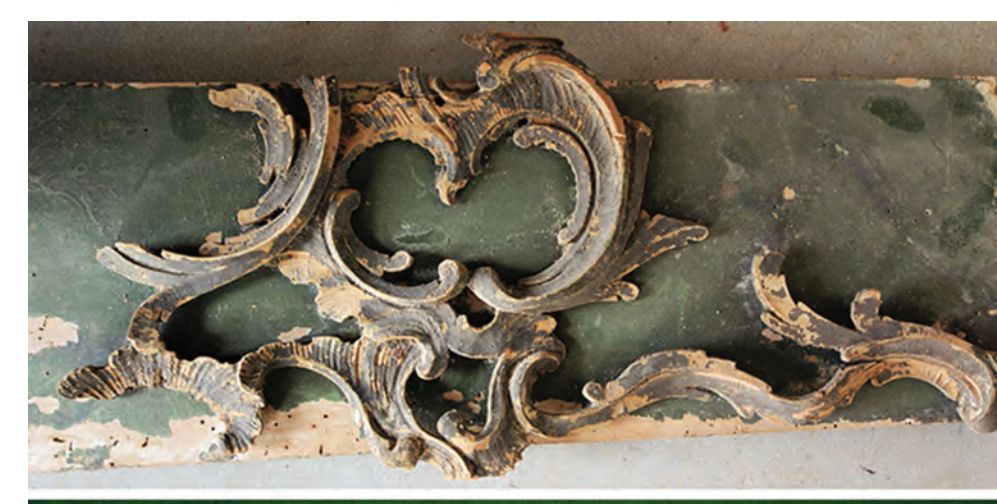
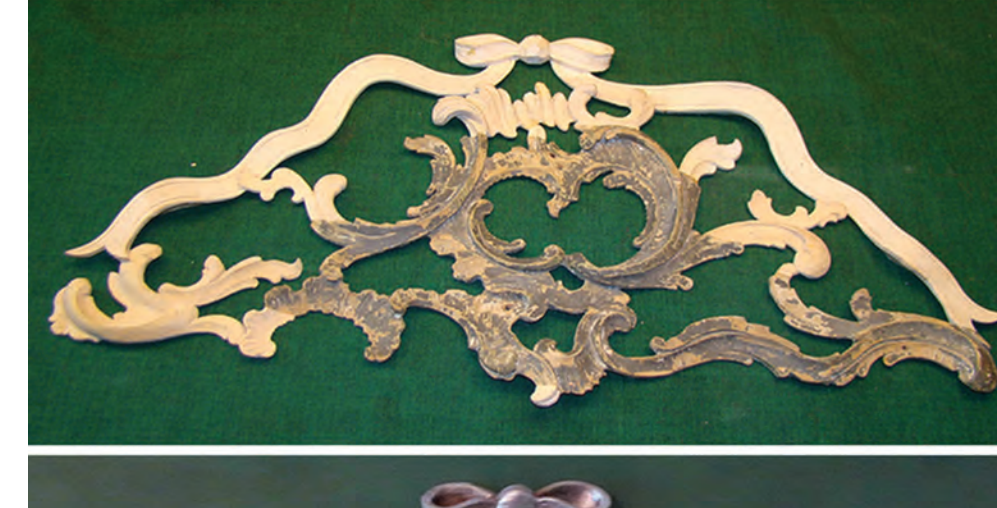
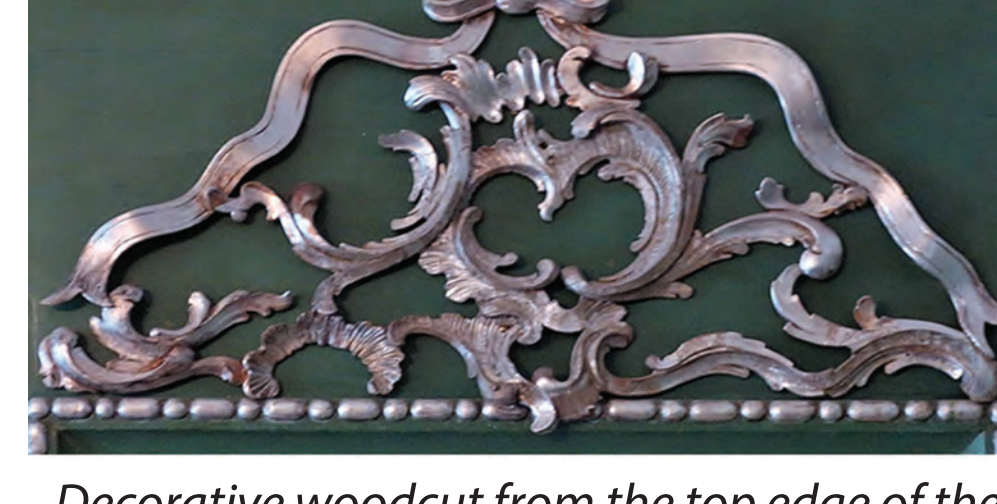
Decorative woodcut from the top edge of the mirror frame before restoration; The lost parts of the woodcut restored; Woodcut after restoration
