WALLPAPER RESTORATION OF EDUARDS SMILGI'S CABINET

The new Riga Theater located at 25 Lacplesa Street (Riga) will open its doors in 2021. Currently, reconstruction works are held there to preserve the values of the Latvian theater history with its distinctive details and the cabinet of Eduards Smilgis.

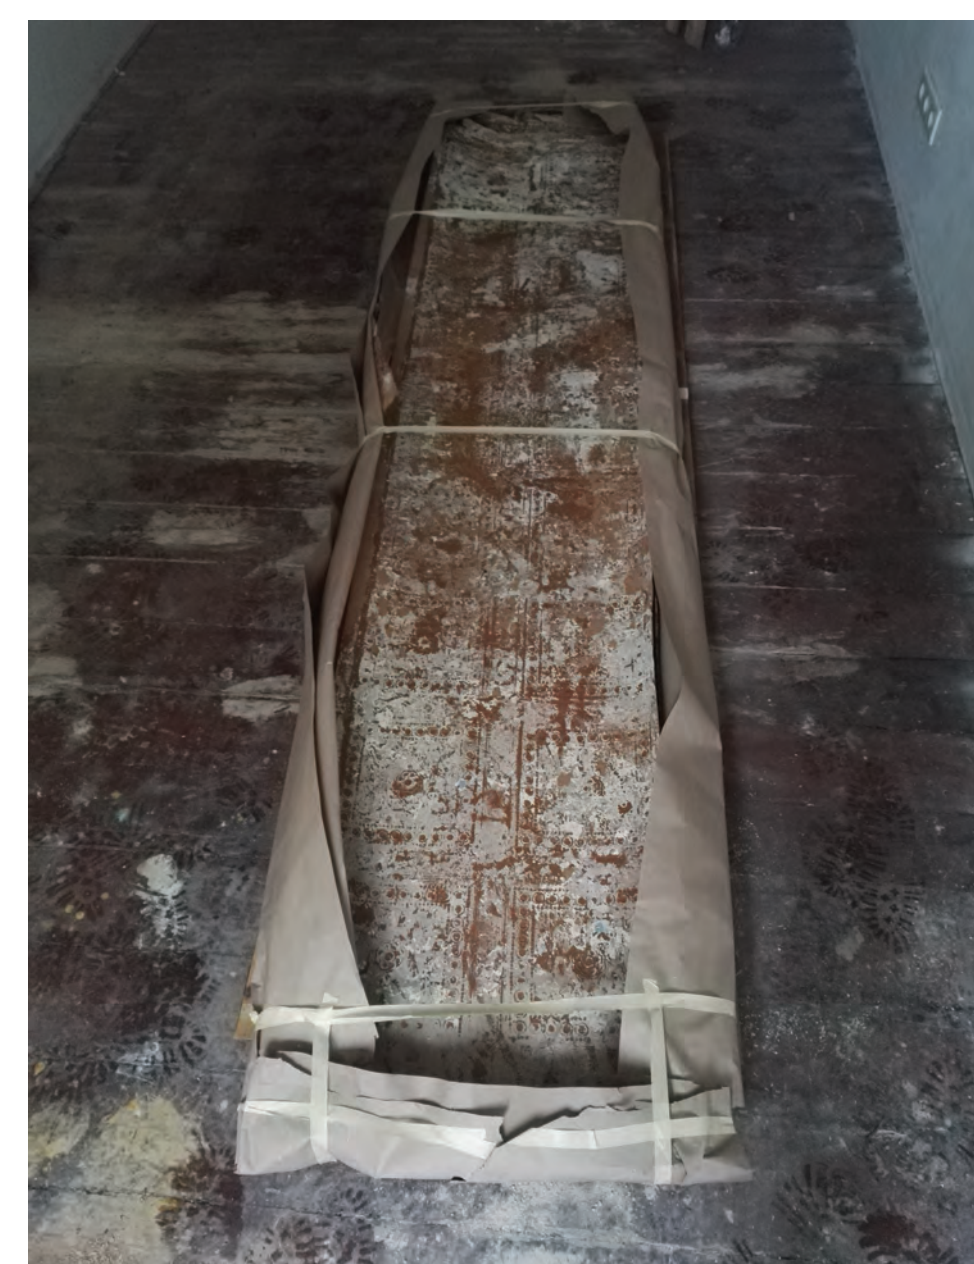
Fig.3. Wallpapers after dismantling and prepared for transportation.

After dismantling the wallpaper was dirty, covered with dust and plaster. During the dismantling minor tears occurred, material losses that occurred during the use of the room when the wallpaper was on the wall became more prominent.

The restoration process began with the wallpaper dismantling. The wallpaper was taken off in a wet manner, completely moistened with water. Moistening was repeated several times due to the thickness of the wallpaper and partially preserved surface coating. Further restoration processes took place in the workshop.

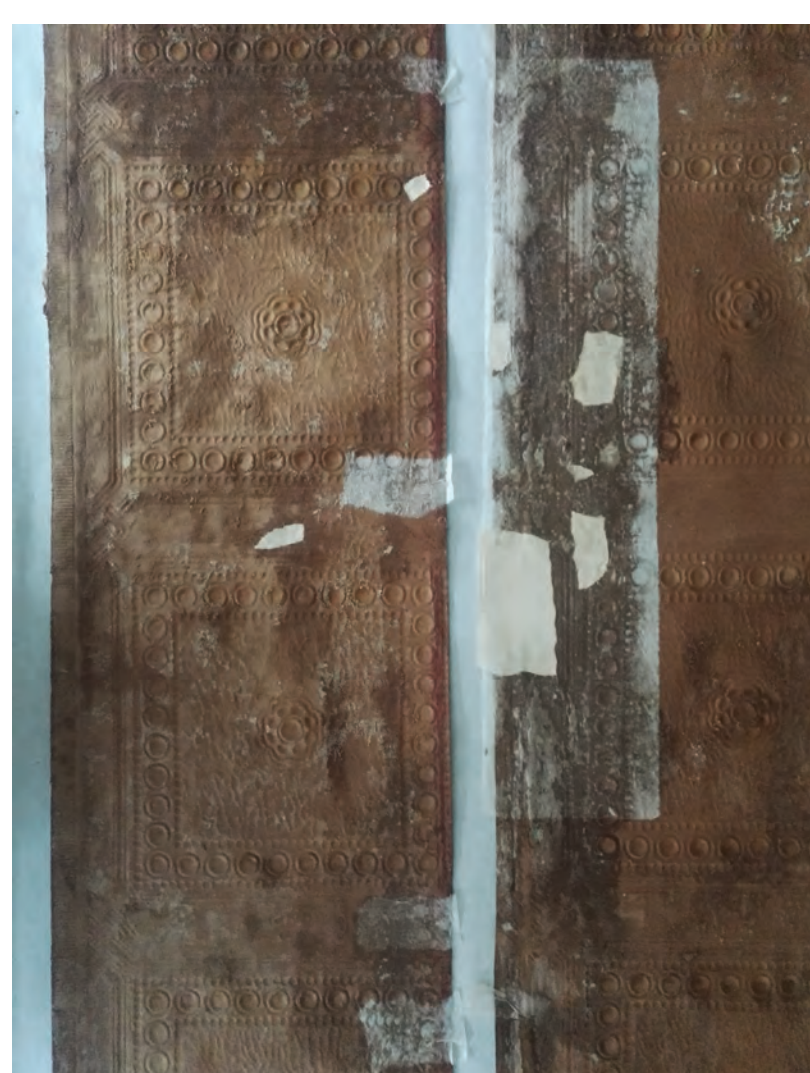
Fig.6. Filling of losses, bonding and securing of fractures.

After all wallpapers were cleaned, they were primed. Quelyd Special Vinyl paste was used for priming, which is suitable for all types of heavy wallpaper with paper and textile backing. It contains modified starch and anti-mold additives.

Immediately after priming, the losses were filled in, tears were glued and reinforced. For gluing the same glue was used as for priming. Mica coated paper was used to fill the losses, tears as well for reinforcement.

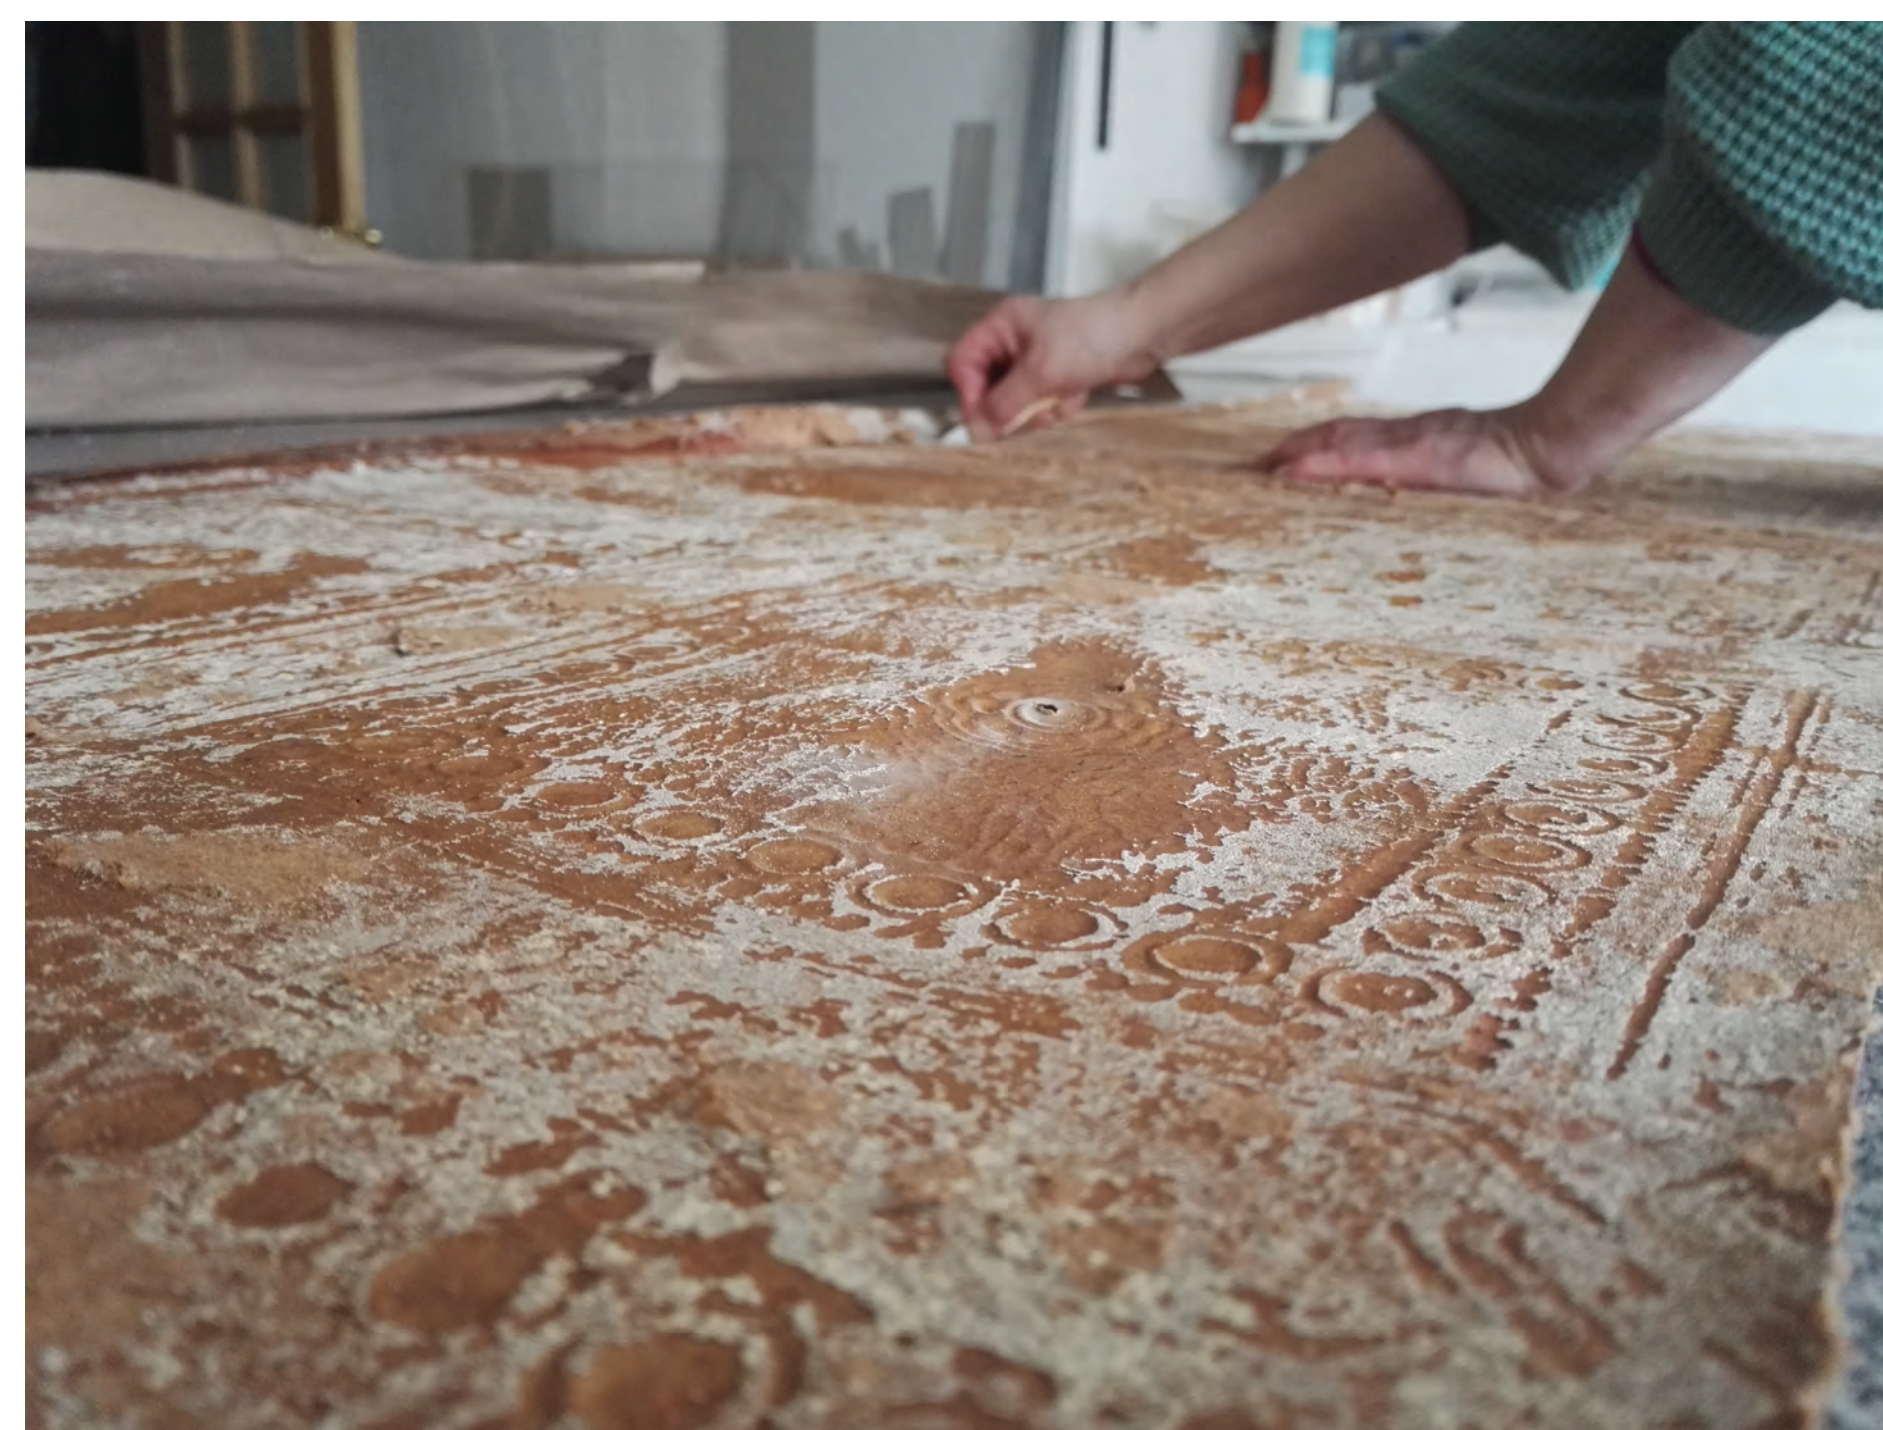
Fig.4. Mechanical cleaning.

The restoration work was started with mechanical cleaning. The plaster was maximally cleaned off the back of the wallpaper without leaving a thick layer of plaster. Scalpels were used; small parts of the plaster were collected with vacuum cleaner. The front of the wallpaper was cleaned of dust using moistened soft sponges.

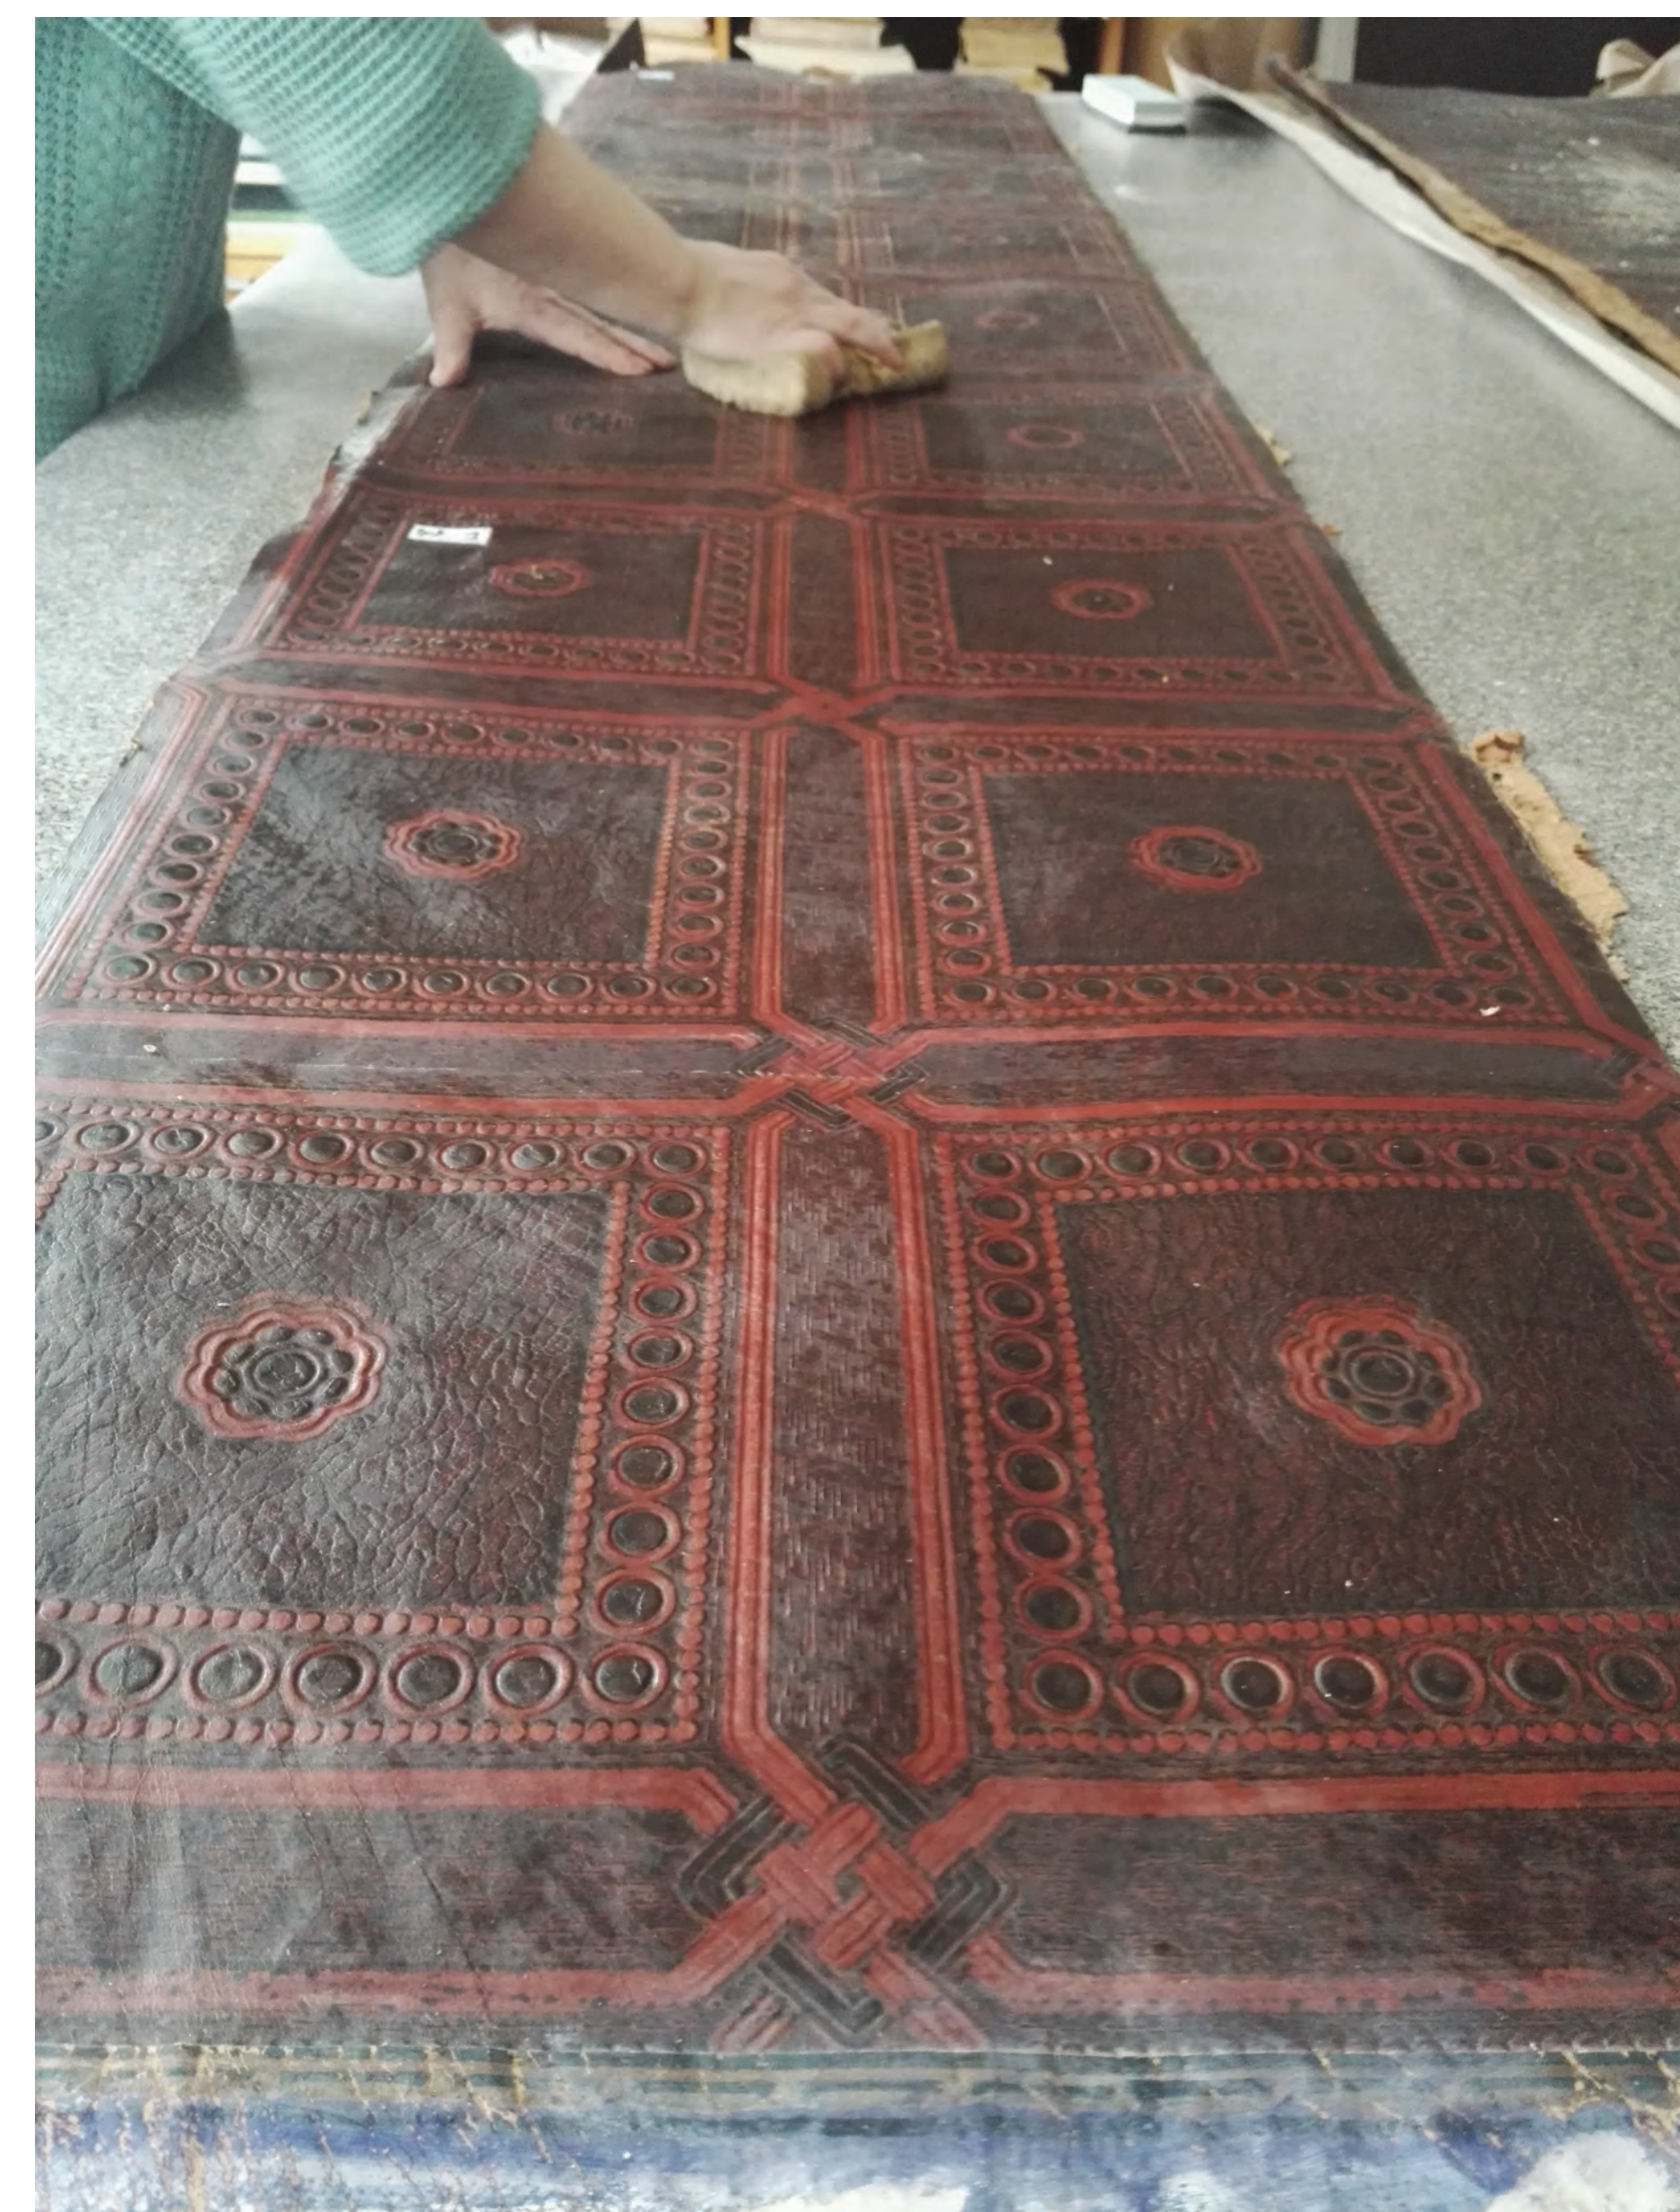
Fig.5. Wallpaper cleaning from the front side.
