DIGITAL RECONSTRUCTION OF ICONS ON THE FAÇADE OF VENTSPILS' ST. NICHOLAS ORTHODOX CHURCH

INTRODUCTION

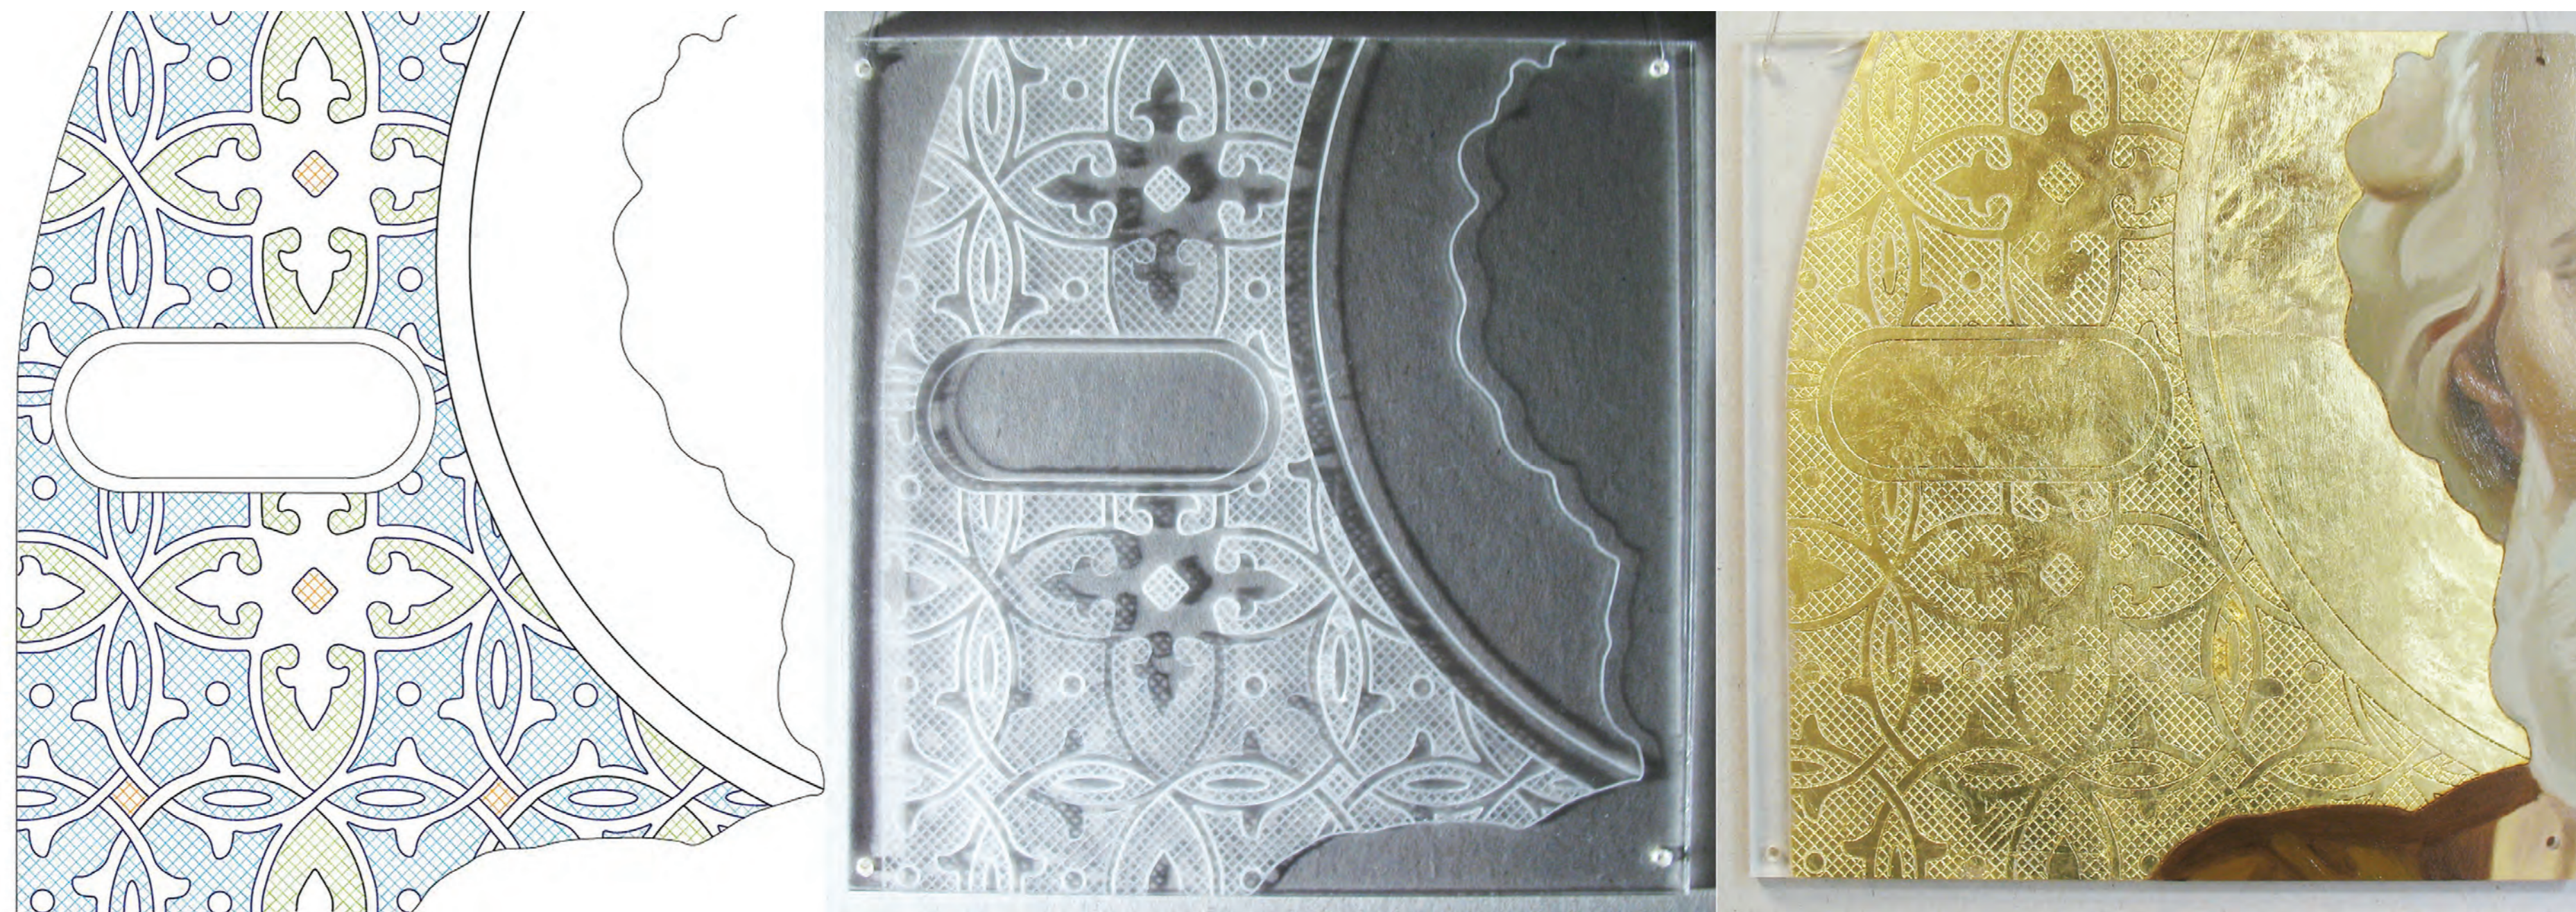
Fig. 2. Preparation of an example – the pattern was developed using Adobe Illustrator, and engraved in the organic glass sheet with a laser, then gilded and painted

Currently, the only material which supports laser engraving well enough to create the background ornamental engraving corresponding to the original is organic glass (modern material research and work with lasers – Andris Skudra). The pattern required for the laser engraving was made in Adobe Illustrator. Eight different samples were prepared by processing the organic glass base prior to gilding and applying paint. The methods used to improve adhesion were: surface machining, surface dissolution and application of a PVB adhesive layer. The examples will be placed on the façade behind glass and kept there for several years, to empirically determine the best technique for recreating icons.

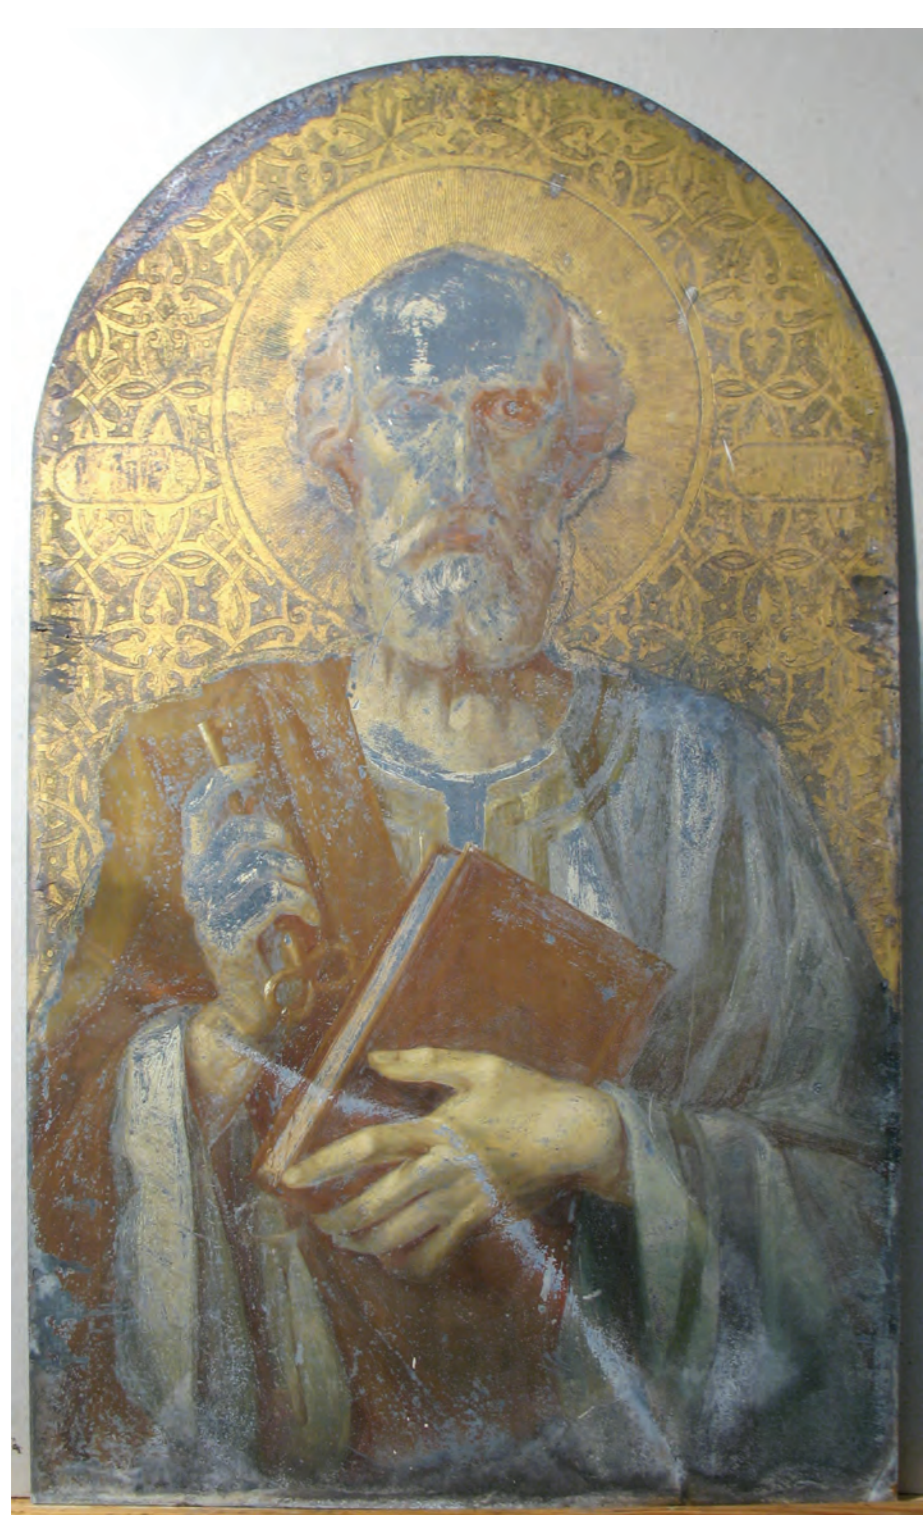
Fig. 3. The icon of St. Peter the Apostle, prior to restoration

The original paint layer had been irreversibly damaged by sunlight, chloride ions (seaside climate and a nearby chemical fertiliser handling terminal) and microscopic coal dust (coal handling terminal). The relevant port infrastructure has been improved in recent years though, which includes improvements to cargo loading. Experimentation has revealed that the microscopic coal dust act as a potent catalyst in some corrosive chemical reactions.

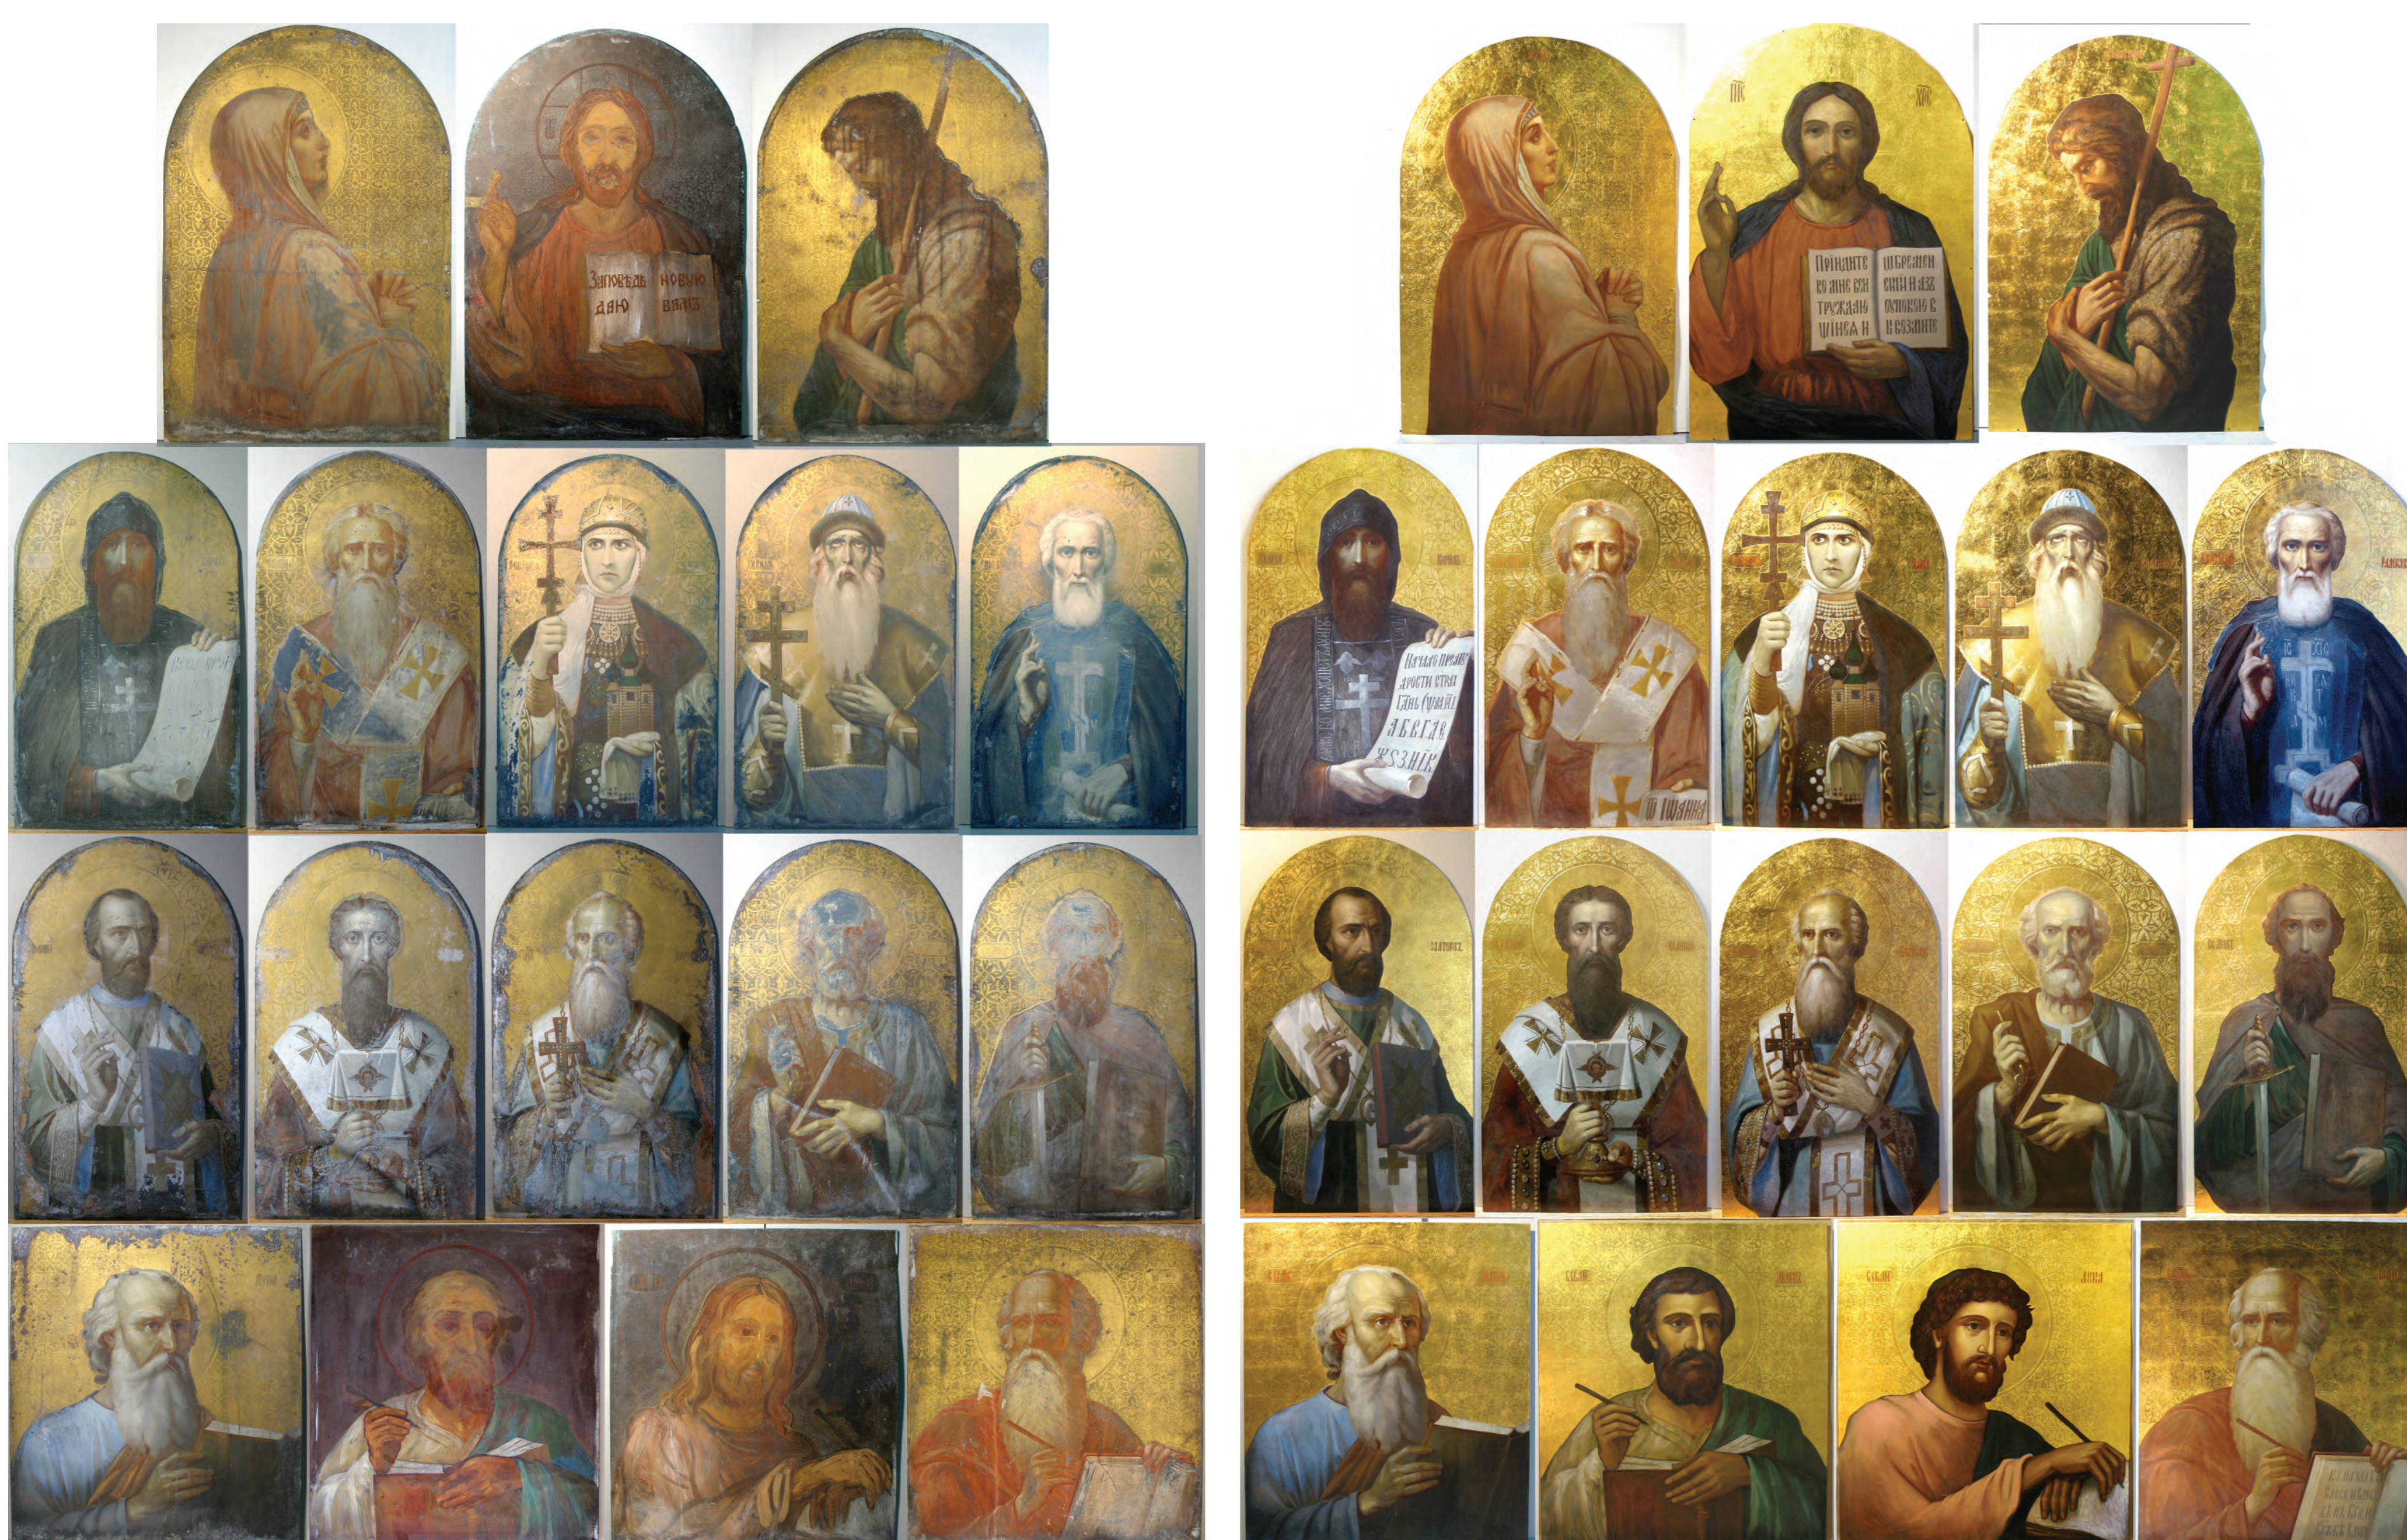
Fig 7. All icons on the façade of Ventspils' St. Nicholas orthodox church prior to restoration

Fig 8. All icons on the façade of Ventspils' St. Nicholas orthodox church after restoration
