“VEB SCHIFFSLATERNENWERK UECKERMUNDE” RESTORATION AND STUDY OF SIGNAL LANTERNS

INETA NIEDOLA

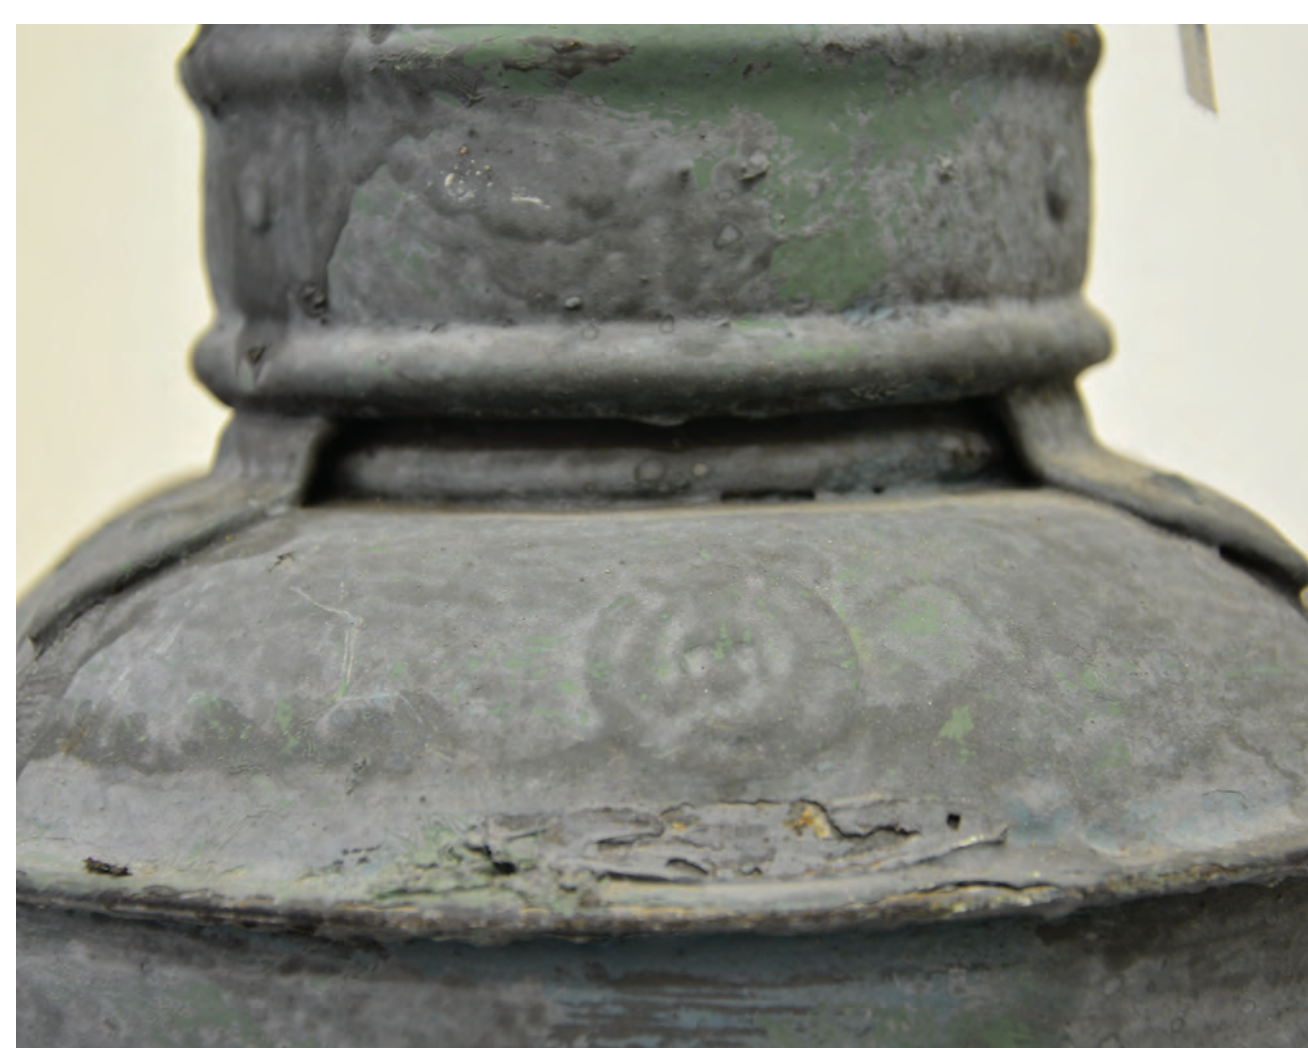
Lantern detail before restoration

In the process of restoration, lanterns have been cleaned from dirt and degreased. Paint layers have been gradually removed by using a gel – wheat flour glue that contains solvents such as dimethylsulfoxide, benzyl alcohol, ethanol and petroleum spirit (1:1:1:1). In order to clean up the doors of the lanterns that are covered with thick paint layers a hairdryer has been used. In the case of some lanterns, a layer of grey or green colour has been left untouched, if it holds well to the metal surface and has not peeled up and the corrosion layer has not been seen under it as well. Areas affected by corrosion are chemically cleaned by using a gel – wheat flour glue that contains 5% of citric acid. By cleaning areas affected by corrosion in this way, no leakage is formed, the selected area is cleaned and the whole process is controlled well. Lanterns are passivated, rinsed and dried. Surfaces are cleaned mechanically. A protective coating is applied on the metal surface.

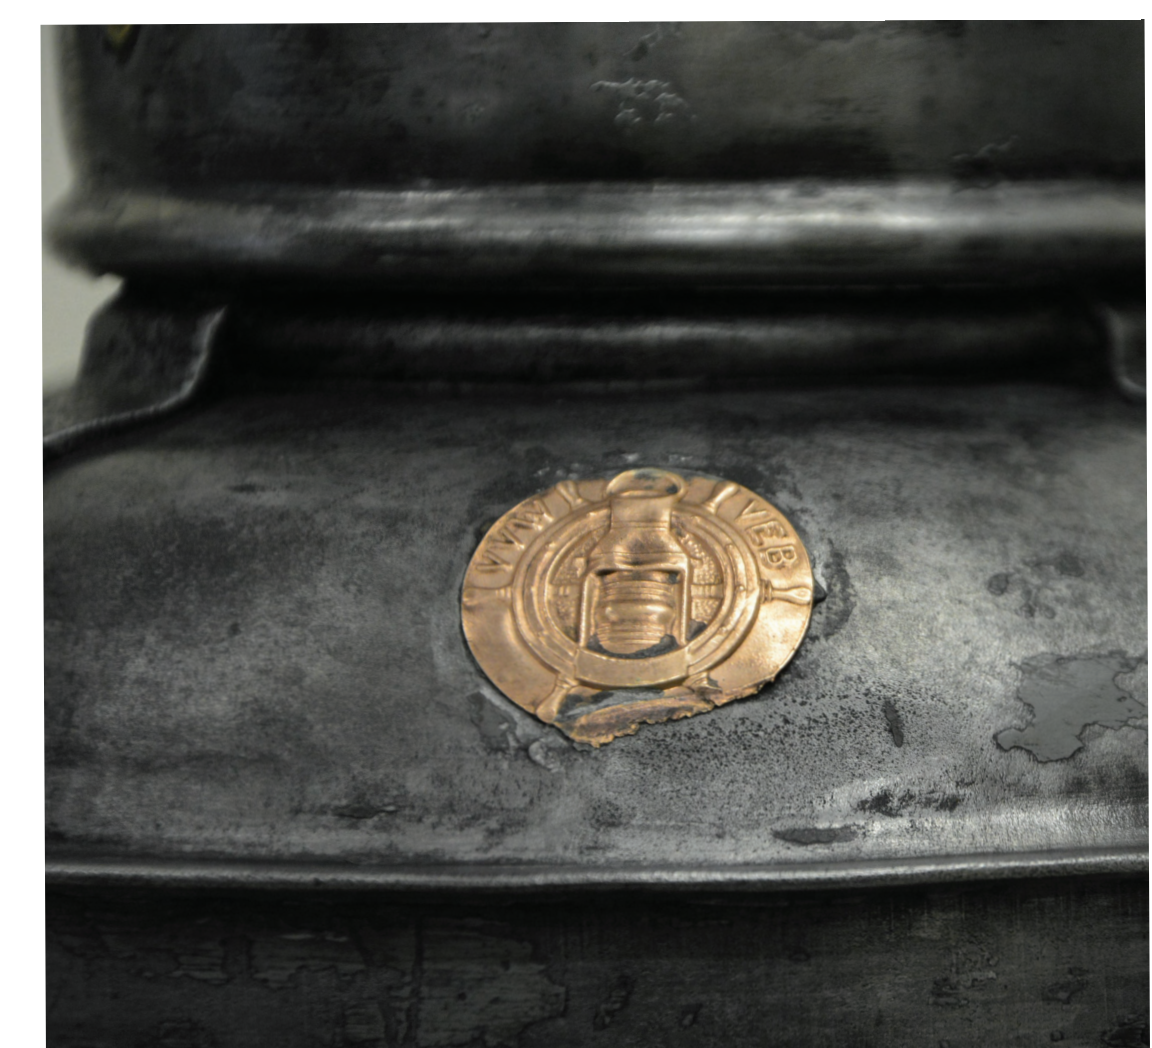
Lantern detail after restoration

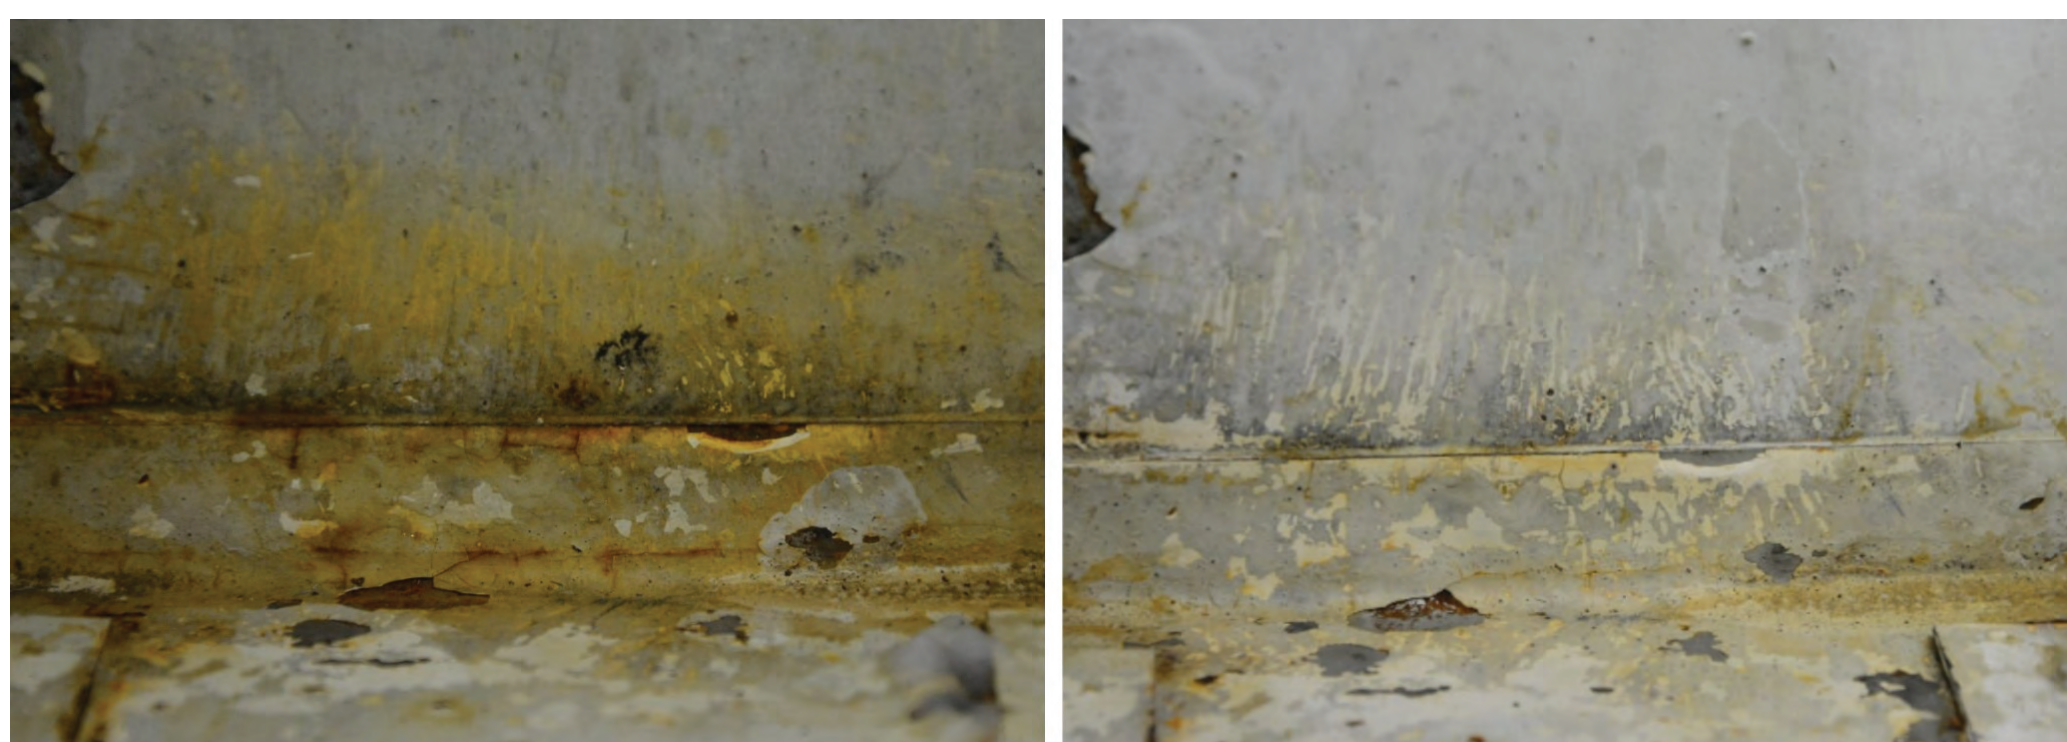
Process: before and after using gel – wheat flour glue that contains 5% of citric acid

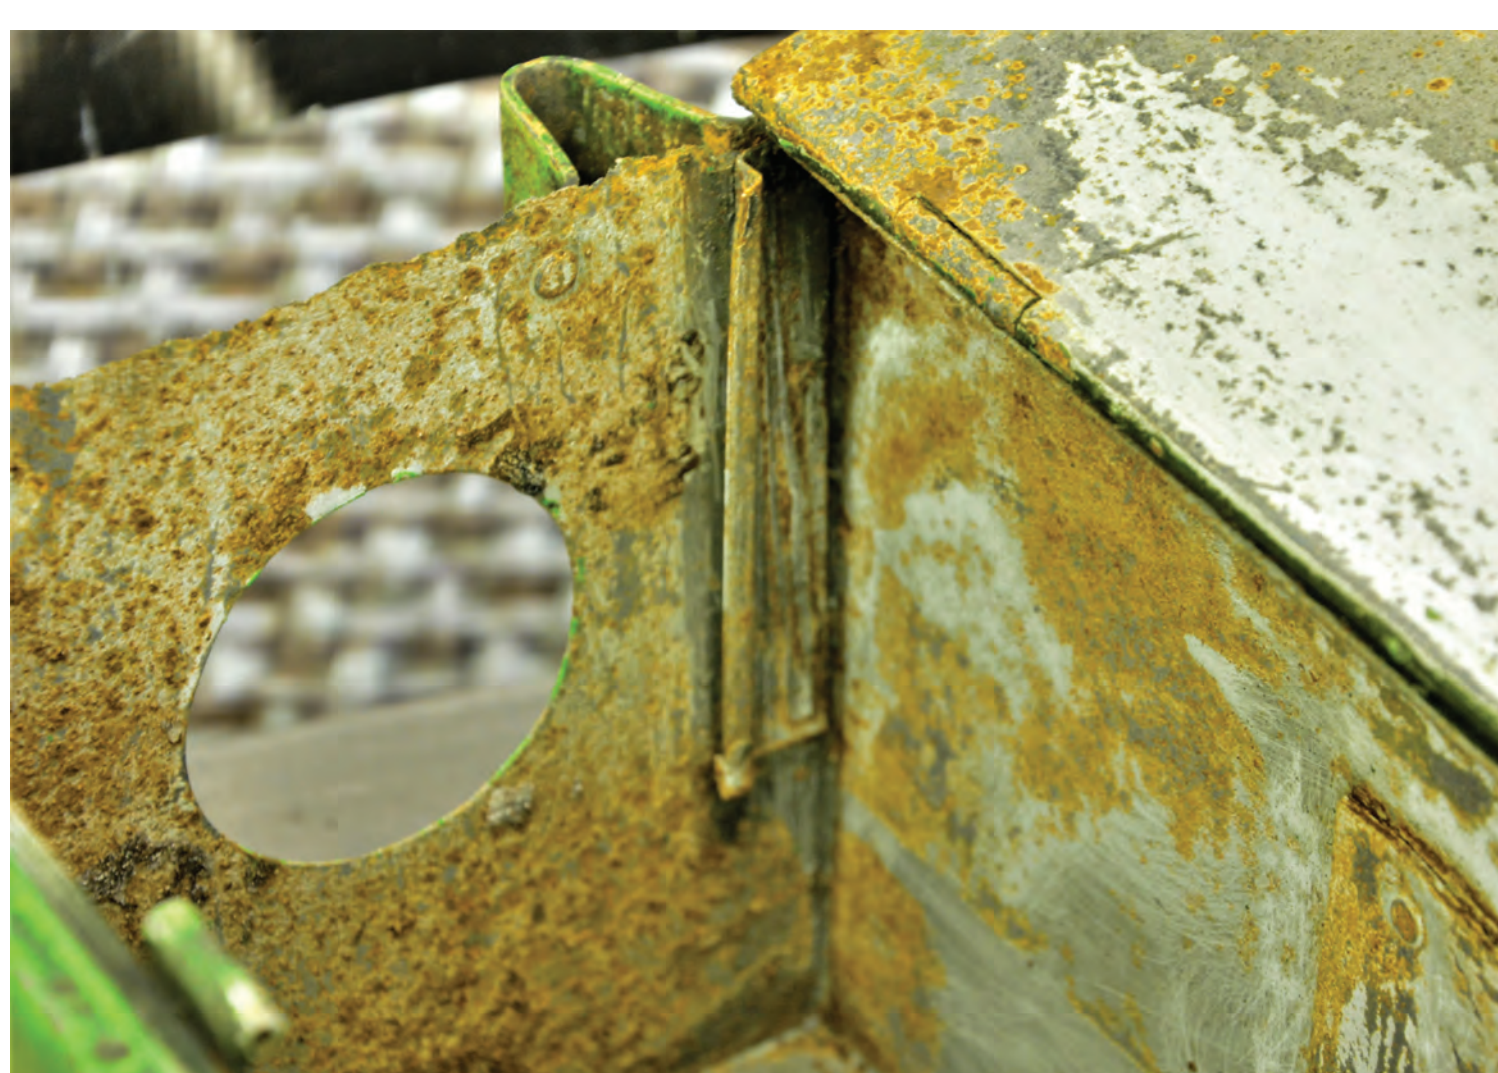
Lantern restoration process

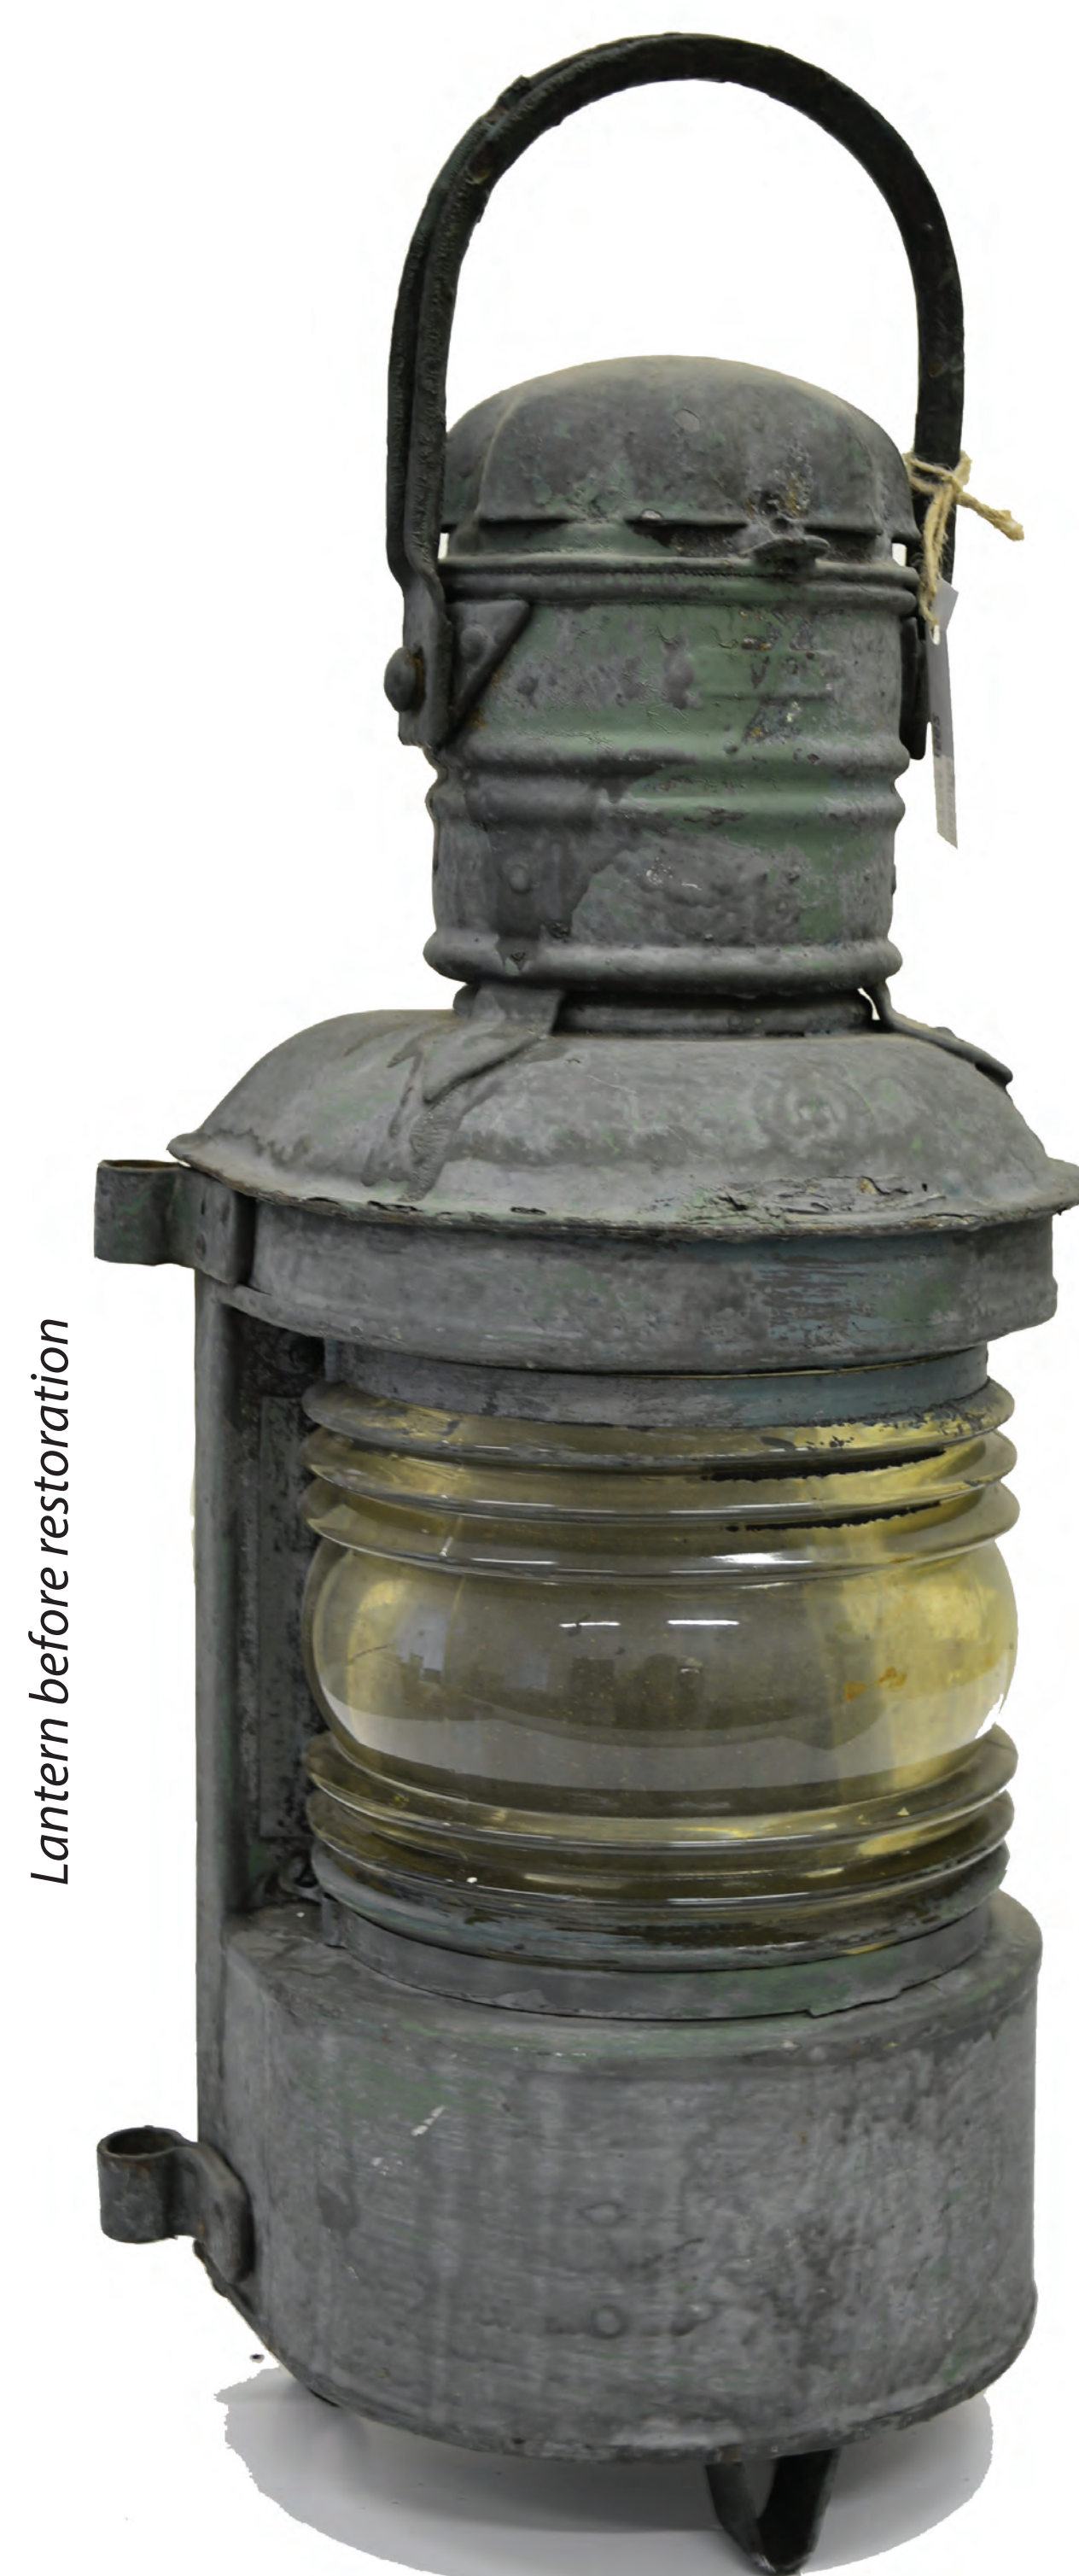
Many lanterns are covered by a thick layer of oil colour in grey or dark blue-grey. The grey colour of fishing vessels and boats was regulated while Latvia was a part of the USSR so that if necessary, the USSR military fleet could be assisted.

The paint was applied by brush. Visible leakage indicates that the lanterns have been repainted several times during the maintenance of the ship in order to avoid corrosion. For some lanterns, the green oil colour of different tones is visible under the layer of grey colour. They supposed to be used as green side flashlights. Here and there, paint layers have scaled off and dried in some places which have corroded over time. Most of all corrosion has affected the inside and the base of the lanterns. At a later time part of the lanterns have been adjusted for electricity.

Lantern before restoration

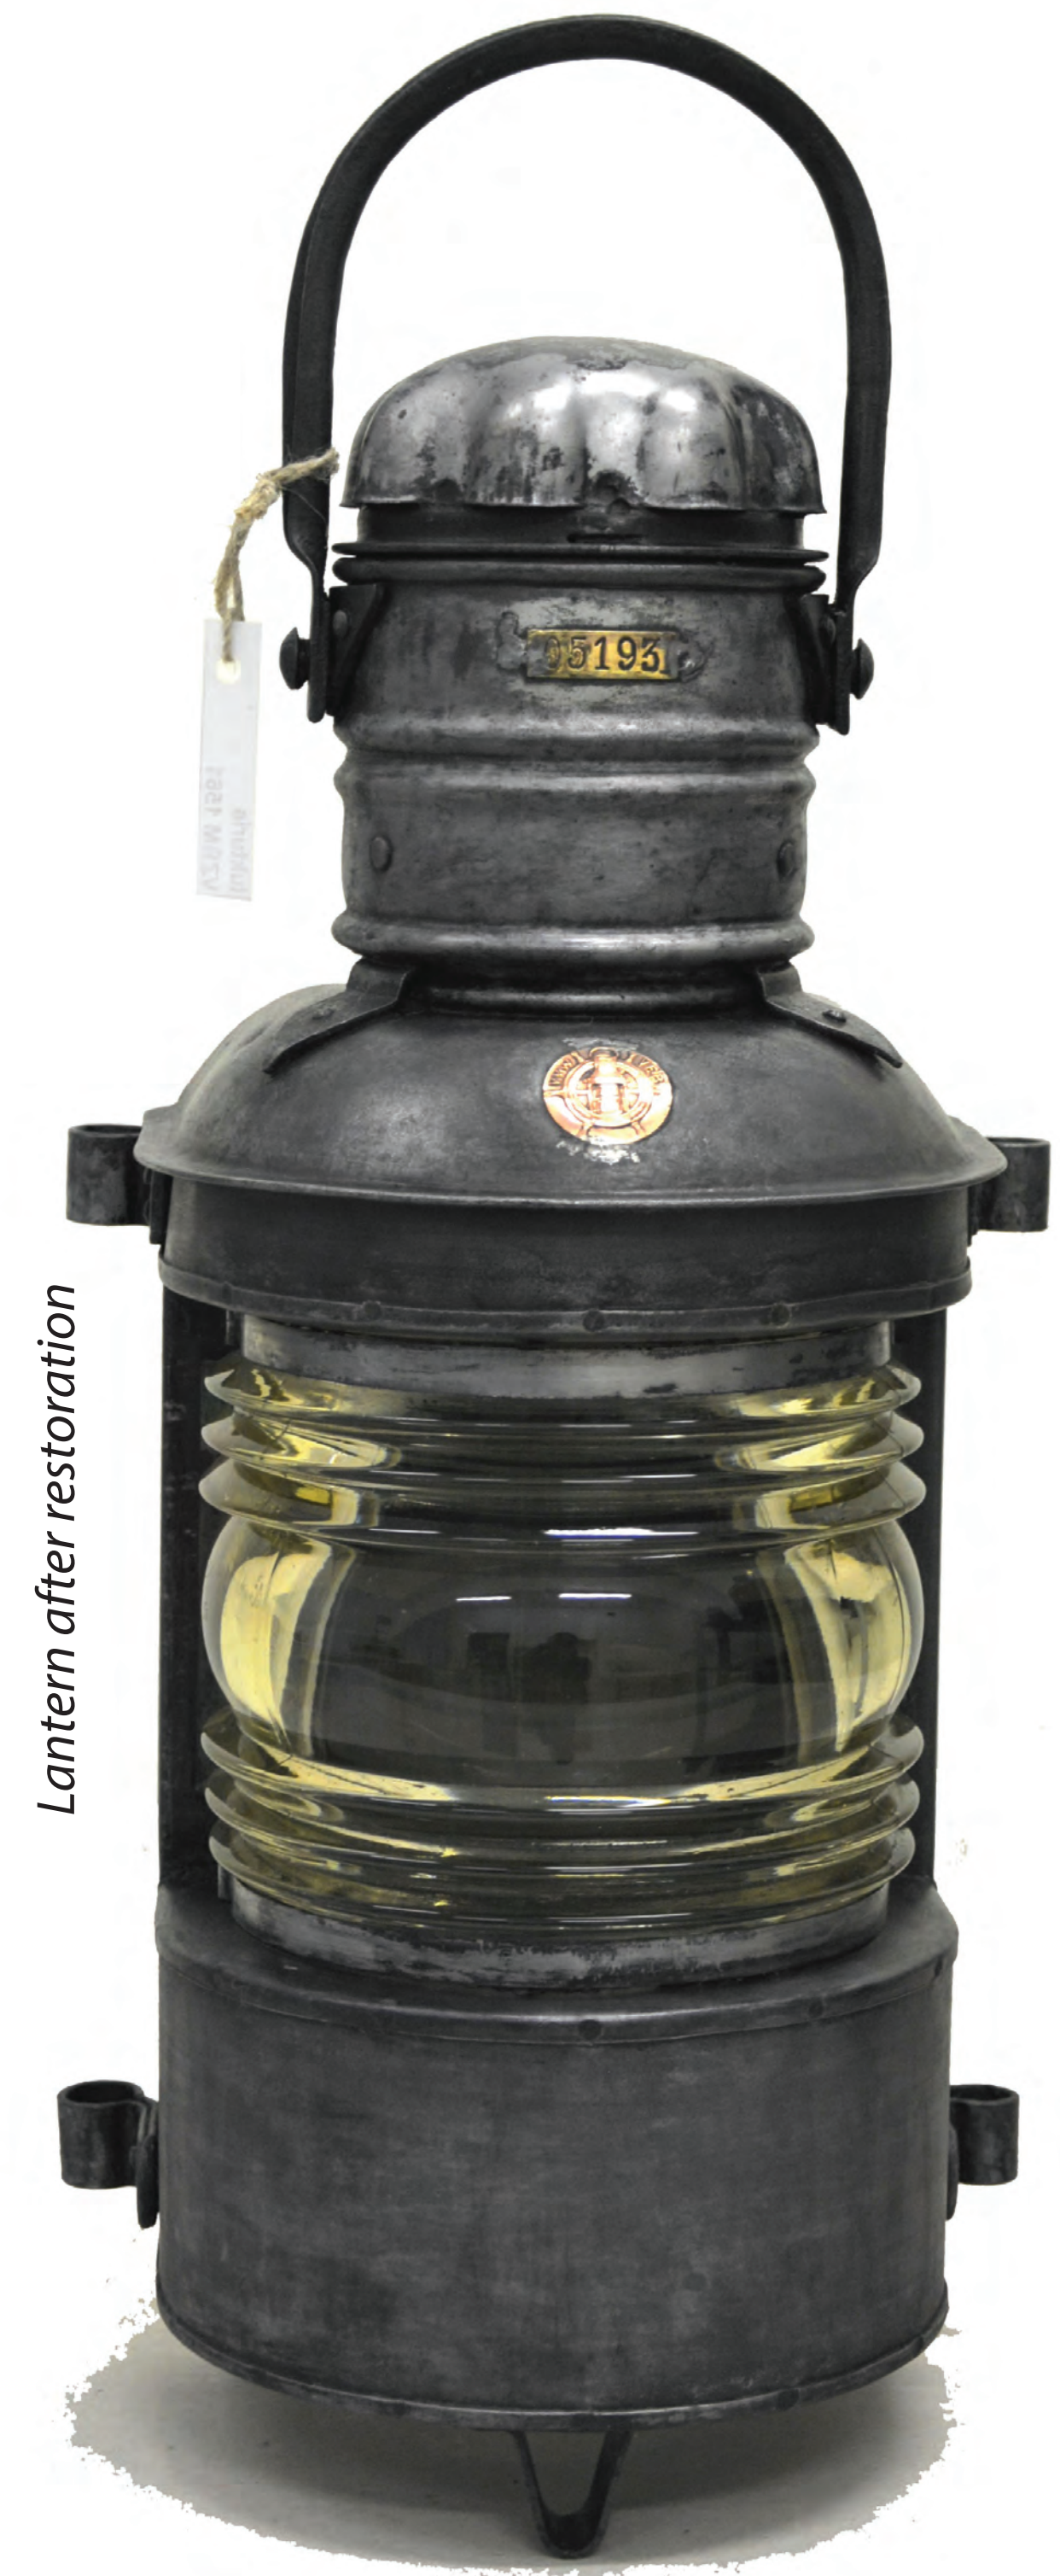
Lantern after restoration
