# UNDER THE MICROSCOPE. RESEARCH AT THE NATIONAL HISTORY MUSEUM OF LATVIA

## A PAIR OF TEMPLE RINGS (Gilberti, Mazjumprava A 5660)

## FIBULA (Rīga, 1694/21a)

## METAL BINDING (Doles Rauši, VI 146:916)

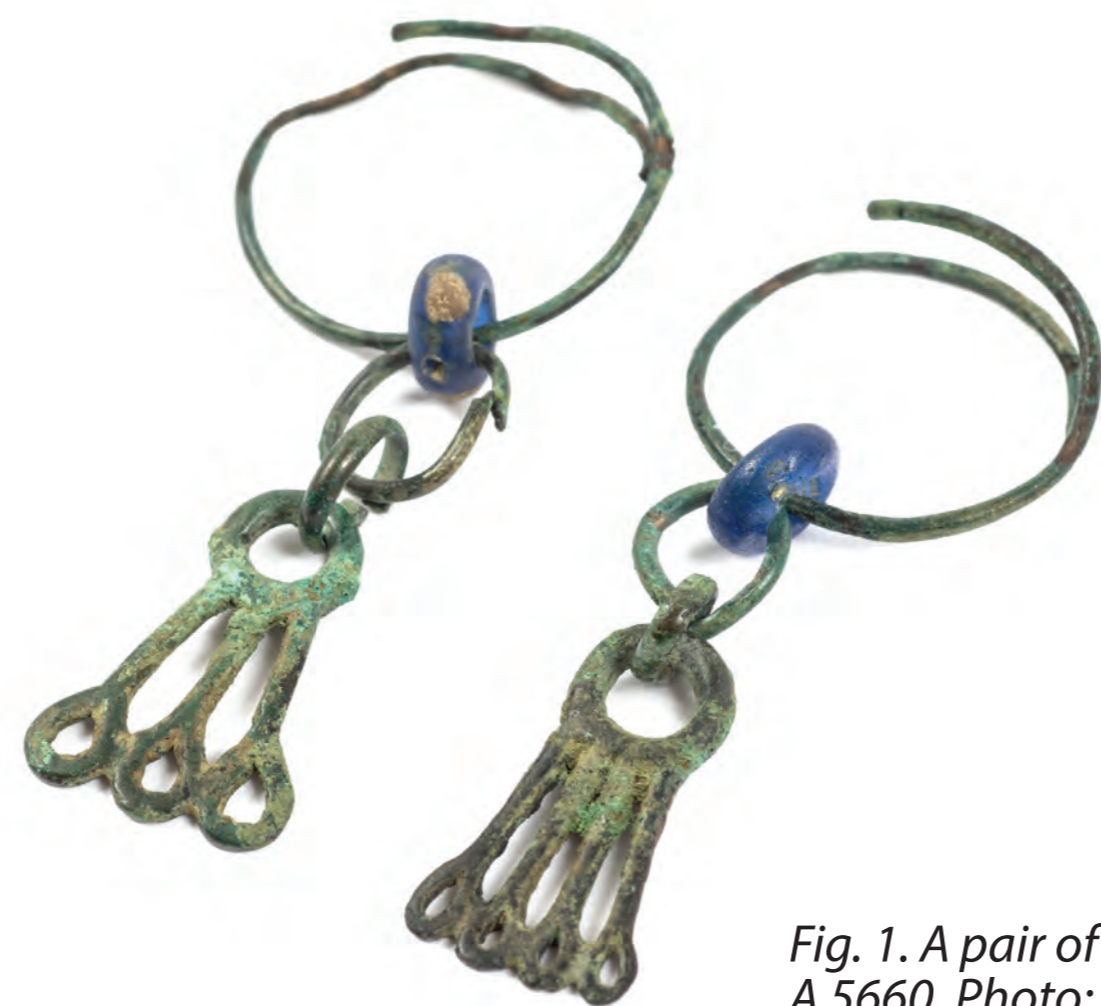
Fig. 1. A pair of temple rings, A 5660. Photo: NHML

A temple ring is a loop with one blue glass bead and an attached pendant decorated with radial rays (see fig. 1, 2). In the body of the blue glass bead, significant amounts of Si, Ca, K, Cu, Fe, Pb, and Co were found, with significant Sr and Zr content. Trace elements such as Ti, Sb, Mn, and Cl were also found. The NHML laboratory results were compared with the Latvian University WDXRF spectrometer S8 Tiger (Bruker, Germany) results and found to be identical except for Na (light elements were problematic to detect with helium-free methods due to small X-ray energy). Copper alloy elements (loops, rings, pendants) have a similar composition with dominant elements such as Cu, Sn, and Pb. Silver was found in trace elements, and it is difficult to conclude whether silver is a lost gilding part or a part of the copper alloy.

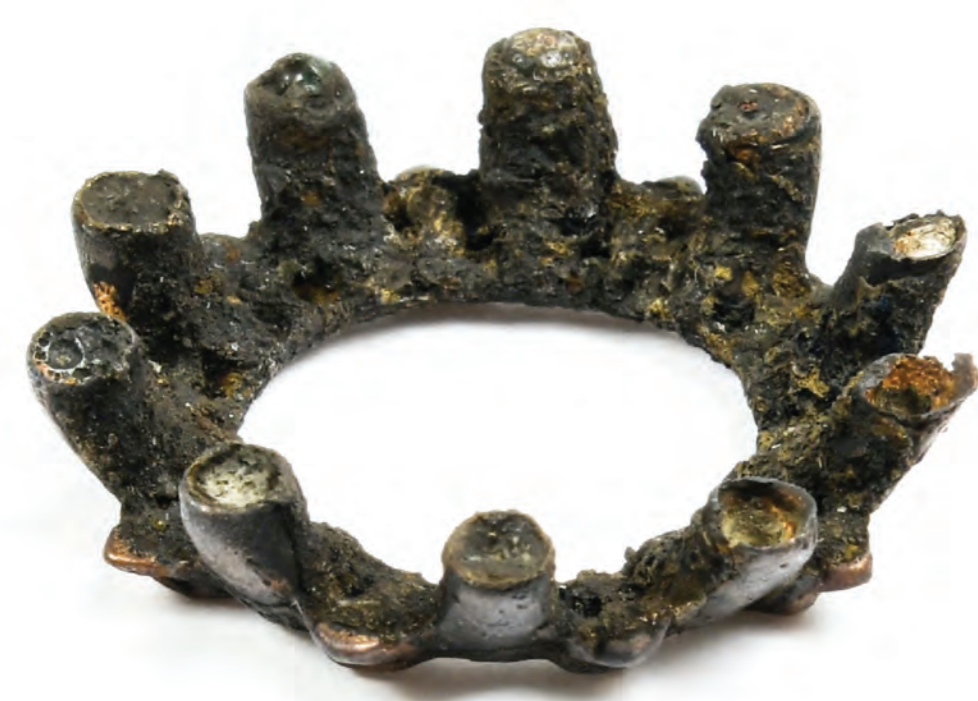
Fig. 3. Fibula, 1694/21a. Photo: NHML

The fibula is circular in shape, and the outer face features ten raised circular turreted collets (see fig. 3). The reverse is flat, and the pin is absent. Two green glass stones and one brown glass stone remain at the collets of the fibula and one of the glass stones (brown) is presented separately. In the glass stones significant amounts of Si, Ca, and K were found, while Mn and Ti were found in trace elements. According to the XRF data, the glass stones are divided into two types: type A (green), where the dominant elements are lead and copper, and type B (brown), where the dominant element is calcium, with significant Zn, Fe, Pb, Sr, and Zr content. Traces of calcium carbonate remain in some of the collets, more often at collets where type B glass stones were found. Zn and Sr were also detected in these white residues. In the body of the fibula, Cu, Zn, Sn, and Fe were found, while Pb and As were found in trace elements. On the surface of the fibula, unique blue copper sulphide crystal aggregates were found, which were the reason for leaving corrosion products on the fibula's surface (see fig. 4, 5).

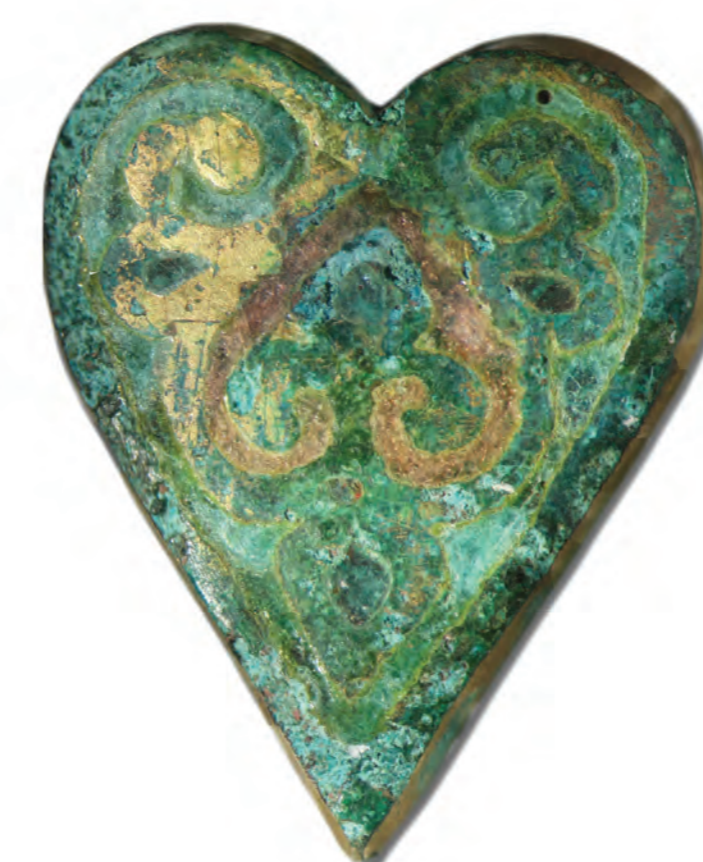
Fig. 6. Metal binding, VI 146:916. Photo: A. S.

The metal binding is in the shape of a heart with two spiral and four drop-shaped glassy elements and traces of gold gilding on the outer face (see fig. 6, 7). The reverse is flat, and the pin's fragment is present. At the body of the metal binding, Cu, Sn, Pb were found, and the precision detection of the alloy's content was problematic due to gold gilding, corrosion products present, and the interreaction of enamel's elements. At the enamel's content, different quantities of Si, Ca, K, Cu, and Mn were found, while Ti was found in trace elements. According to the XRF data, the enamels were divided into four types: type A (brown), where the dominant elements are Pb and Mn; type B (green), where the dominant elements are Pb and Cu; type C (dark green I), where the dominant elements are Ca and Cu; and type D (dark green II), where the dominant elements are Pb, Cu, and Mn (see fig. 8).
