ENHANCED INVESTIGATION OF THE COMPOSITION OF THE VALMIERMUIŽA CASTLE TOWER GROUND FLOOR CEILING'S MONUMENTALLY DECORATIVE PAINTING

EVITA LAMASA, M.A.
Restorer
merkuss@gmail.com
Latvia

INGŪNA STROŽA, M.A.
Restorer
inguna.stroza@gmail.com
Latvia

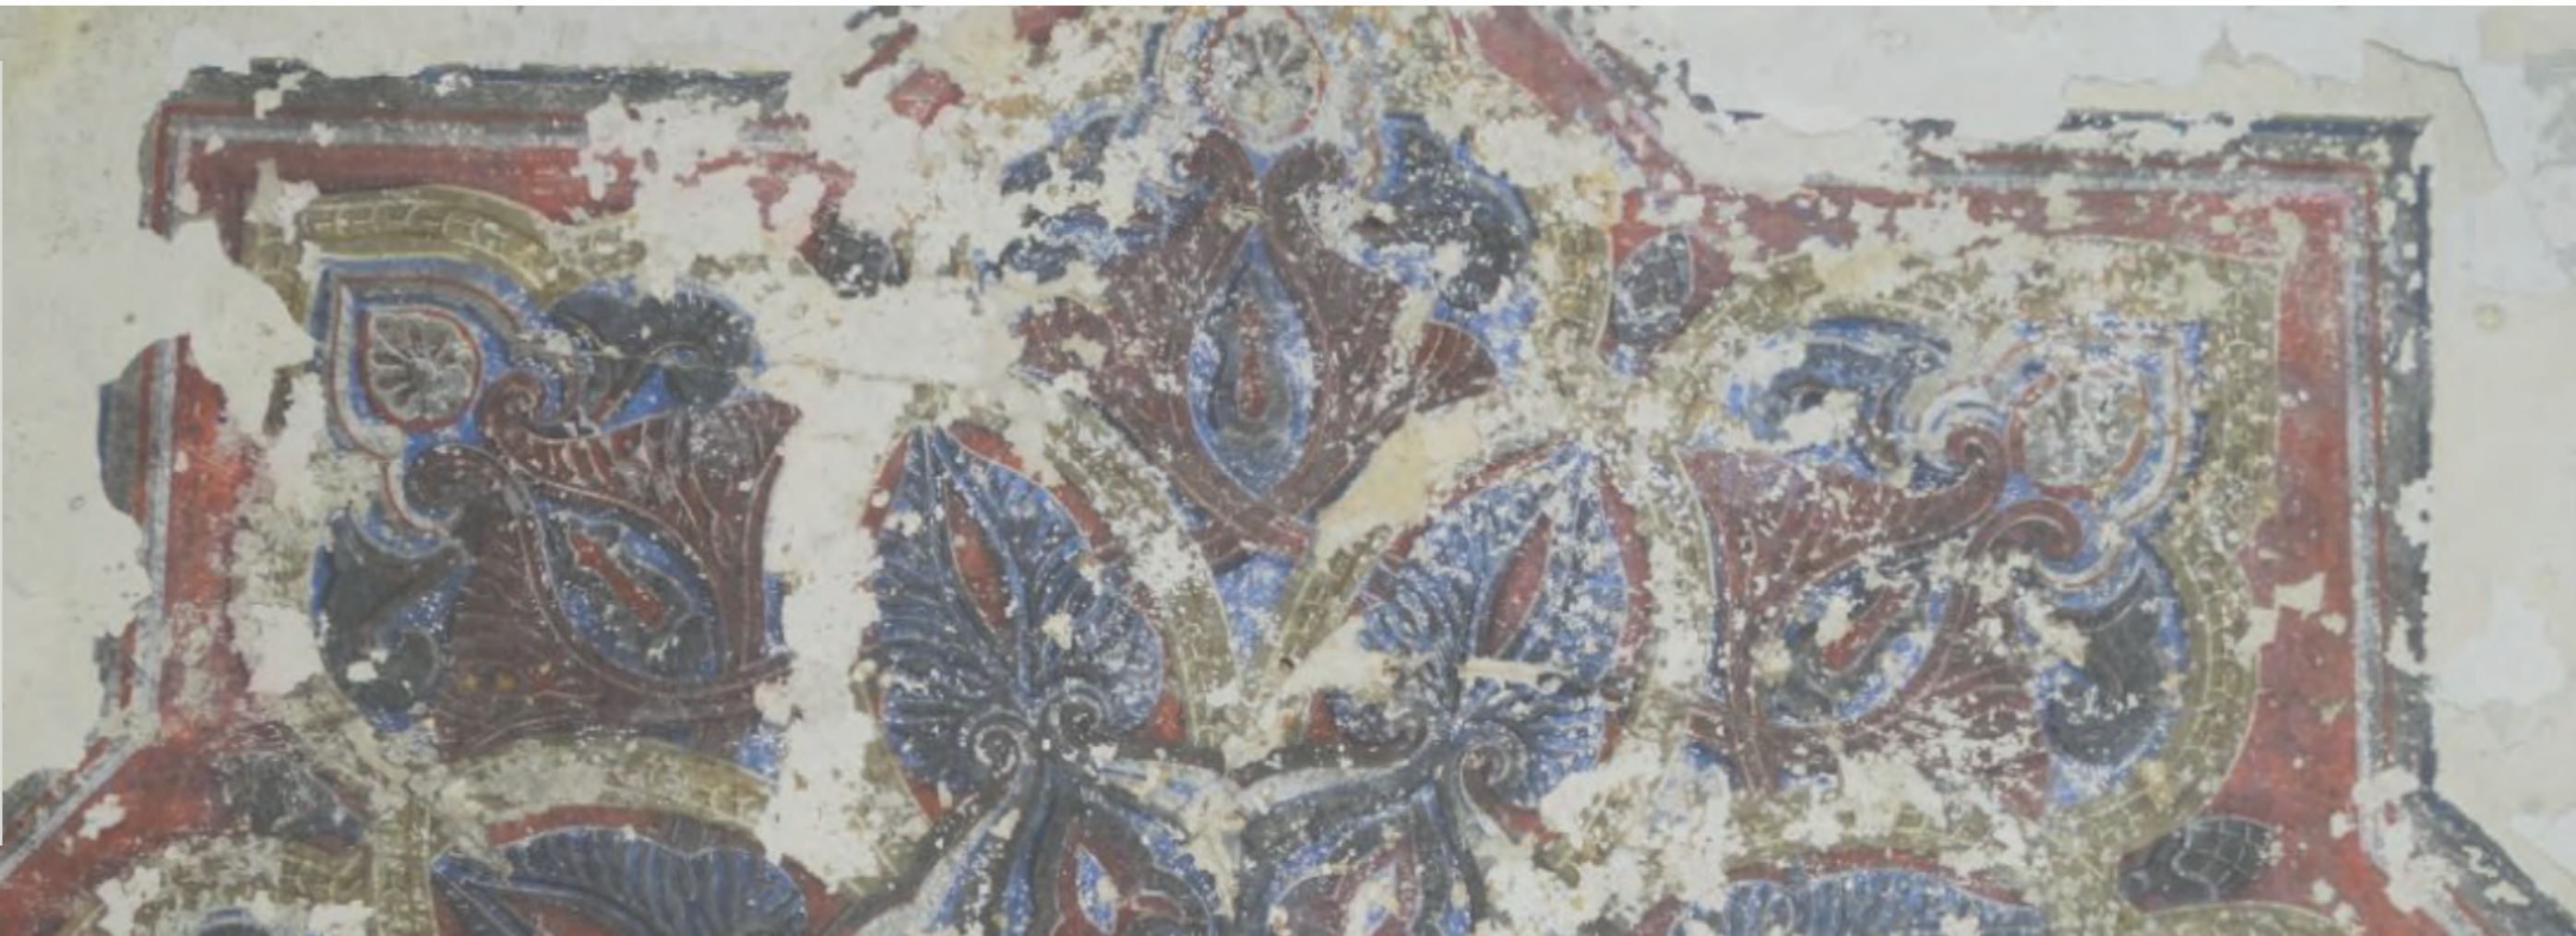
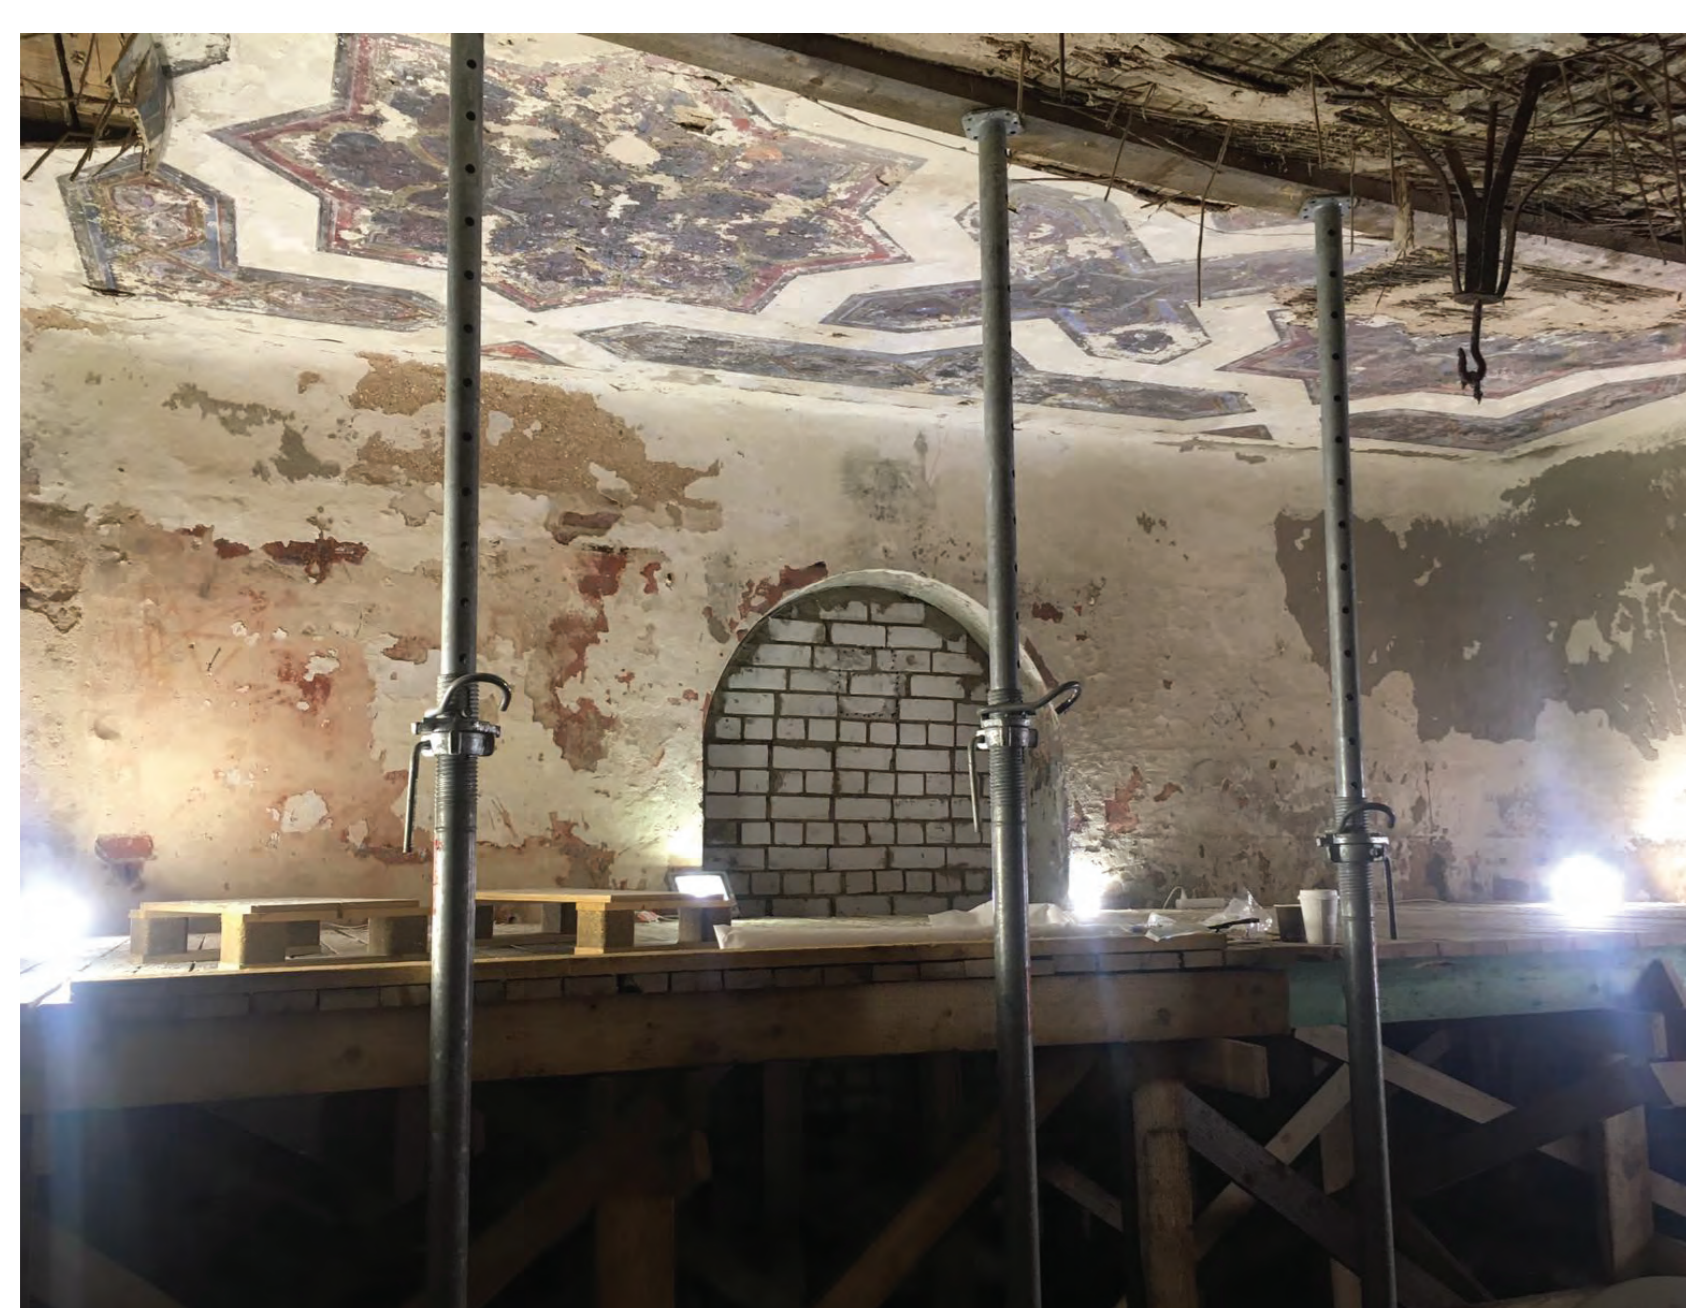
Fig. 2. The Valmiermuiža Castle tower's ground floor ceiling's monumentally decorative painting composition

The entire paint layer is covered by a comparatively thick layer of grime. The overall loss of the paint layer on the ceiling is ~ 65 % (Fig. 2.1). The monumentally decorative ceiling painting is in an emergency condition - fragile, crumbling and breaking up into a fine craquelure. Under the impact of pressure, the paint chips have become detached from the base and become rolled-up, forming scales.

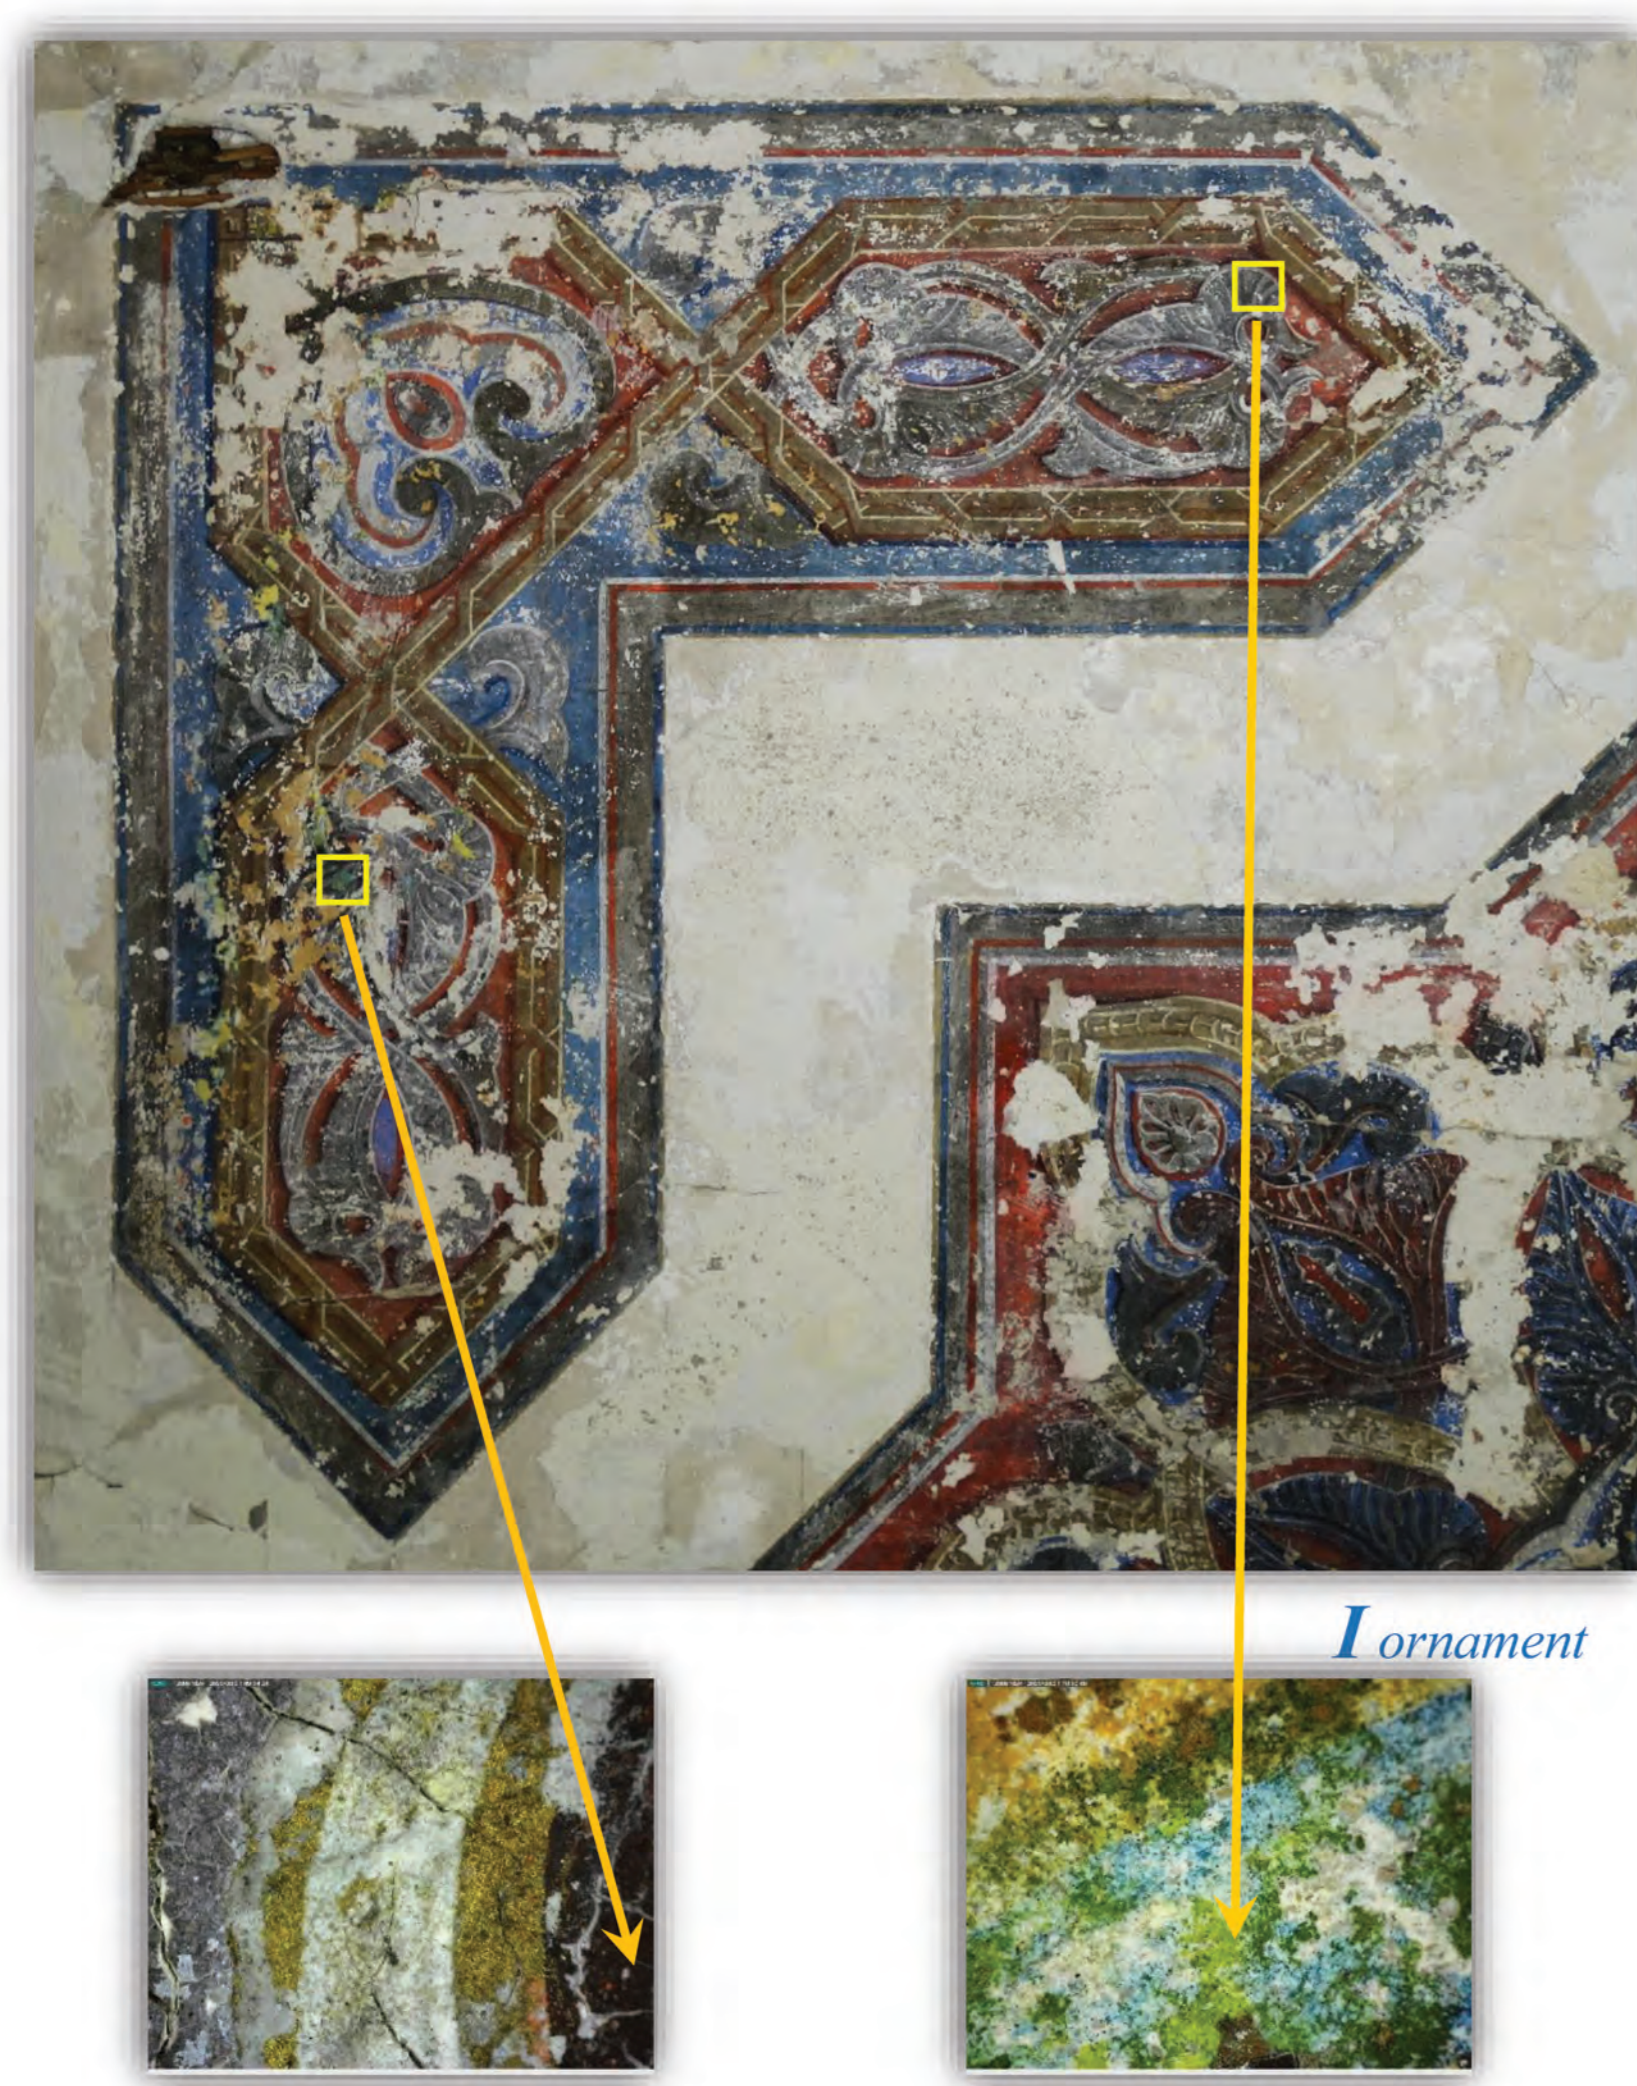
Fig. 7. I ornament of the monumentally decorative ceiling painting composition

I ornament

4th sample 2nd periods

7th sample 1st period

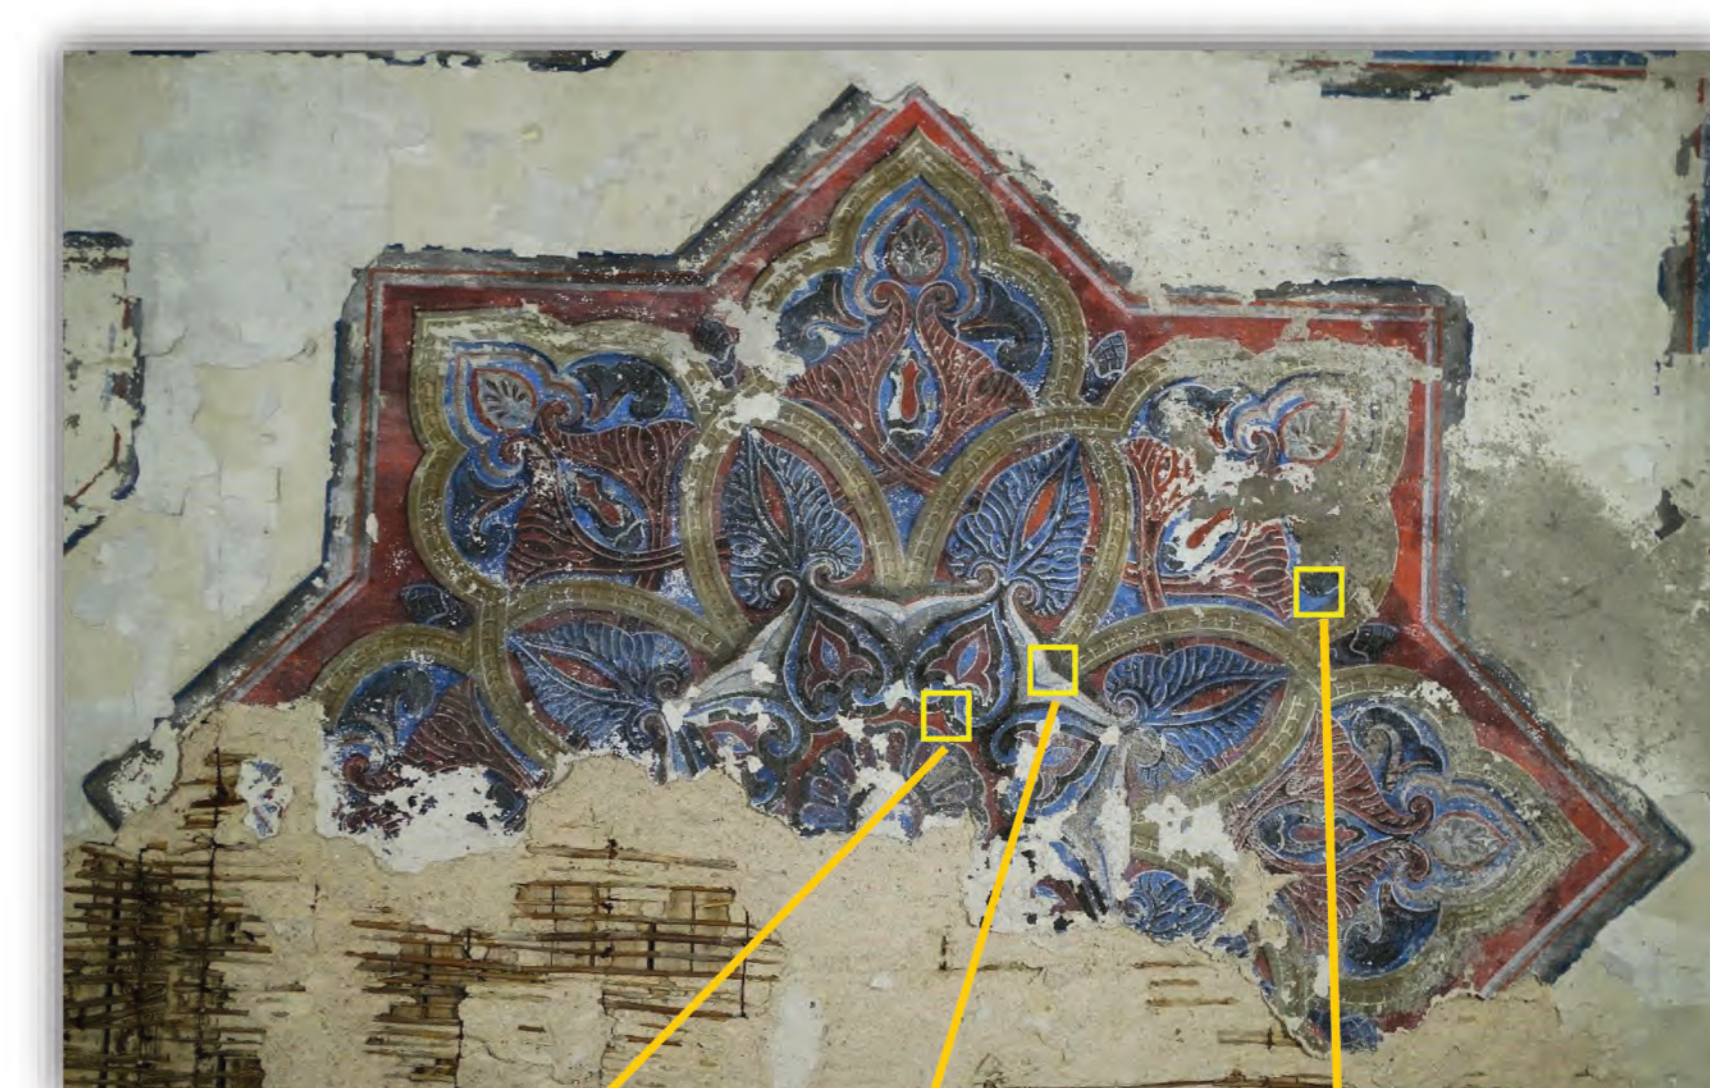
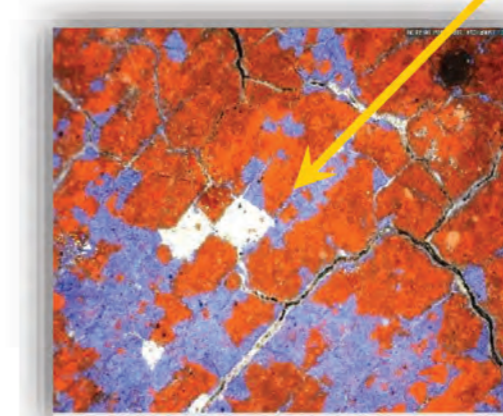
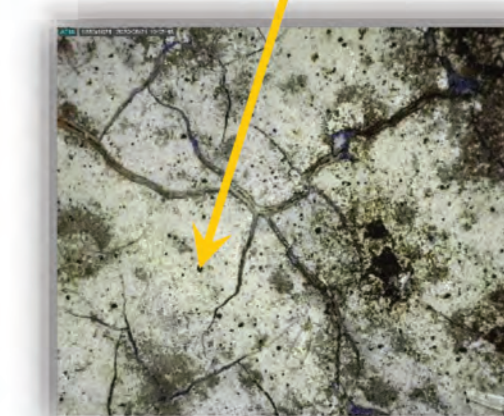
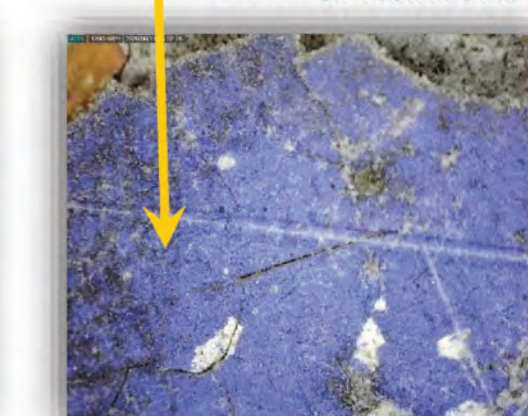
Fig. 6. IX ornament of the monumentally decorative ceiling painting composition

IX ornament

3rd sample 2nd period

5th sample 2nd period

2nd sample 2nd period

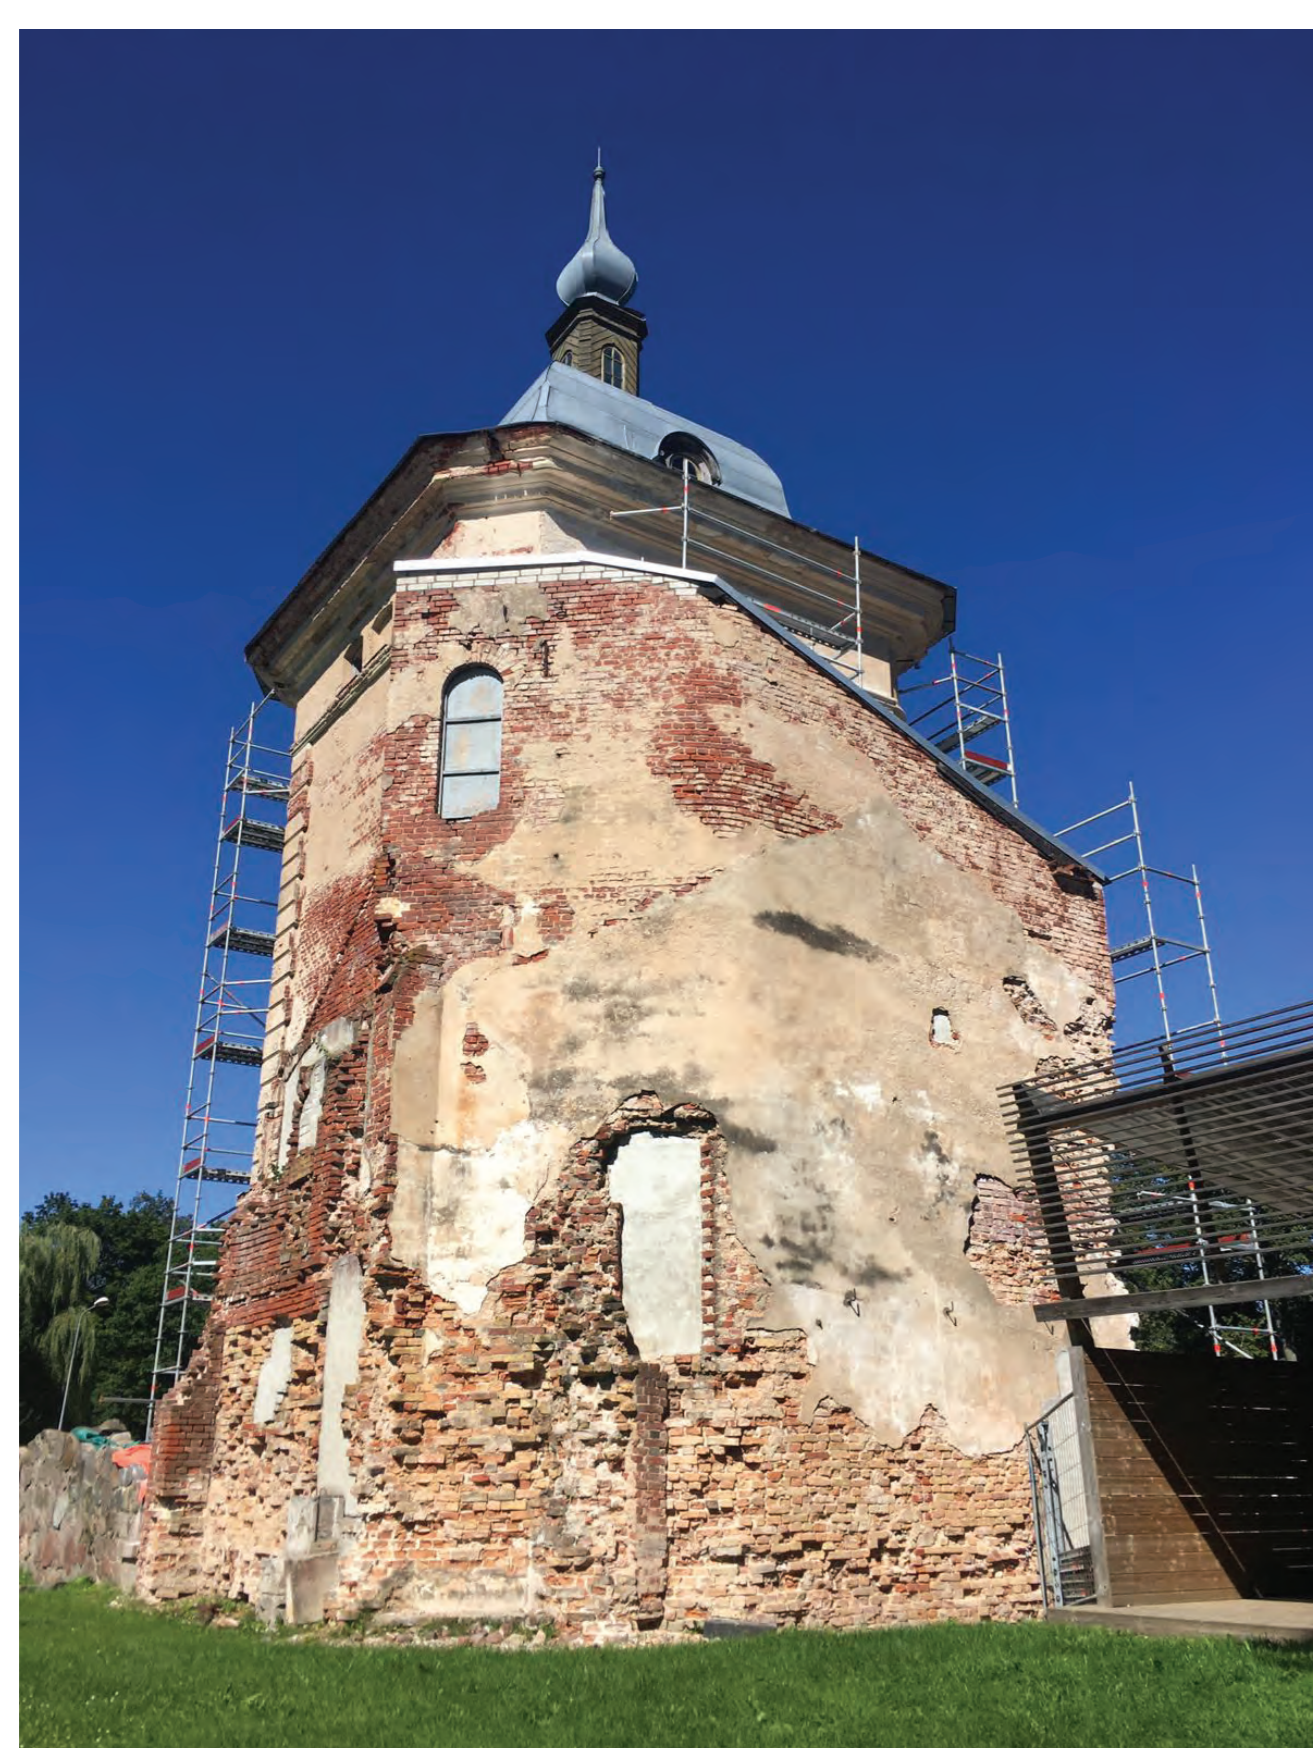
Fig. 1. Valmiermuiža Castle tower, 2020

No serious capital repair work had been undertaken on the tower for an extended period, which is why there is damage mainly of a technical nature (holes in the roof, open window apertures without window frames or glass), which has created serious damage in the interior's artistic finish. The painting has been subjected to radical weather fluctuations (air humidity and temperature), corresponding to seasonal changes in the weather and the impact of wind (dust and pollen).
